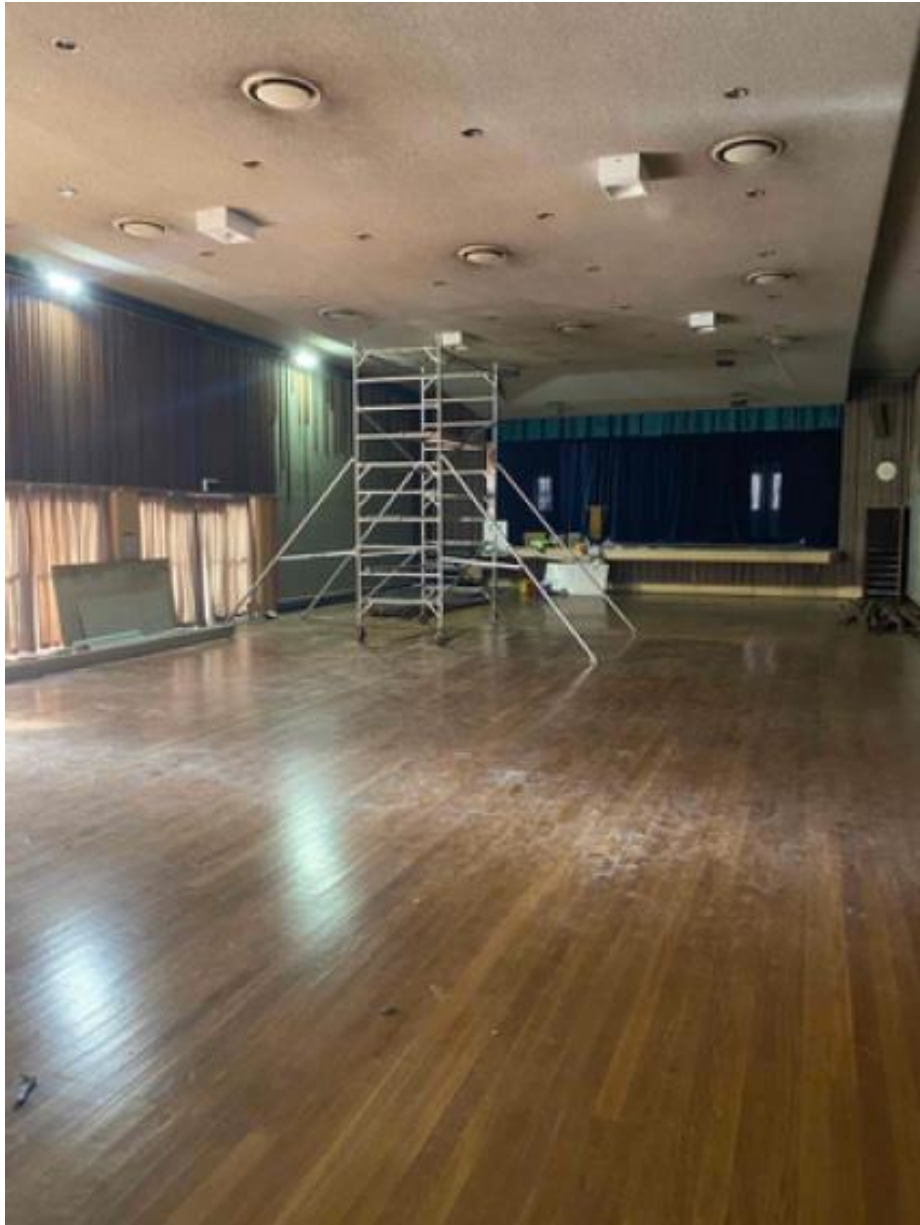
Lead Dust

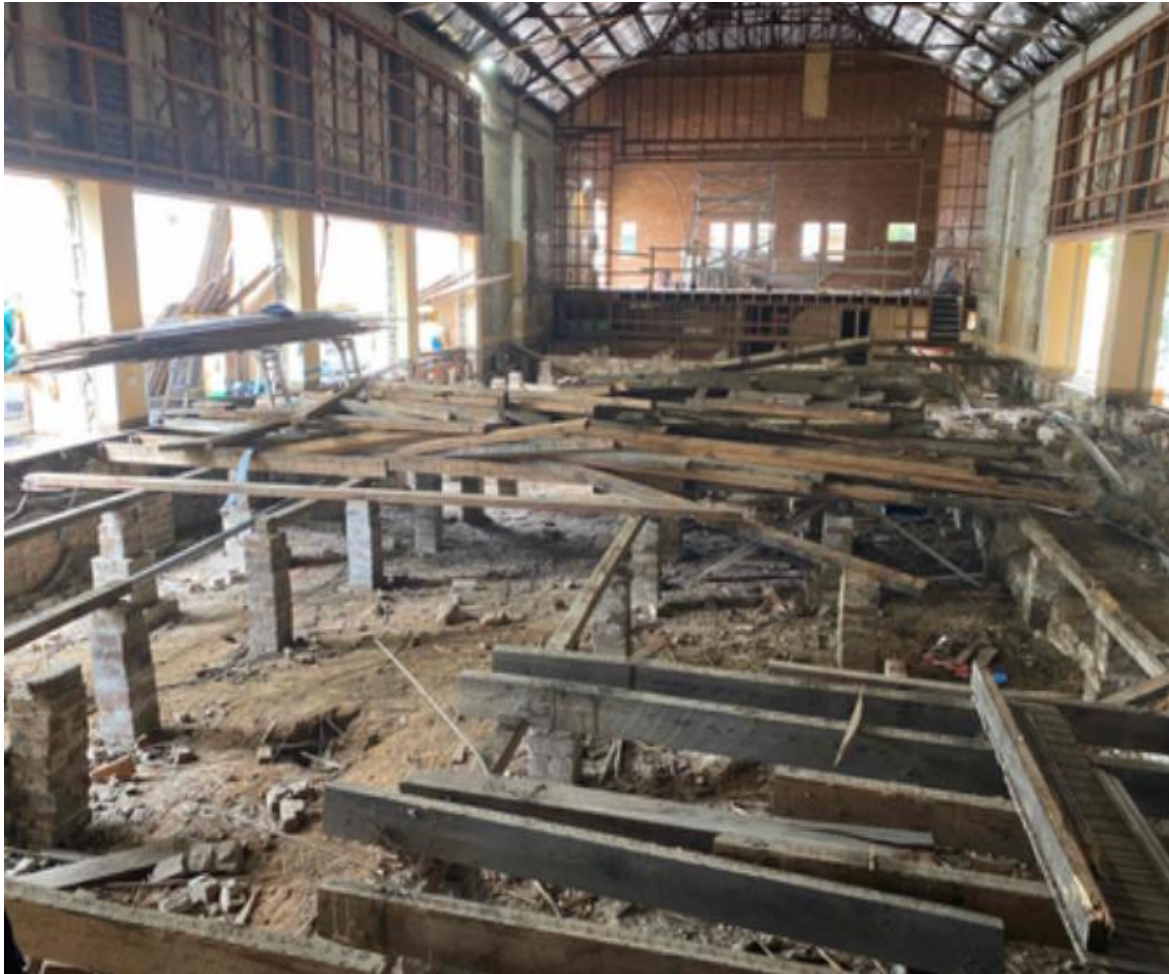
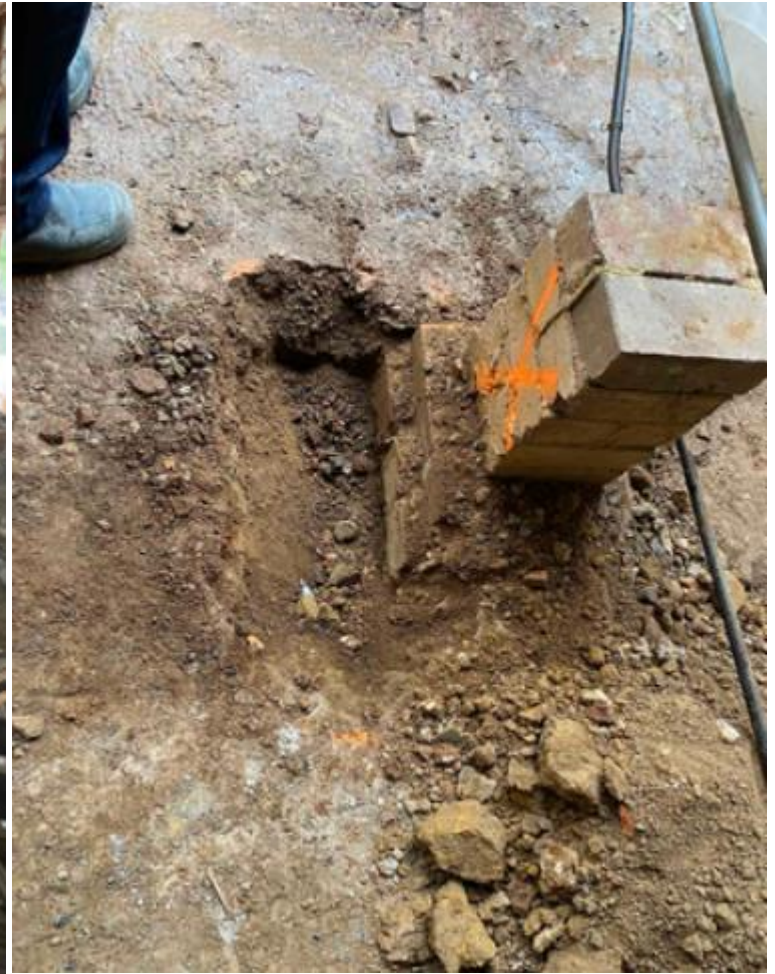
Failing footings

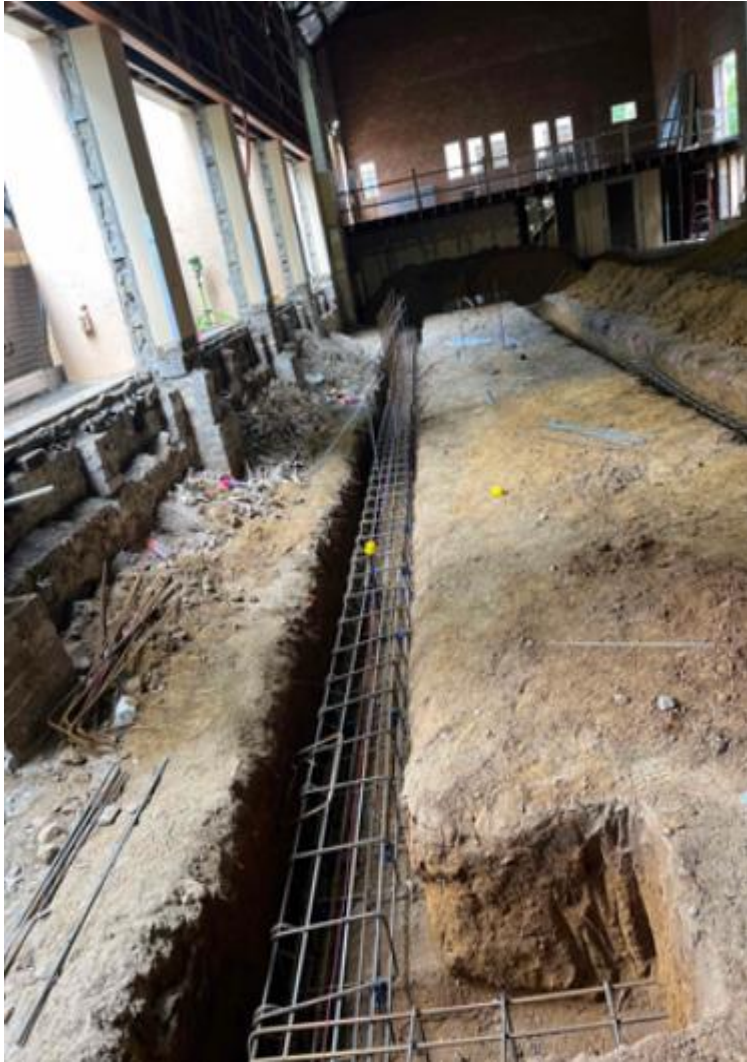
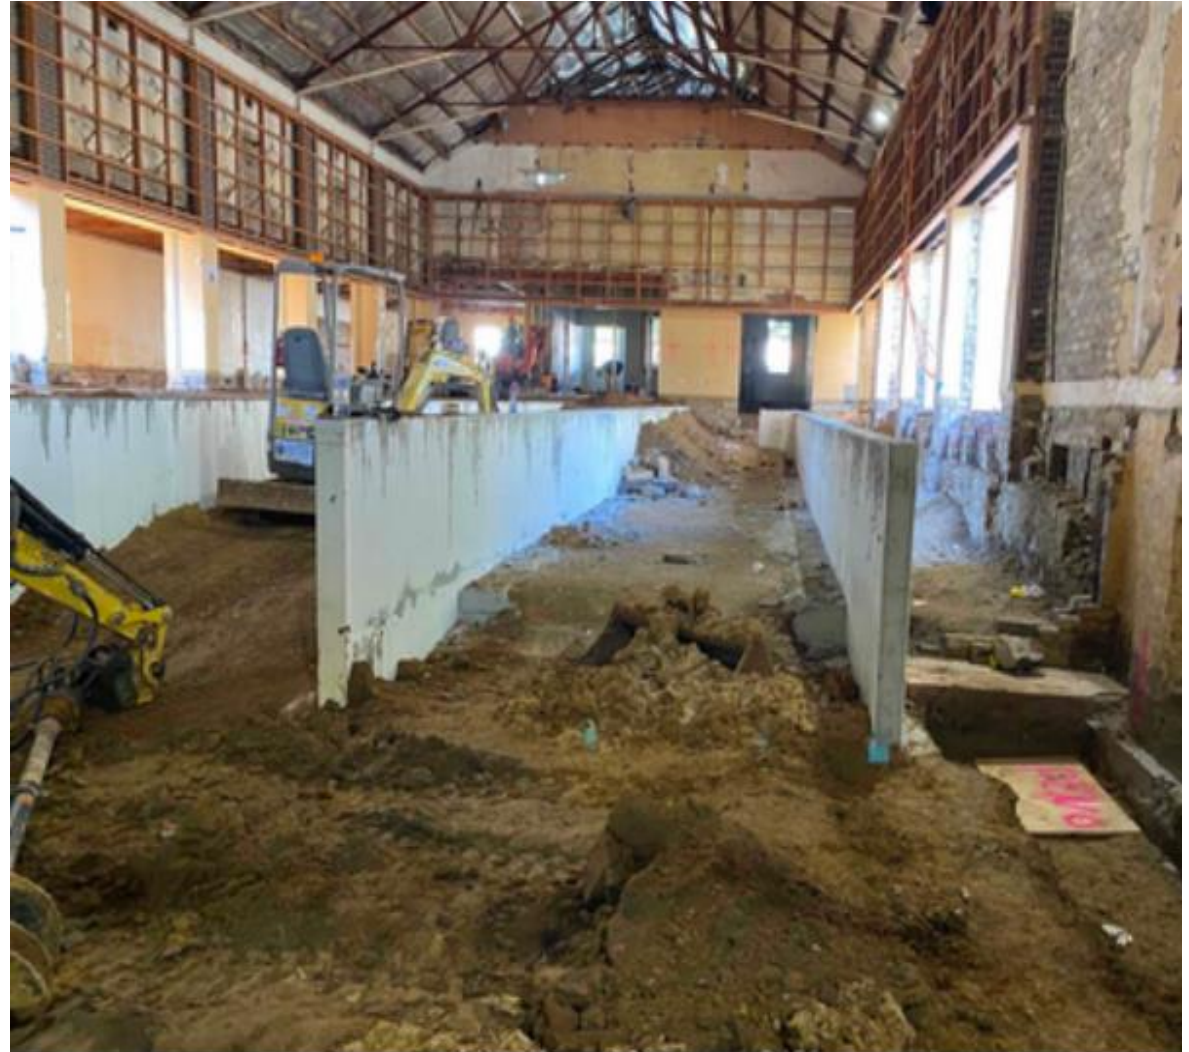
New footing system

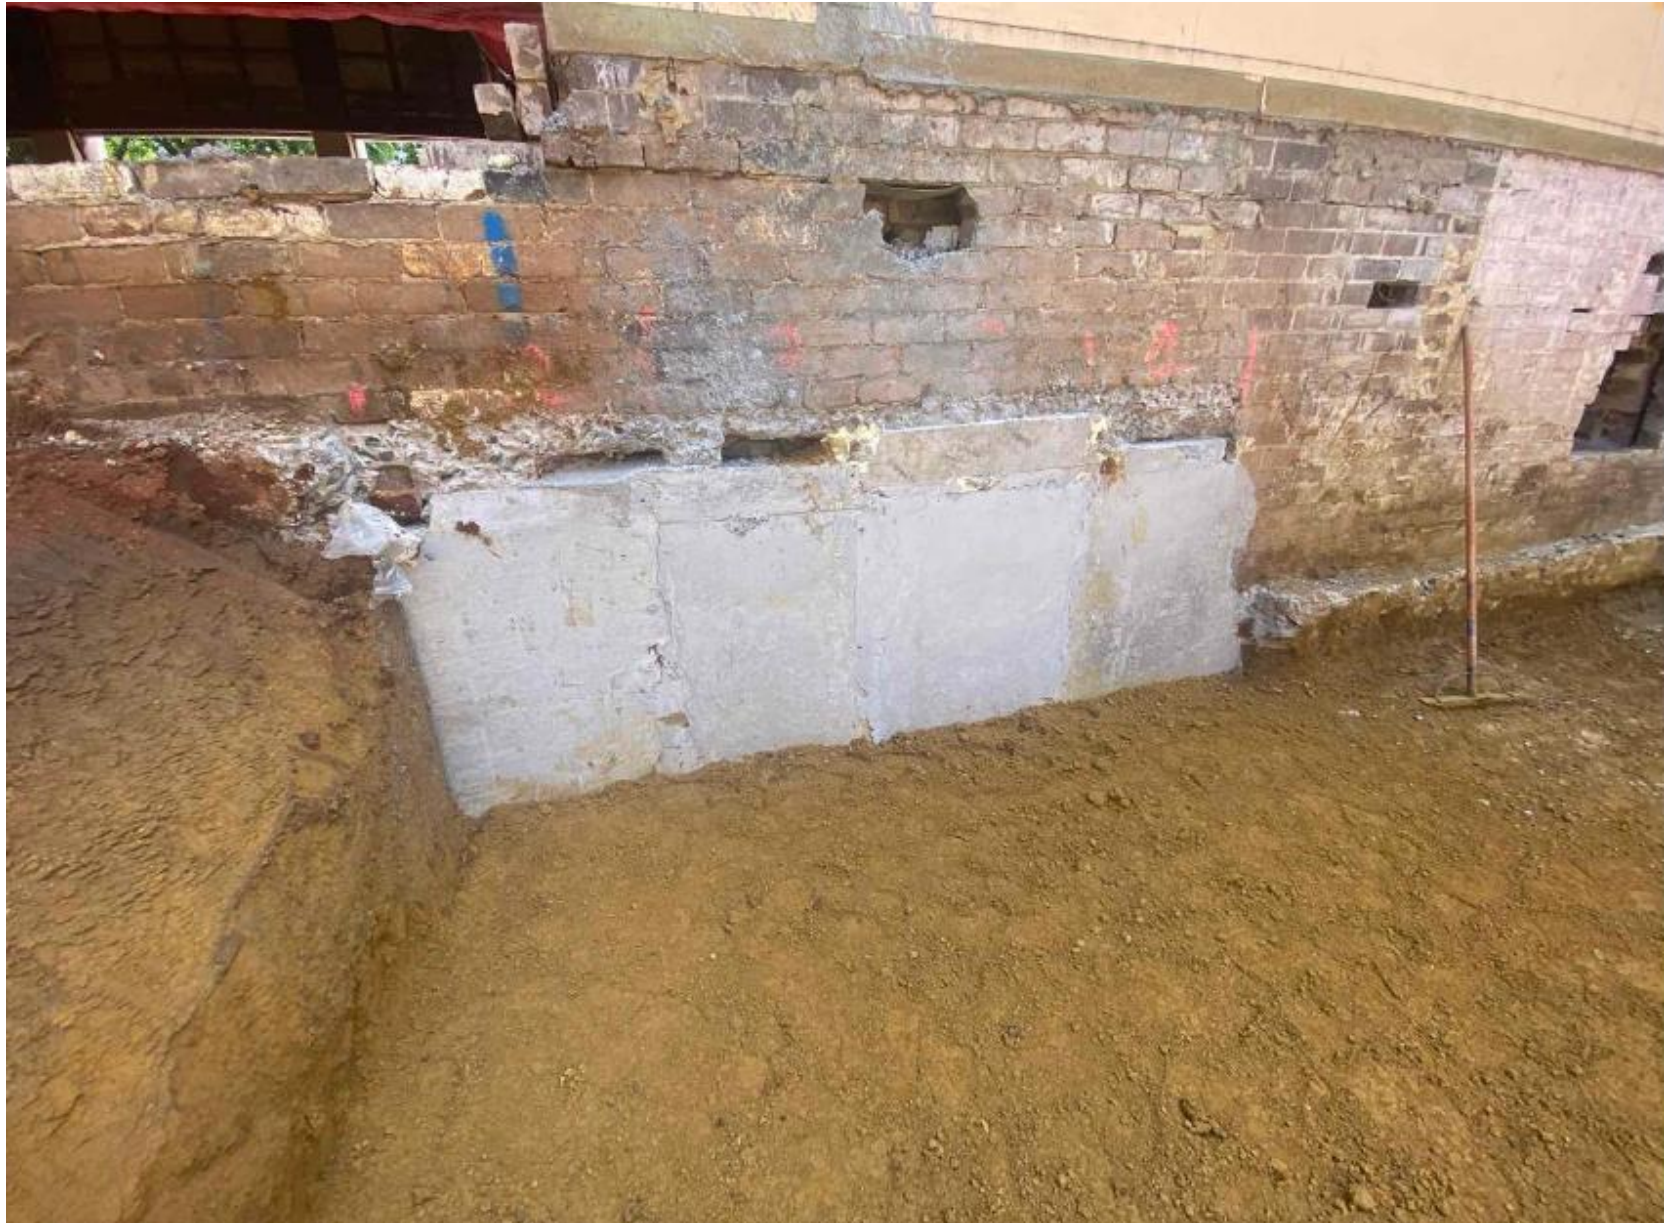
Southern Wall structural failure

Underpinning to Southern wall

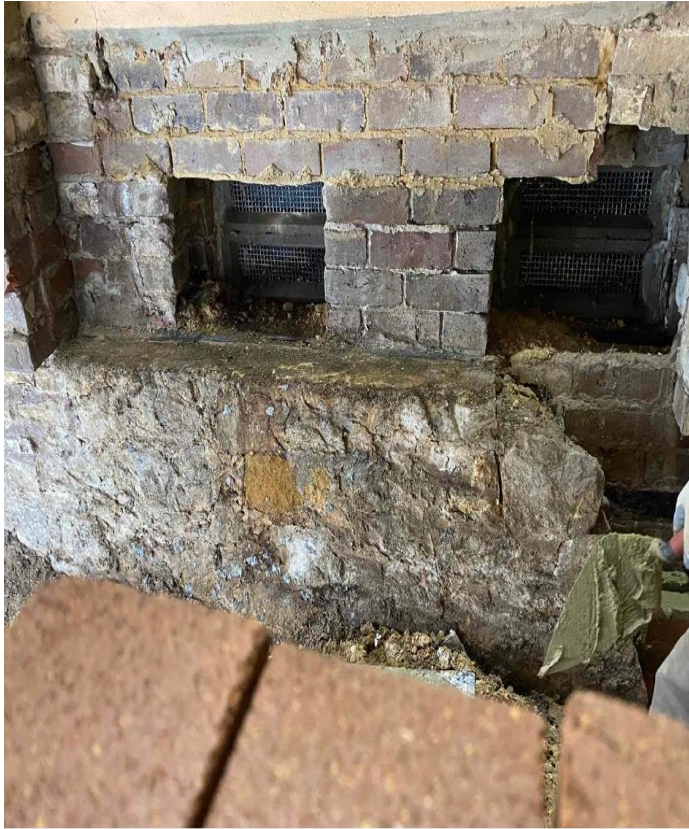
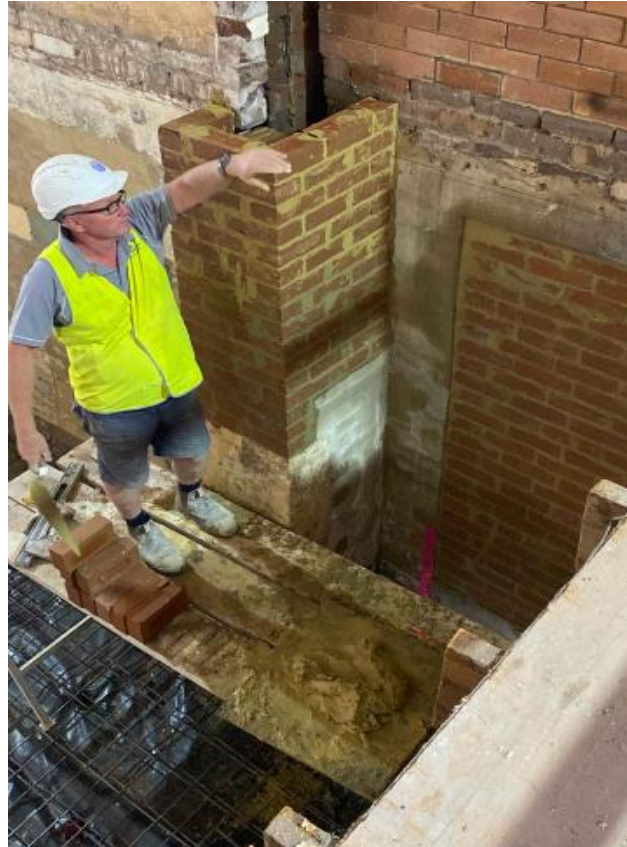
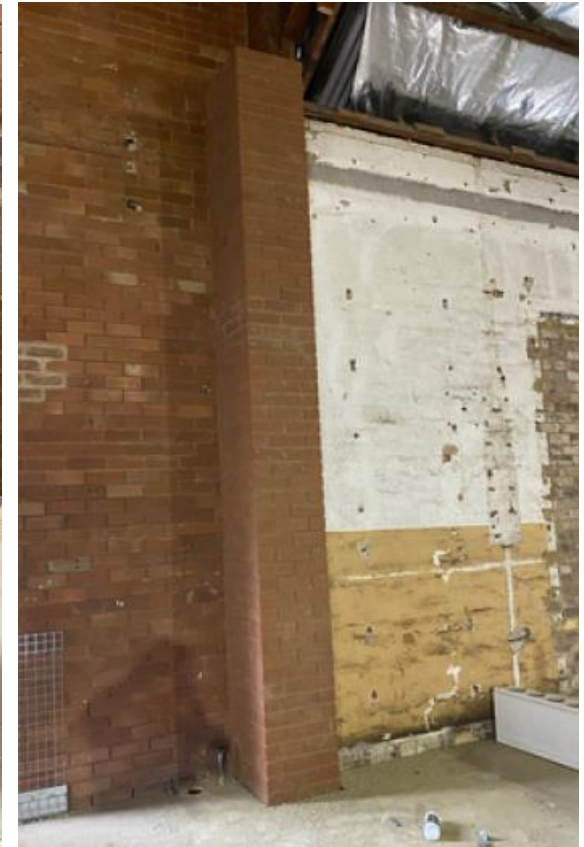
Failed wall and pier repairs

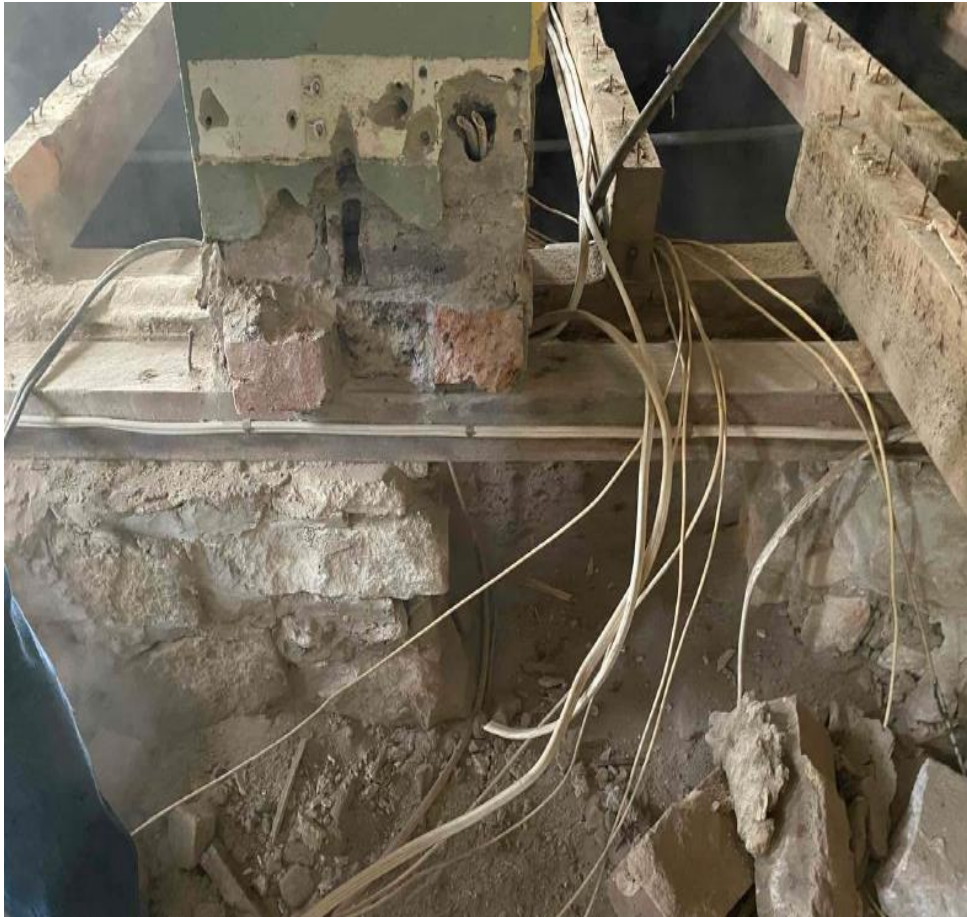
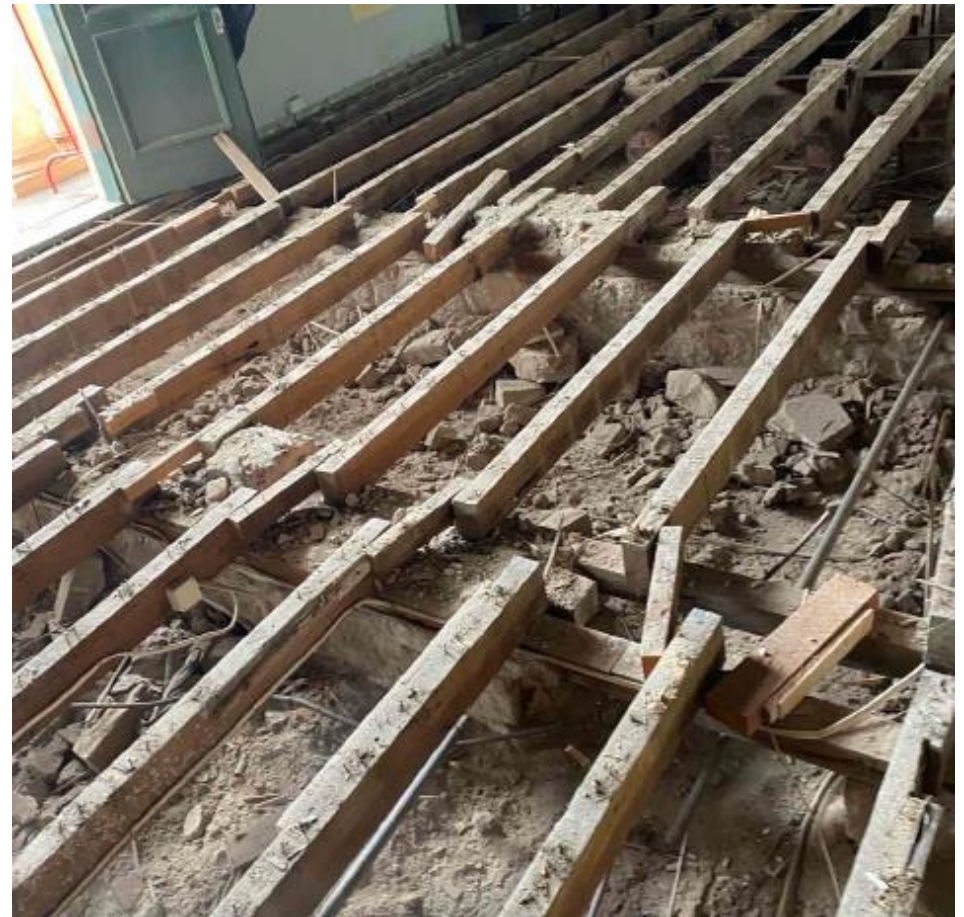
Entry foyer footings & asbestos

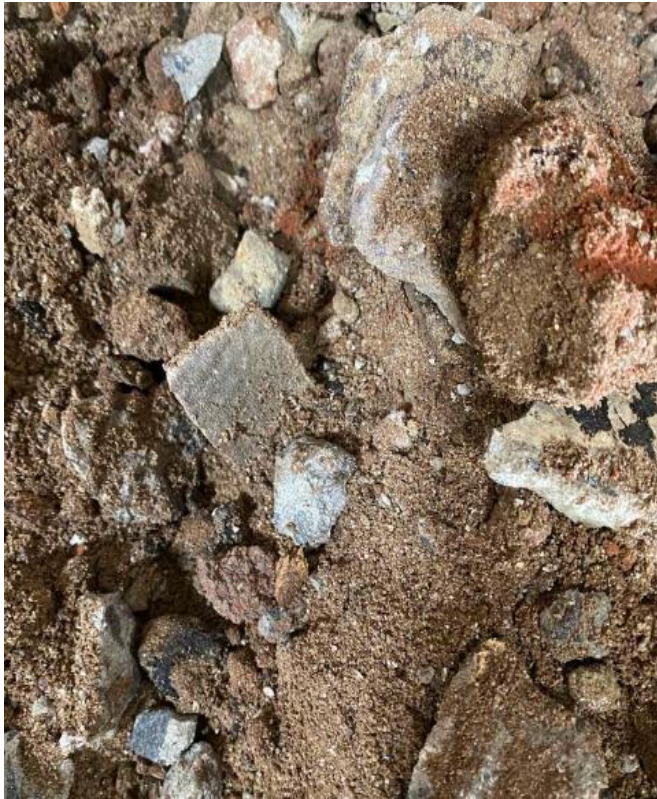
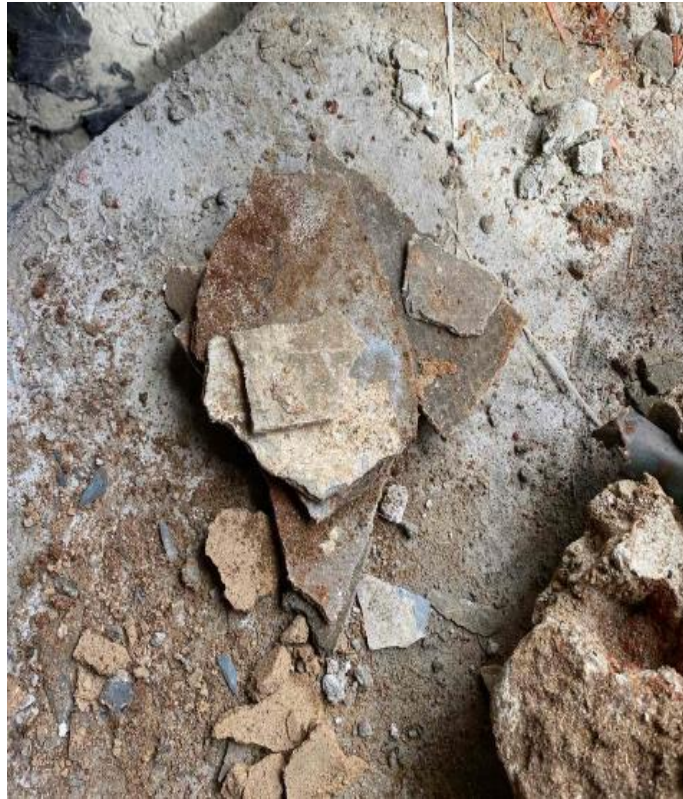
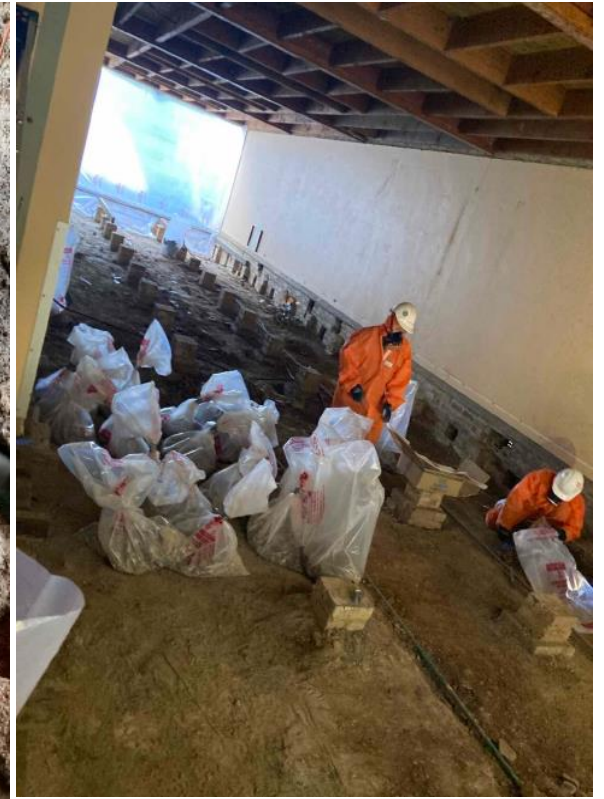
Failing footings in foyer floor
