Vegetation Management Plan

Erith Street, Bundanoon NSW 2578

Report prepared by Narla Environmental Pty Ltd

Project no:	CDSO1 var1
Date:	August 2022
Version:	Final v3.0

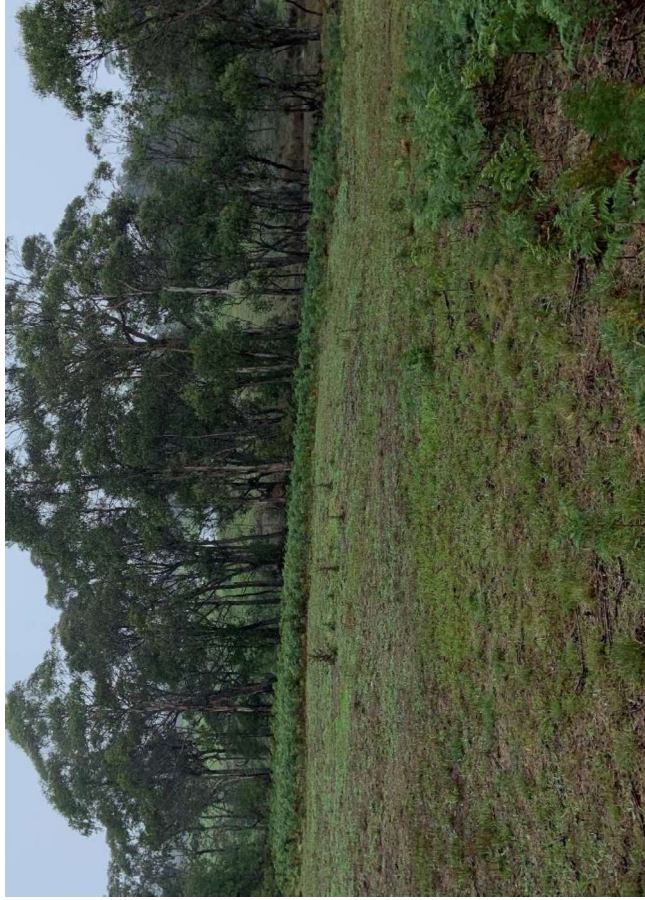
Management Zone 1 – Development Footprint (Wholesale Clearing Area)
Approximate Area = 4.21ha

This Management Zone encompasses the area of the proposed subdivision that will require wholesale vegetation removal to facilitate the proposed building envelopes, driveway, fence buffer areas and drainage systems. Vegetation consisted of poor-moderate quality Plant Community Type (PCT) 944; Mountain Grey Gum – Narrow-leaved Peppermint grassy woodland on shales of the Southern Highlands, southern Sydney Basin Bioregion. Plant Community Type 944 is a component of the Endangered Ecological Community, Southern Highlands Shale Woodlands in the Sydney Basin Bioregion (SHSW). Patches of native canopy species were present including *Eucalyptus cypellocarpa*, *E. globoides*, and *E. radlata*. This zone also included areas typical of a historically cleared landscape with no trees or shrubs present. The groundlayer was comprised of regenerating native grasses and groundcovers with a high abundance of the Priority Weed, *Rubus fruticosus*. Other environmental weeds were also present including *Cirsium vulgare* and *Paspalum dilatatum*.

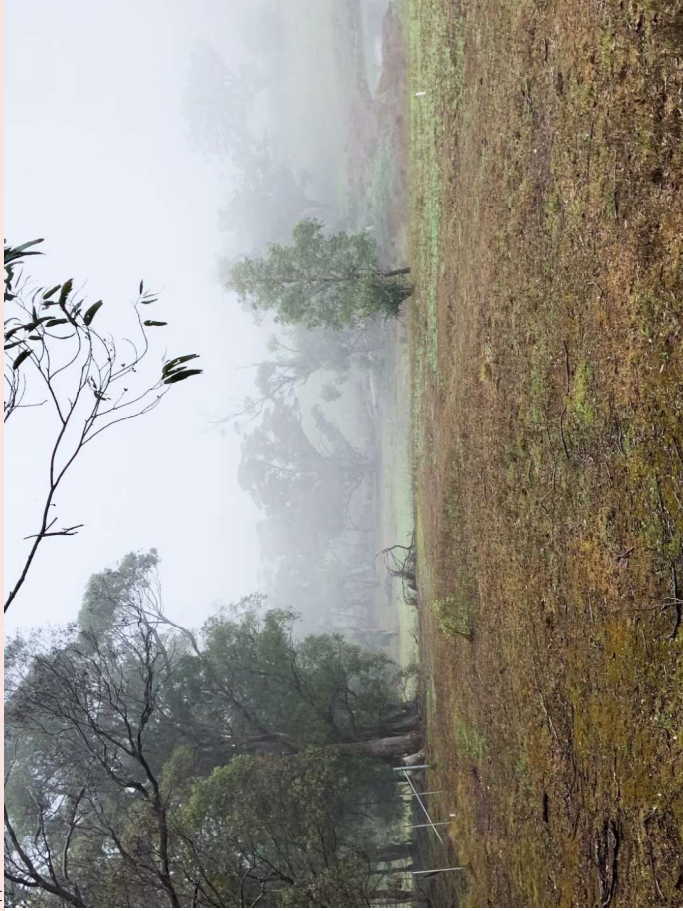
Management Zone 2 – Development Footprint (Inner Protection Area)

This Management Zone encompasses the Inner Protection Area (IPA) (excluding the proposed 88b easement) of the Protection Zone as described by Harris Environmental. The majority of the vegetation within this zone consisted of grassland condition PCT 944 along with patches of remnant canopy species. Grassland condition PCT 944 contained exotic grasses and groundcover species such as *Cirsium vulgare*, *Hypochaeris radicata*, and *Paspalum dilatatum*. Native species present included *Lomandra filiformis* and *Microlophena stipoides*. The Priority Weed, *Rubus fruticosus*, was also present. Patches of remnant canopy species included *Eucalyptus radiata*, *E. globoides* and *E. cypellocarpa*.

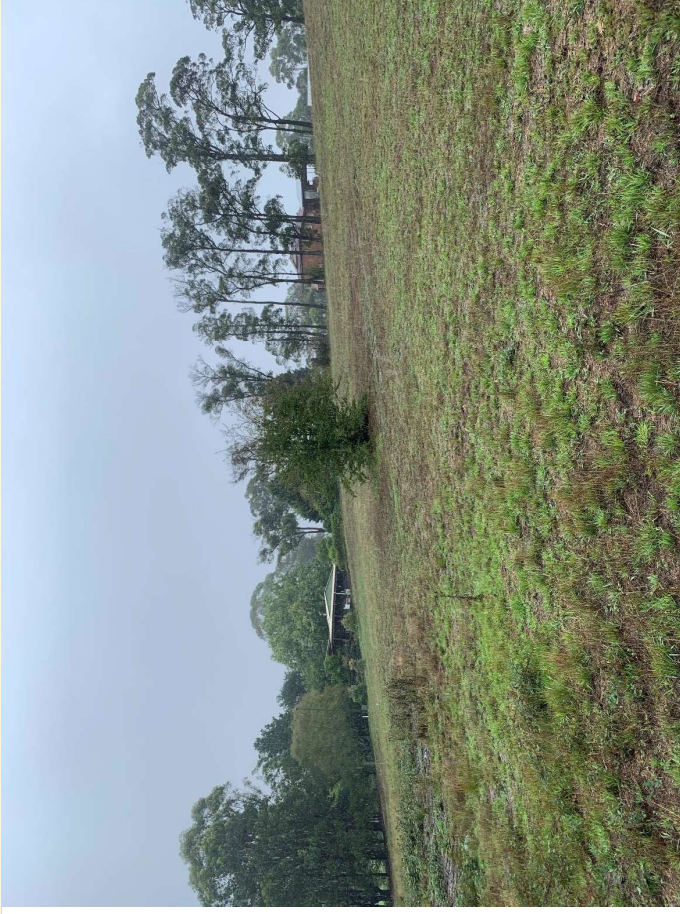
Management Zone 3 – Proposed 88b Easement (IPA)
 Approximate Area = 0.13 ha

This Management Zone encompasses the section of the proposed 88b easement that is required to be managed as an Inner Protection Area (IPA) as described by Harris Environmental (2022). The majority of the vegetation within this zone consisted of grassland condition PCT 944 along with patches of remnant canopy species. Grassland condition PCT 944 contained exotic grasses and groundcover species such as *Cirsium vulgare*, *Hypochaeris radicata*, and *Paspalum dilatatum*. Native species present included *Lomandra filiformis* and *Microlaena stipoides*. The Priority Weed, *Rubus fruticosus*, was also present. Patches of remnant canopy species included *Eucalyptus radiata*, *E. globoides* and *E. cypellocarpa*.

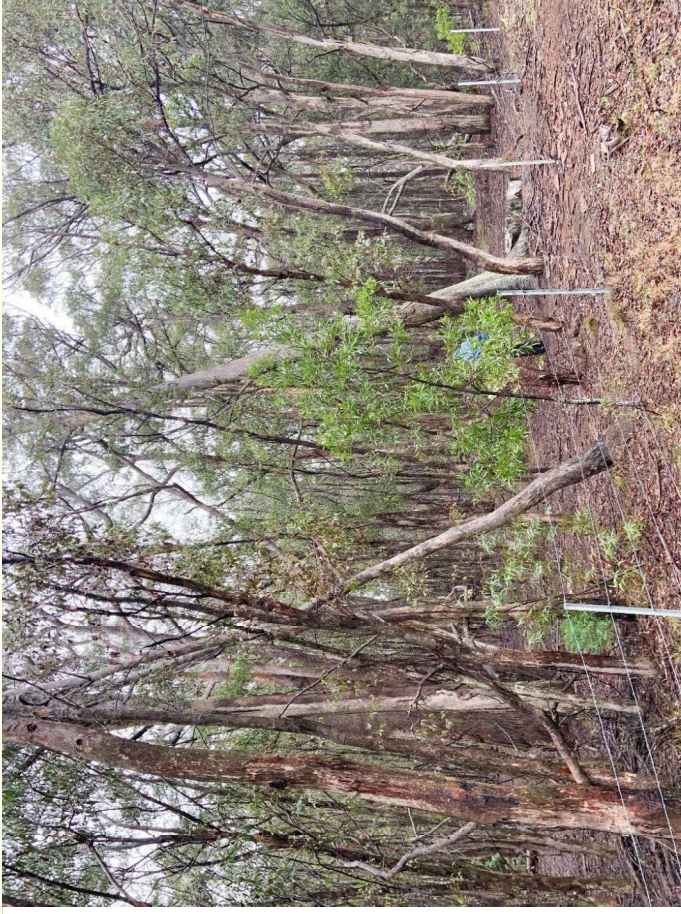
Management Zone 4 – Proposed 88b Easement (oPA)
 Approximate Area = 0.11 ha

This Management Zone encompasses the section of the proposed 88b easement that is required to be managed as an Outer Protection Area (OPA) as described by Harris Environmental (2022). Vegetation within this zone consisted of canopy condition PCT 944, a component of SHSW, along with patches of grassland condition PCT 944. Canopy condition PCT 944 contained *Eucalyptus radiata*, *E. globoides* and *E. cypellocarpa*, while the mid-storey and ground layer strata appeared to be altered by historical clearing or under scrubbing, with low overall coverage present. Grassland condition PCT 944 contained exotic grasses and groundcovers including *Cirsium vulgare*, *Hypochaeris radicata*, and *Paspalum dilatatum* with some native species such as *Lomandra filiformis* and *Microlaena stipoides* present. The Priority Weed, *Rubus fruticosus*, was also present.

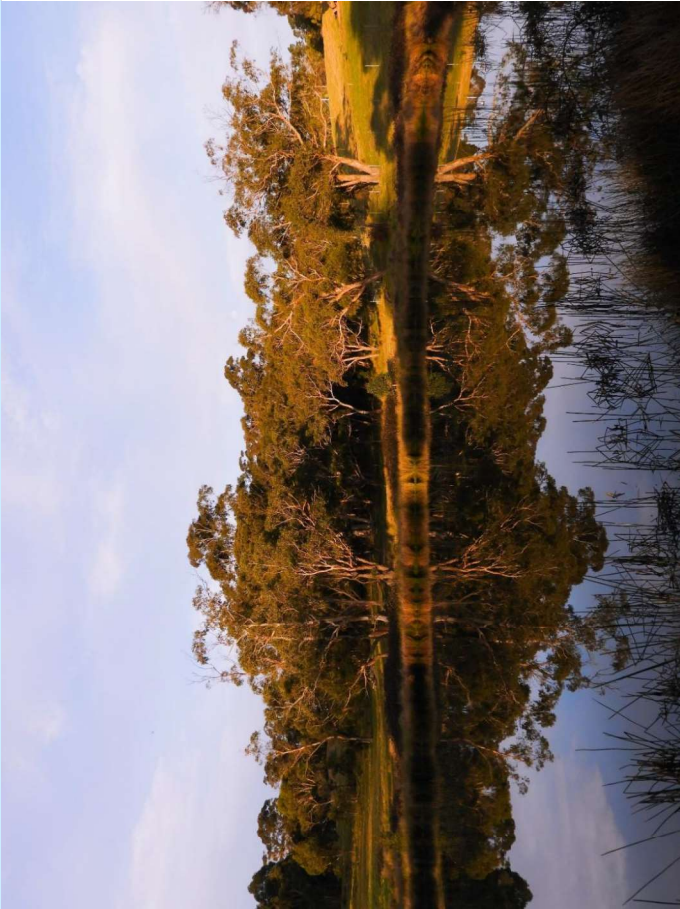
Management Zone 5 – Community Lot (Drainage Reserve)
Approximate Area = 1.34 ha

This Management Zone encompasses the 10m riparian buffer surrounding the 1st order watercourse and adjoining areas along the southern border of the Subject Property which will be dedicated as a "Community Lot" as a result of the proposed subdivision. Vegetation within this zone consisted of poor-moderate quality PCT 944: Mountain Grey Gum – Narrow-leaved Peppermint grassy woodland on shales of the Southern Highlands, southern Sydney Basin Bioregion, a component of SHSW. Patches of native canopy species were present including *Eucalyptus cypselocarpa*, *E. globoides*, and *E. radiata*. This zone also included areas typical of a historically cleared landscape with no trees or shrubs present. The groundlayer was comprised of regenerating native grasses and groundcovers with a high abundance of the Priority Weed, *Rubus fruticosus*. Other environmental weeds were also present including *Cirsium vulgare* and *Paspalum dilatatum*.

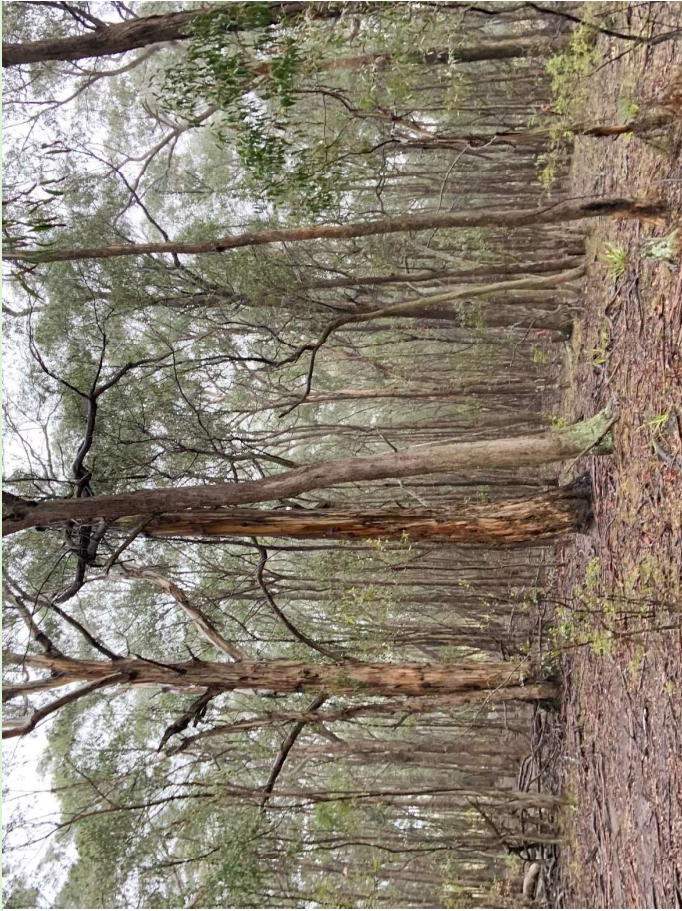
Management Zone 6 – Community Lot (Remnant Bushland)
 Approximate Area = 1.38 ha

This zone exists as a remnant stand of native vegetation in the northern corner of the Subject Property which will be dedicated as a "Community Lot" as a result of the proposed subdivision. Vegetation within this zone consisted of canopy condition PCT 944, a component of SHSW. The vegetation contained low-moderate native species diversity. Canopy species within this zone included *Eucalyptus radiata*, *E. globoides* and *E. cypellocarpa*. The mid-storey and ground layer strata appeared to be altered by historical clearing or under scrubbing, with low overall coverage present. Native species in the mid-stratum included *Acacia stricta*, *Bursaria spinosa*, *Daviesia ulicifolia*, and *Podolobium ilicifolium*. The groundlayer was dominated by *Lomandra filiformis*, *Microlaena stipoides*, and *Rytidosperma* species with minimal weeds present.
