### **ORDINARY COUNCIL MEETING**

Wednesday 25 November 2020

#### **Walking Tracks Strategy**

Draft Walking Tracks Strategy

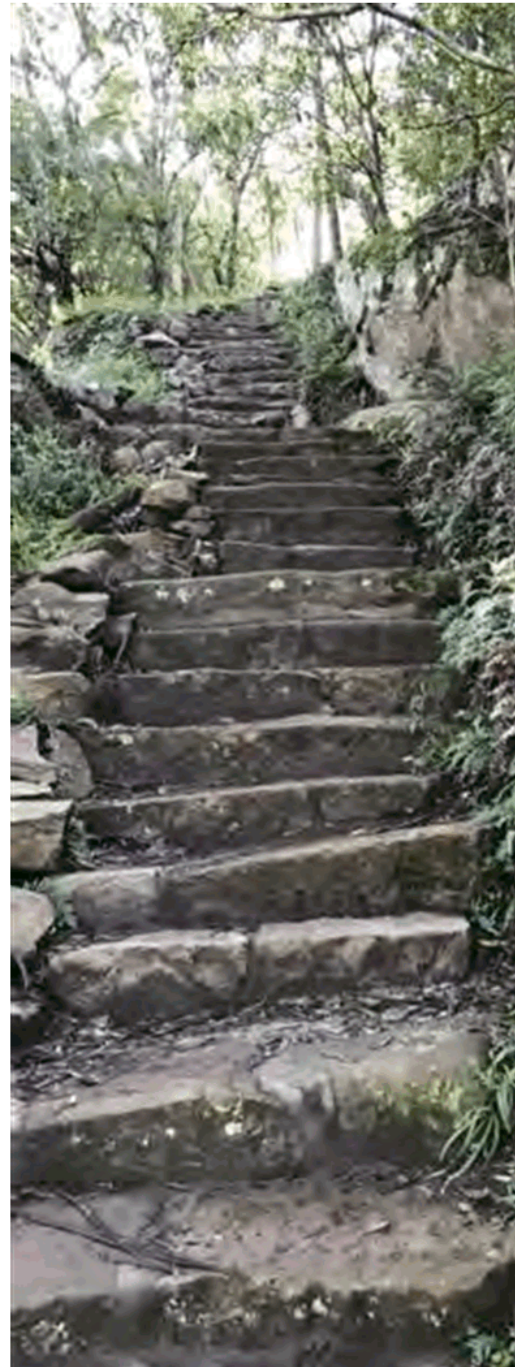
Figure 6: Trail Infrastructure (Heritage Staircase) at Heritage Quarries Circuit (, Mt Gibraltar Reserve

When laying out or planning new work on a track, the choice of track class and the actual structures to be installed should consider the expected number, class of visitors and the recreational opportunities to be provided (see AS 2156.1). In deciding what structures to use it should be remembered that once a structure is in place, it may be difficult to remove without damage to the environment (e.g. a cultural site). The design of elements, choice of materials and colours of structures should cause minimal adverse visual impact on natural areas or culturally significant sites.

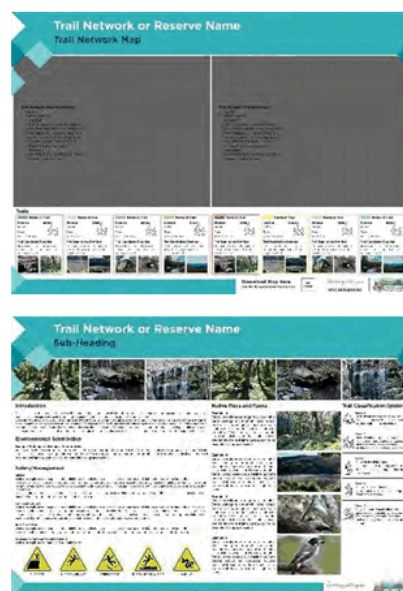
There are two trailhead sign templates. The first is designed to cater for Mt Alexandra which has an extensive network of trails needing two panels to exhibit the required level of information. The second is designed to be tailored to suit the other walking track networks.

Figure 7: Lake Alexandra Trailhead Sign Template – Panels 1 and 2

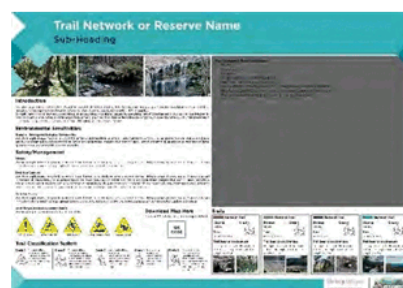
Figure 8: General Trailhead Sign Template

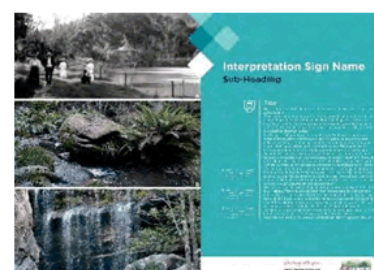
Interpretive signs come in varying shapes, sizes and style. The template provides a proposed style which is consistent with other signage templates, however, this may be further tailored to suit the distinct location and enhance the 'sense of place'.

Figure 9: Interpretation Sign Template

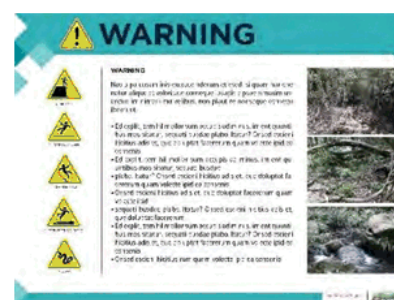
Figure 10: Management Warning Sign Template

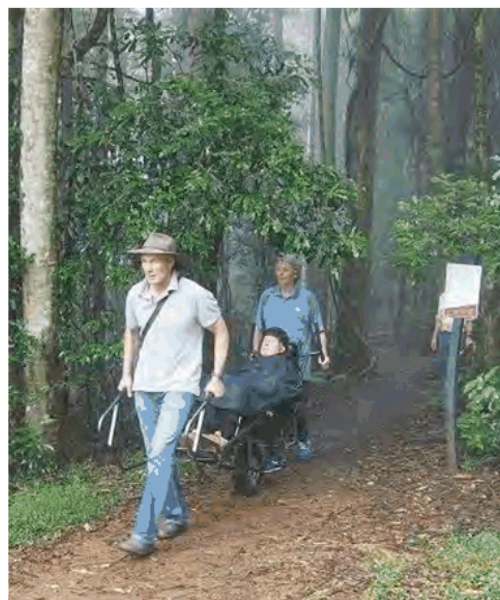
There are innovative ways of providing trail access to people of varying abilities. For example, The NSW National Parks and Wildlife Service (NPWS) has a program which provides an all-terrain wheelchair, known as a TrailRider, for visitors at national parks (NP). This program is currently operational at Kamay Botany Bay National Park, Dorrigo National Park and Kosciuszko National Park. This offers people with mobility restrictions the opportunity to experience national parks beyond Grade 1 and 2 trails.

Figure 13: Use of a TrailRider in Dorrigo NP

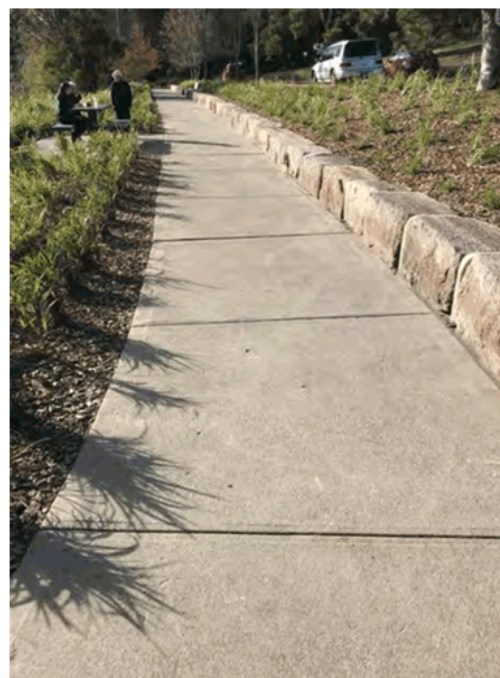
Trails, signage and infrastructure can also be designed to cater for people who are blind, deaf or have hearing loss. For example, the Grade 1 accessible trail at Lake Alexandra Reserve provides Braille on trail signage, as well as other universal access features along the trail.

Figure 14: Lake Alexandra Circuit - Grade 1

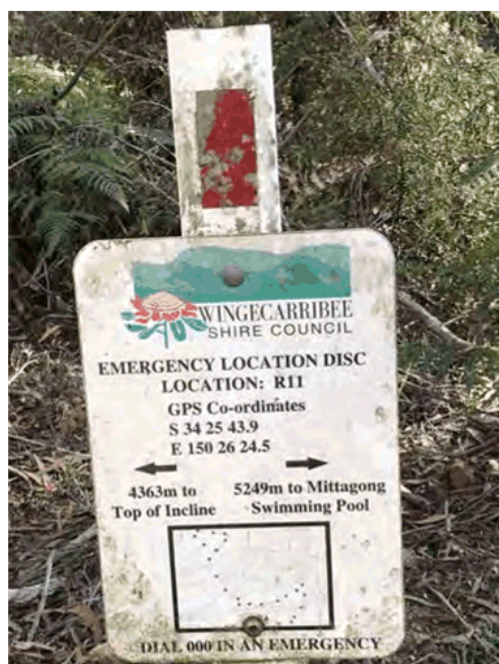
**Figure 16: Emergency Location Marker in Mt Alexandra Reserve**

Location information challenges are particularly difficult for 'open space' locations with no set addresses such as bushland reserves. Mt Alexandra Reserve is a large reserve with extensive networks of walking tracks and fire trails. Emergency location systems can help mitigate this risk, and it is noted that aged Emergency Location Markers currently exist in Mt Alexandra Reserve, as shown in Figure 16.

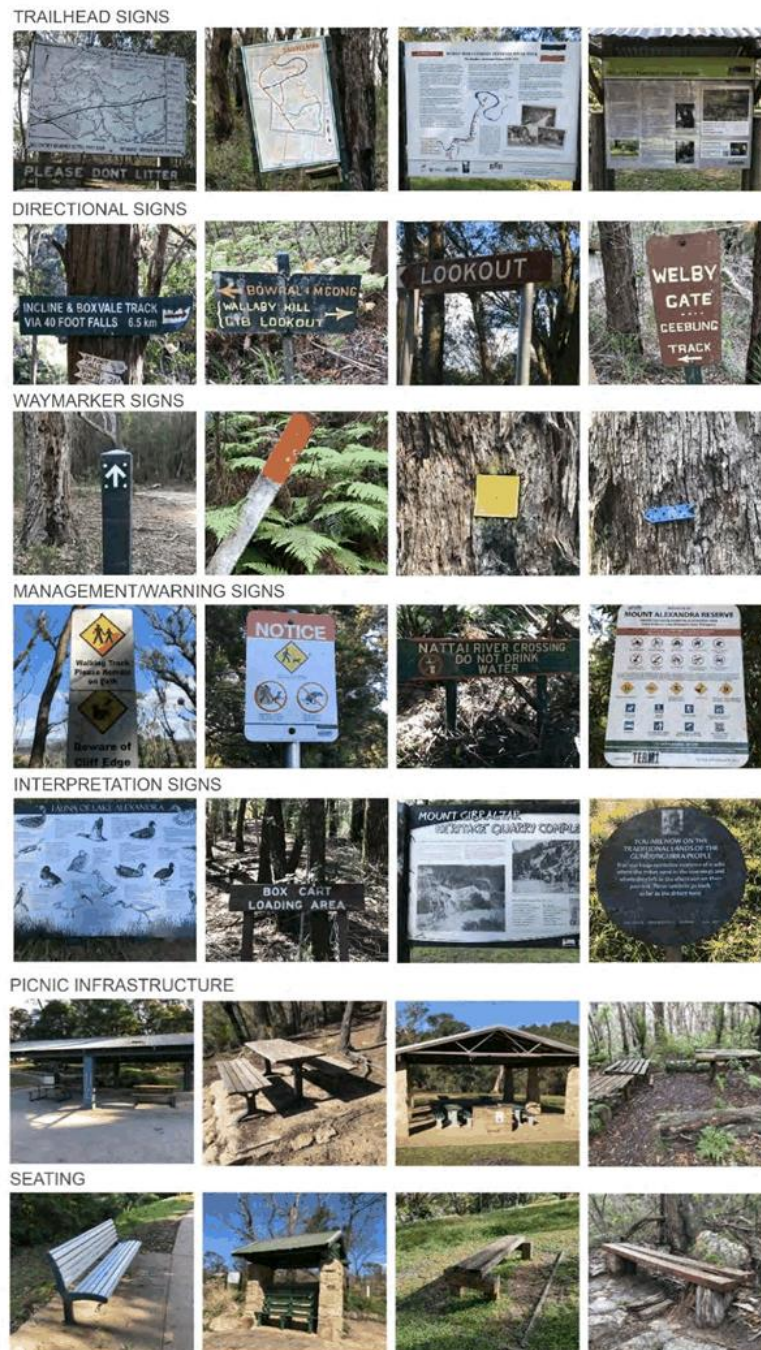
Figure 17: Examples of Signage and Infrastructure

Figure 17 provides a photo montage of a selection of the trailhead, directional, waymarker, management/warning and interpretation signs, as well as picnic infrastructure and seating. A complete record of trail alignment and infrastructure is contained within the ArcGIS Online System, with further photographs of each category provided in Appendix 4.

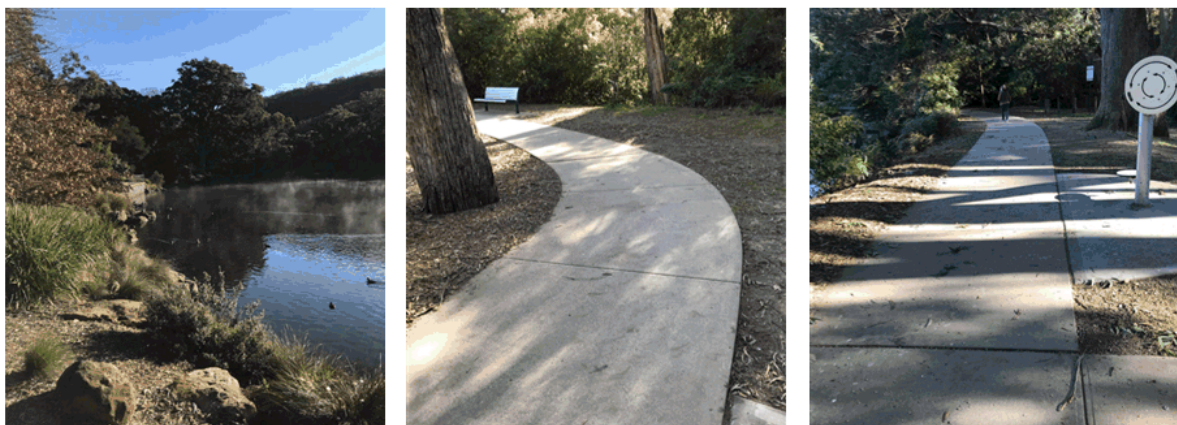
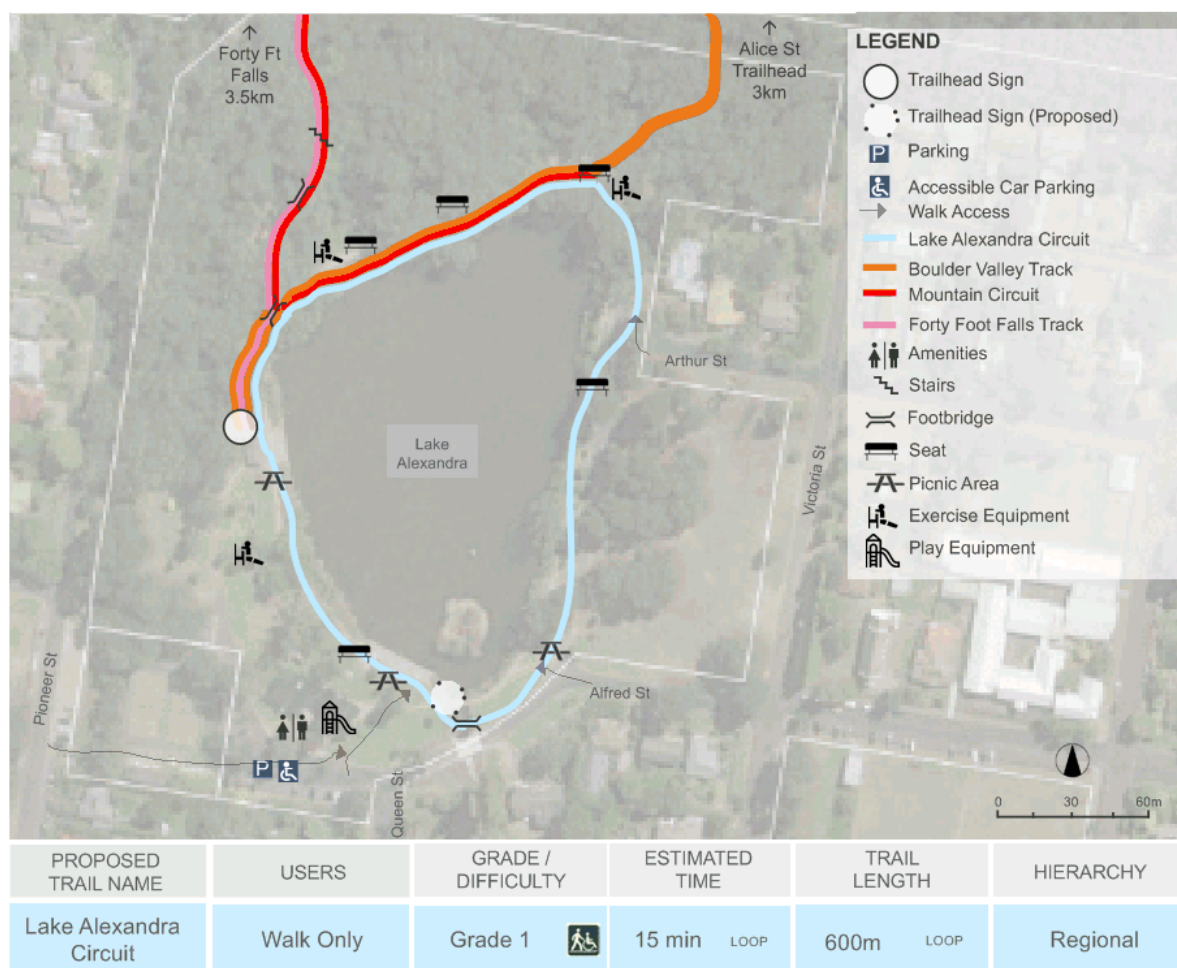
### CONCEPT PLAN

Lake Alexandra Reserve is a premier community park, located at the base of Alexandra Park in Mittagong. The lake was historically created as a dam supplying water for engines hauling coal to the Fitzroy iron mines. The reserve has been designed to include people who use a wheelchair, who are deaf and those who are deaf or have hearing loss. Facilities offered include barbecues, picnic settings, play equipment, amenities and a sealed path surrounding the lake with exercise equipment along the route.

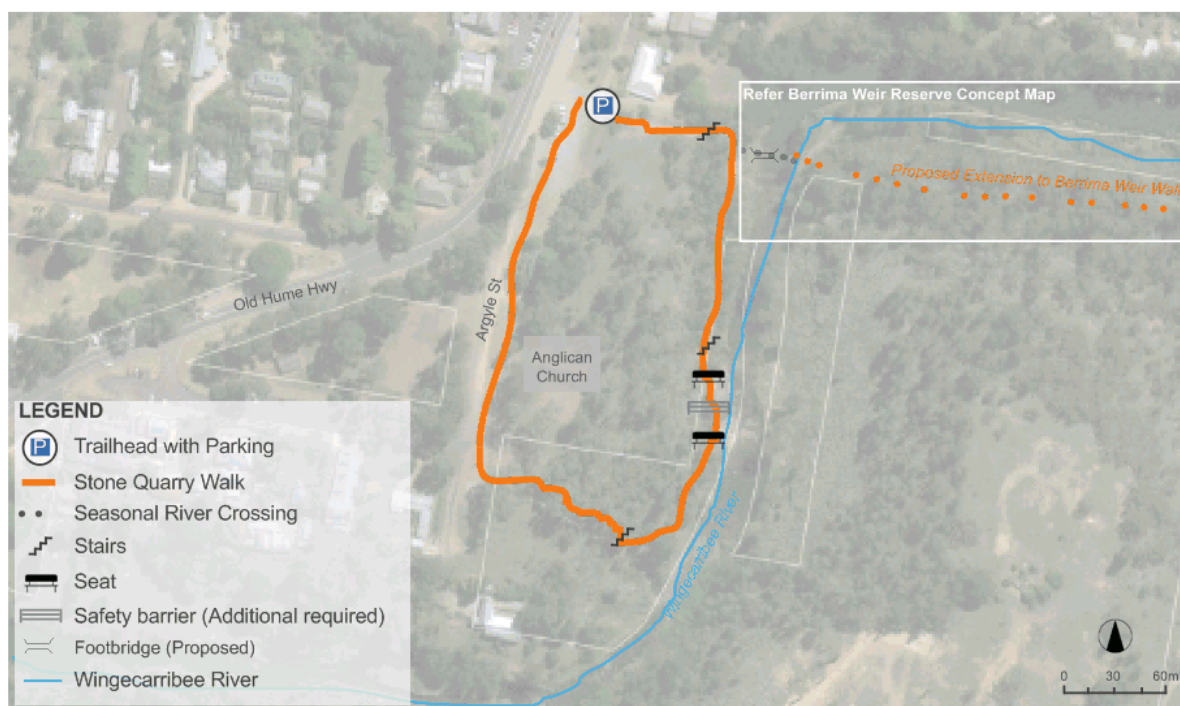
### CONCEPT PLAN

TRAIL NAME	USERS	GRADE / DIFFICULTY	ESTIMATED TIME	TRAIL LENGTH	HIERARCHY
Stone Quarry Walk	Walk Only	Grade 3

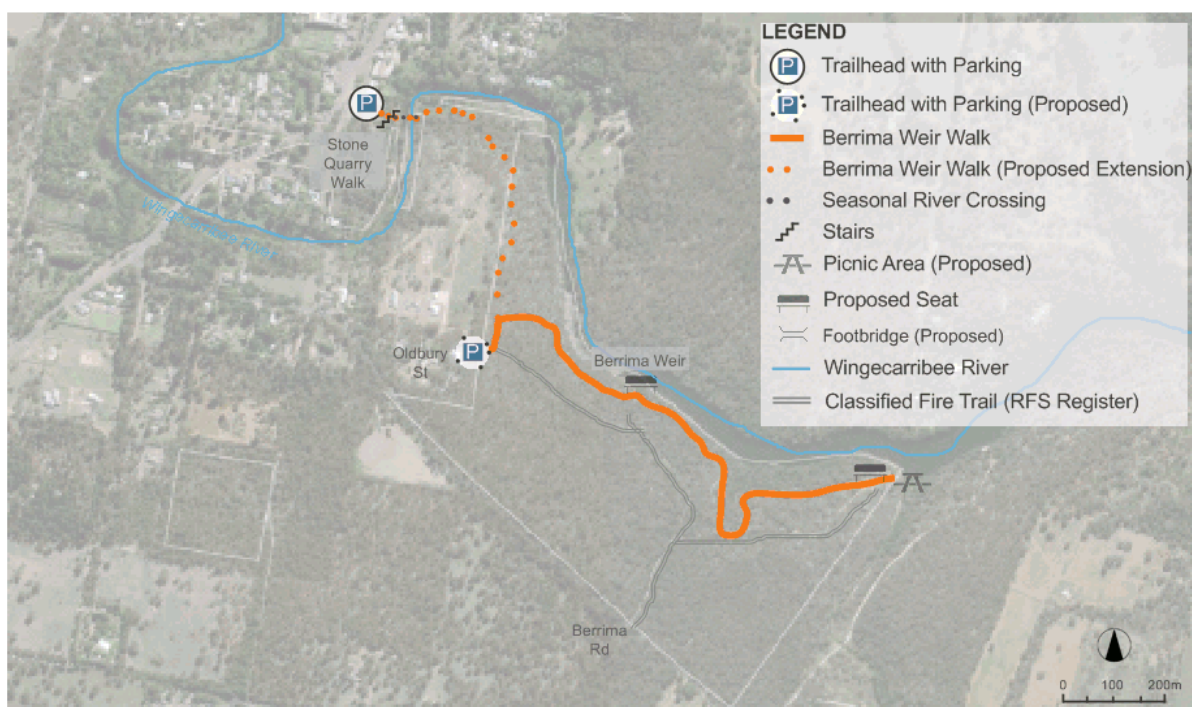
### CONCEPT PLAN

PROPOSED TRAIL NAME	USERS	GRADE / DIFFICULTY	ESTIMATED TIME	TRAIL LENGTH	HIERARCHY
Berrima Weir Walk	Walk Off-road cycling on fire trail only	Grade 2

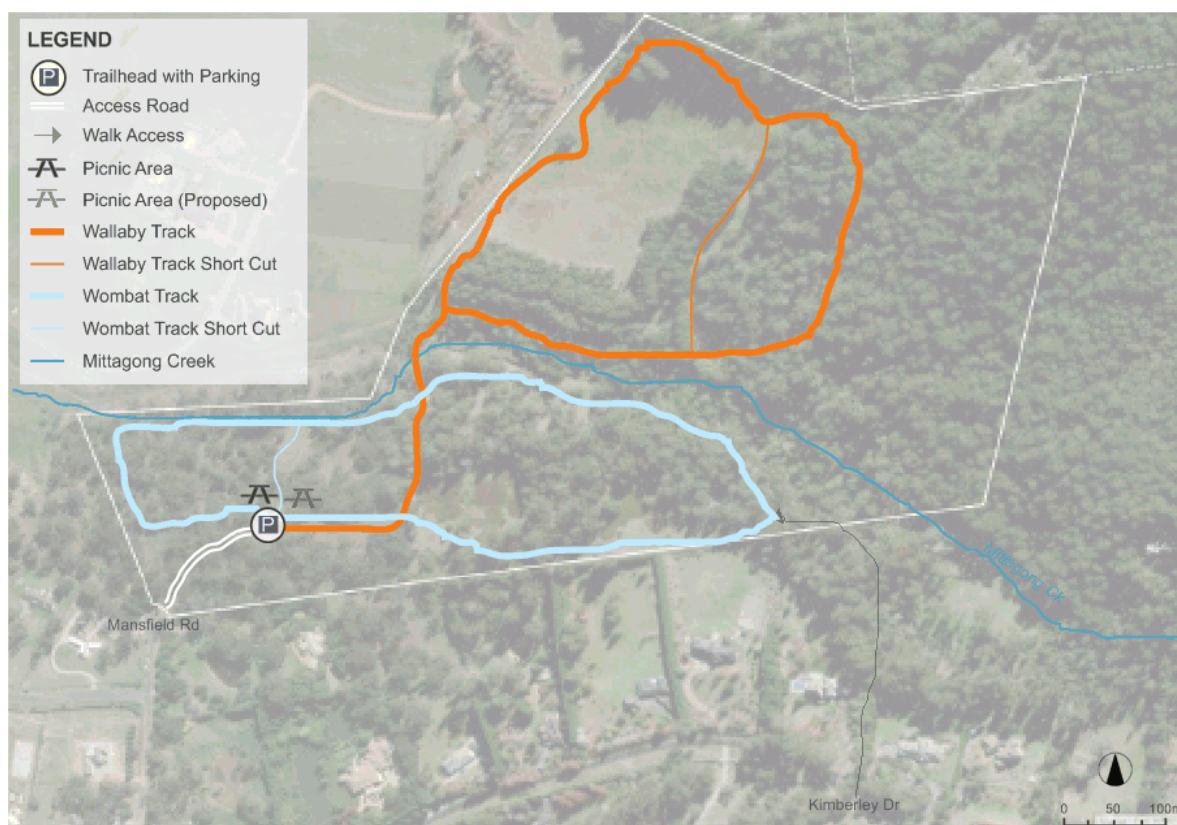
### CONCEPT PLAN

PROPOSED TRAIL NAME	USERS	GRADE / DIFFICULTY	ESTIMATED TIME	TRAIL LENGTH	HIERARCHY
Wallaby Track	Walk Only	Grade 2  	30 min LOOP	2km LOOP	Local
Wombat Track	Walk Only	Grade 2  	20 min LOOP	1.5km LOOP	Local

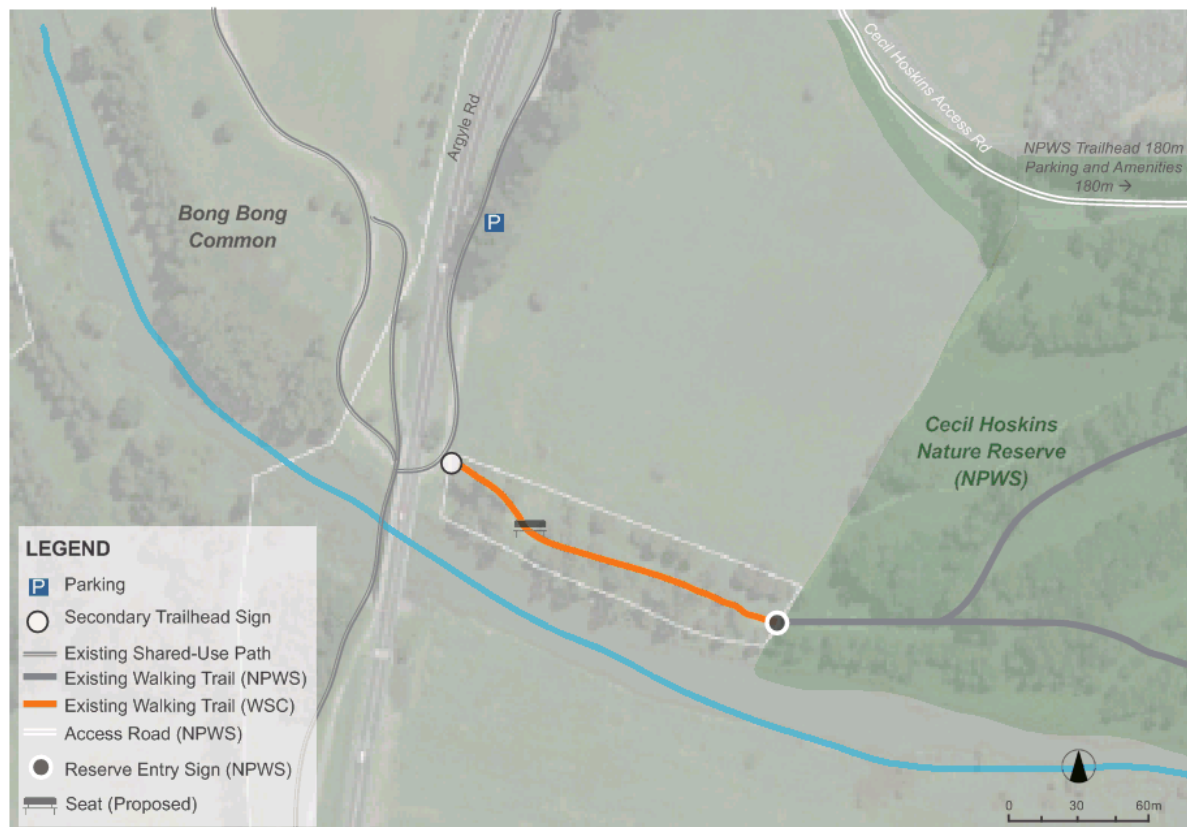
### CONCEPT PLAN

PROPOSED TRAIL NAME	PROMOTED USERS	GRADE / DIFFICULTY	ESTIMATED TIME	TRAIL LENGTH	HIERARCHY
Cecil Hoskins Link Track	Walk Only	Grade 2

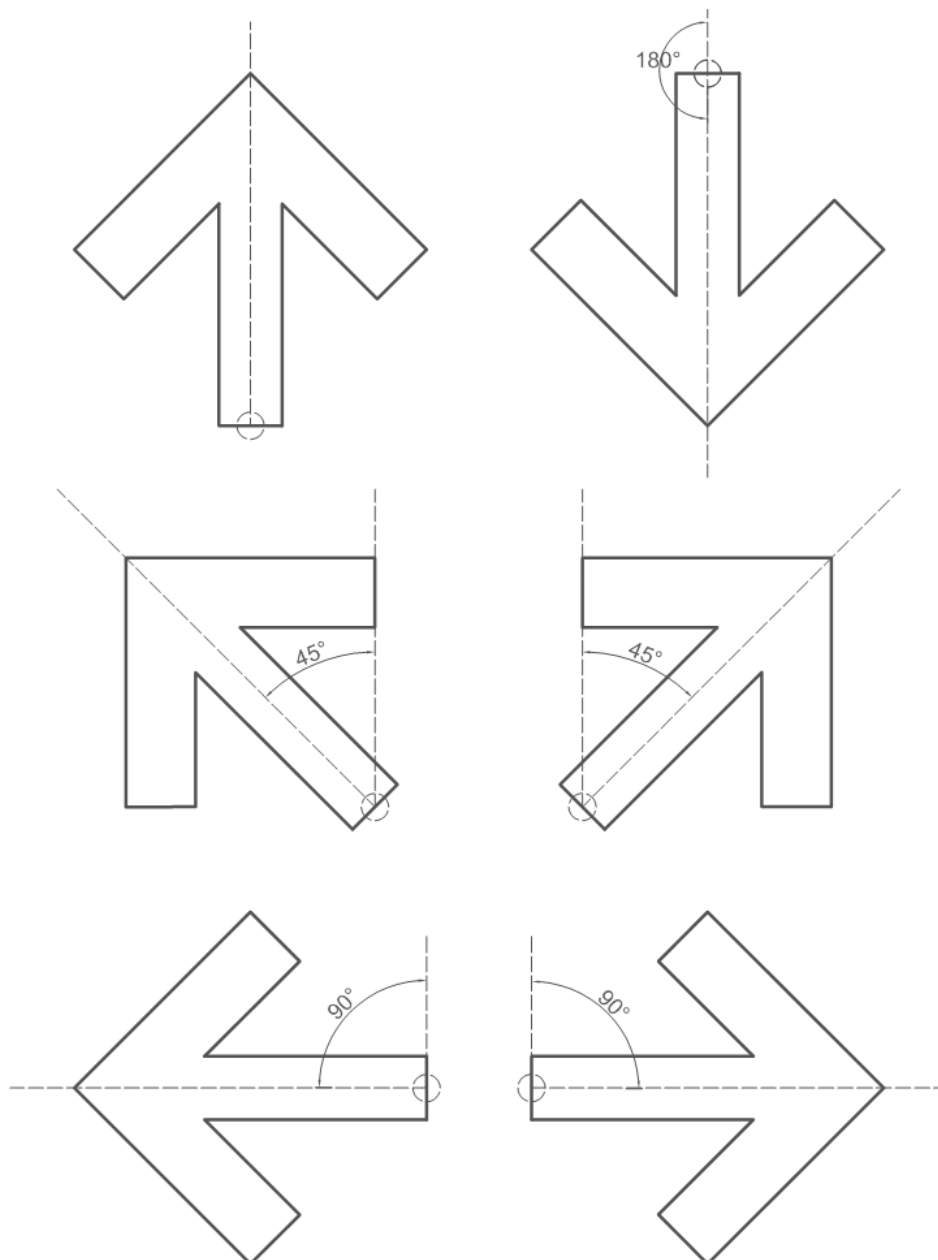
PMS white arrow and/or text to be painted over selected background colour.

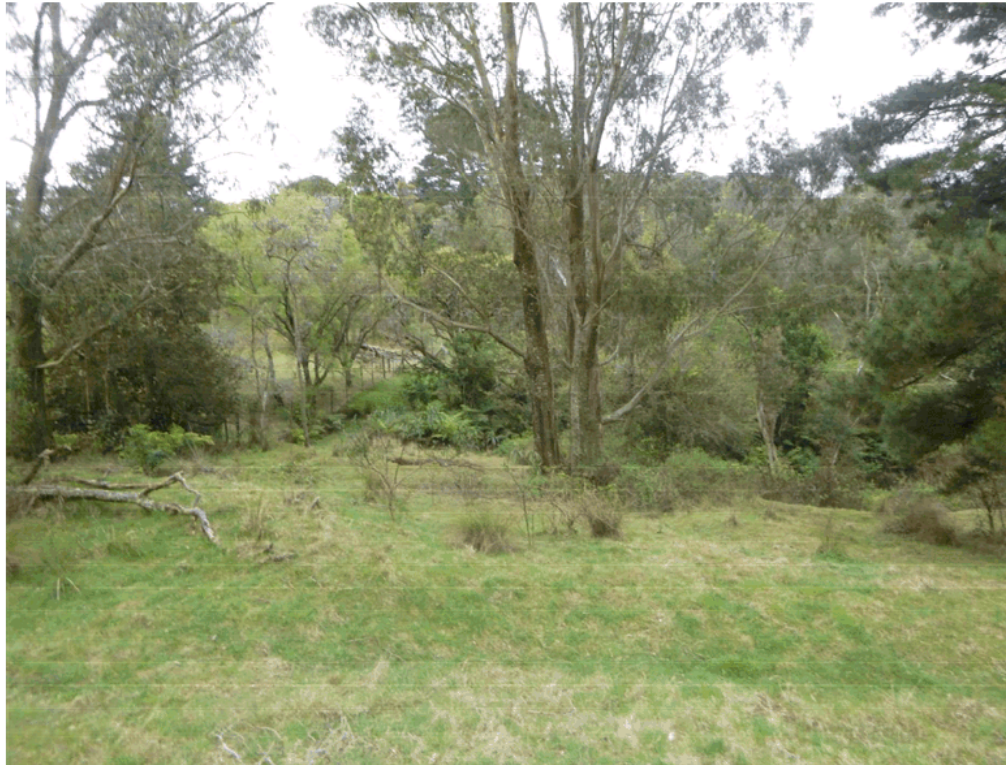
Table 6. PCT 743 - Summary of vegetation within subject property (adjacent to subject land).

PCT: 743 Brown Barrel – Mountain Grey Gum tall moist forest on basalts of the Southern Highlands Bioregion and Sydney Basin Bioregion

<b>Vegetation formation / Keith Class</b>	Wet Sclerophyll Forest (Shrubby sub-formation)
<b>Condition classes on Subject Land</b>	Moderate (under scrubbed and grazed)
<b>Extent within Subject Property (approximate)</b>	0.14 ha (not present within subject land)
<b>Description on Subject Land</b>	
<p>The community was represented primarily by <i>Eucalyptus fastigata</i> (Brown Barrel), <i>Eucalyptus viminalis</i> (Ribbon Gum) <i>Eucalyptus elata</i> (River Peppermint), with scattered planted ornamental trees, including <i>Eucalyptus cinerea</i> (Argyle Apple), <i>Pinus radiata</i> (Radiata Pine) and <i>Eucalyptus scoparia</i> (Wallangarra White Gum). As a result of historical land practices, the mid-stratum was largely absent within community, however, scattered <i>Melicactus dentatus</i> (Prickly Currant Bush), <i>Pittosporum undulatum</i> (Native Daphne) and <i>Solanum aviculare</i> (Kangaroo Apple) were present. The ground layer stratum was dominated by <i>Carex appressa</i>, <i>Microlaena stipoides</i> and <i>Entolasia marginata</i> with scattered native ferns, climbers and sedges.</p>

<b>Description in VIS</b>	
<p>Other Diagnostics Features: Open forest with a sparse shrub layer and dense groundcover of herbs and grass; Landscape Position: Occurs on undulating basalt tablelands between 600 and 1200m, mainly between Oberon and Moss Vale.</p>

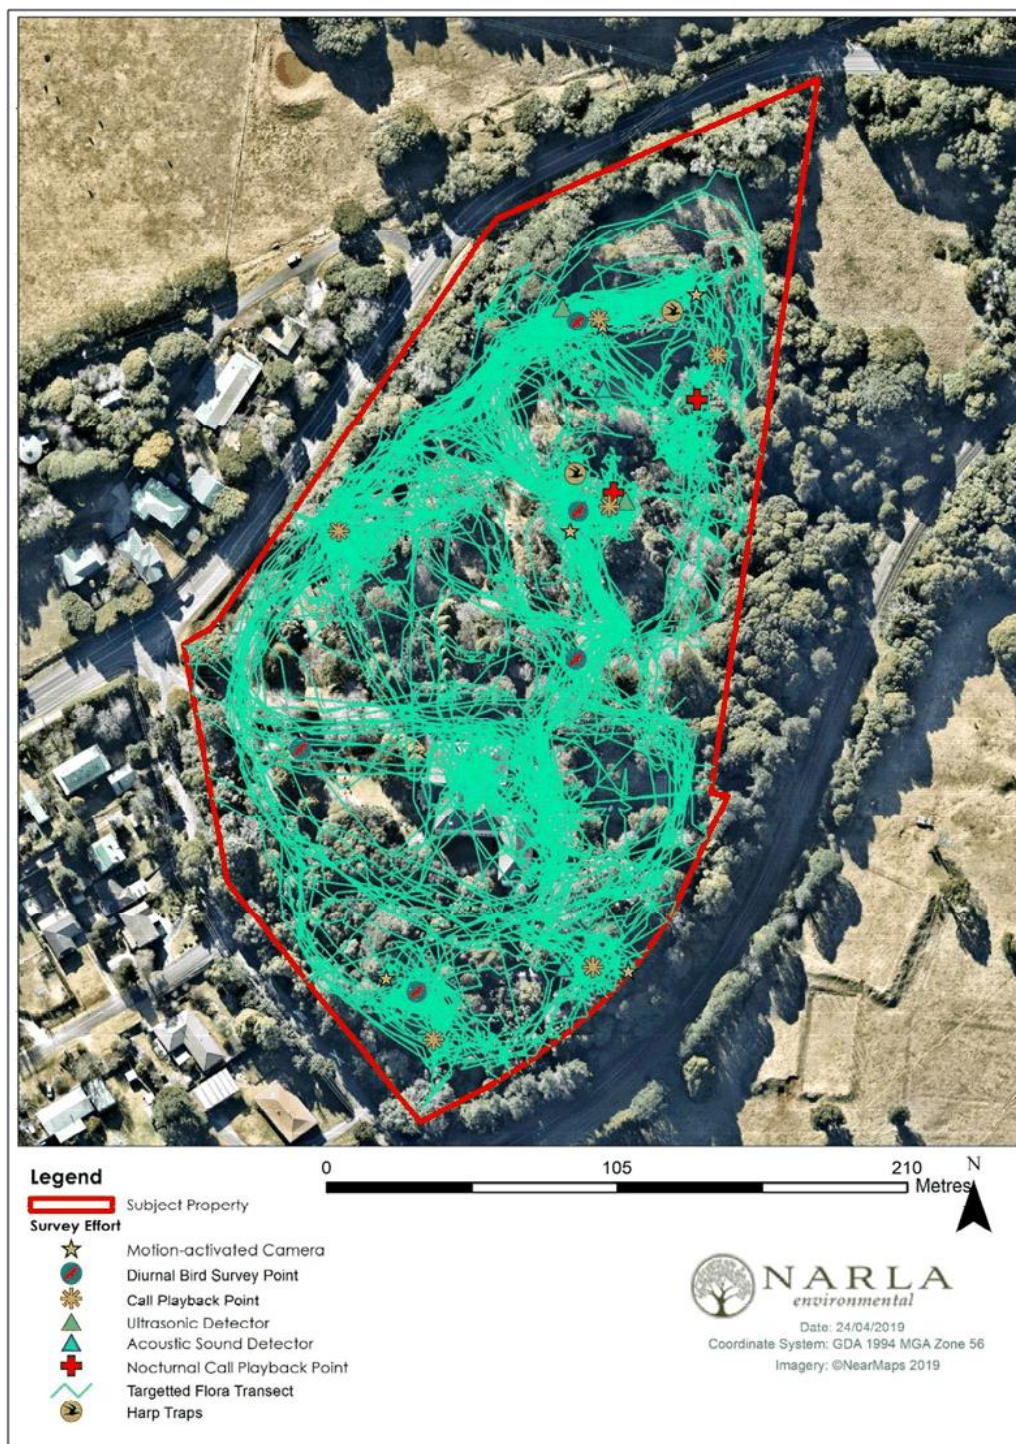
Figure 12. Fauna and flora species credit targeted survey effort undertaken by Narla within the subject land over the course of the study.

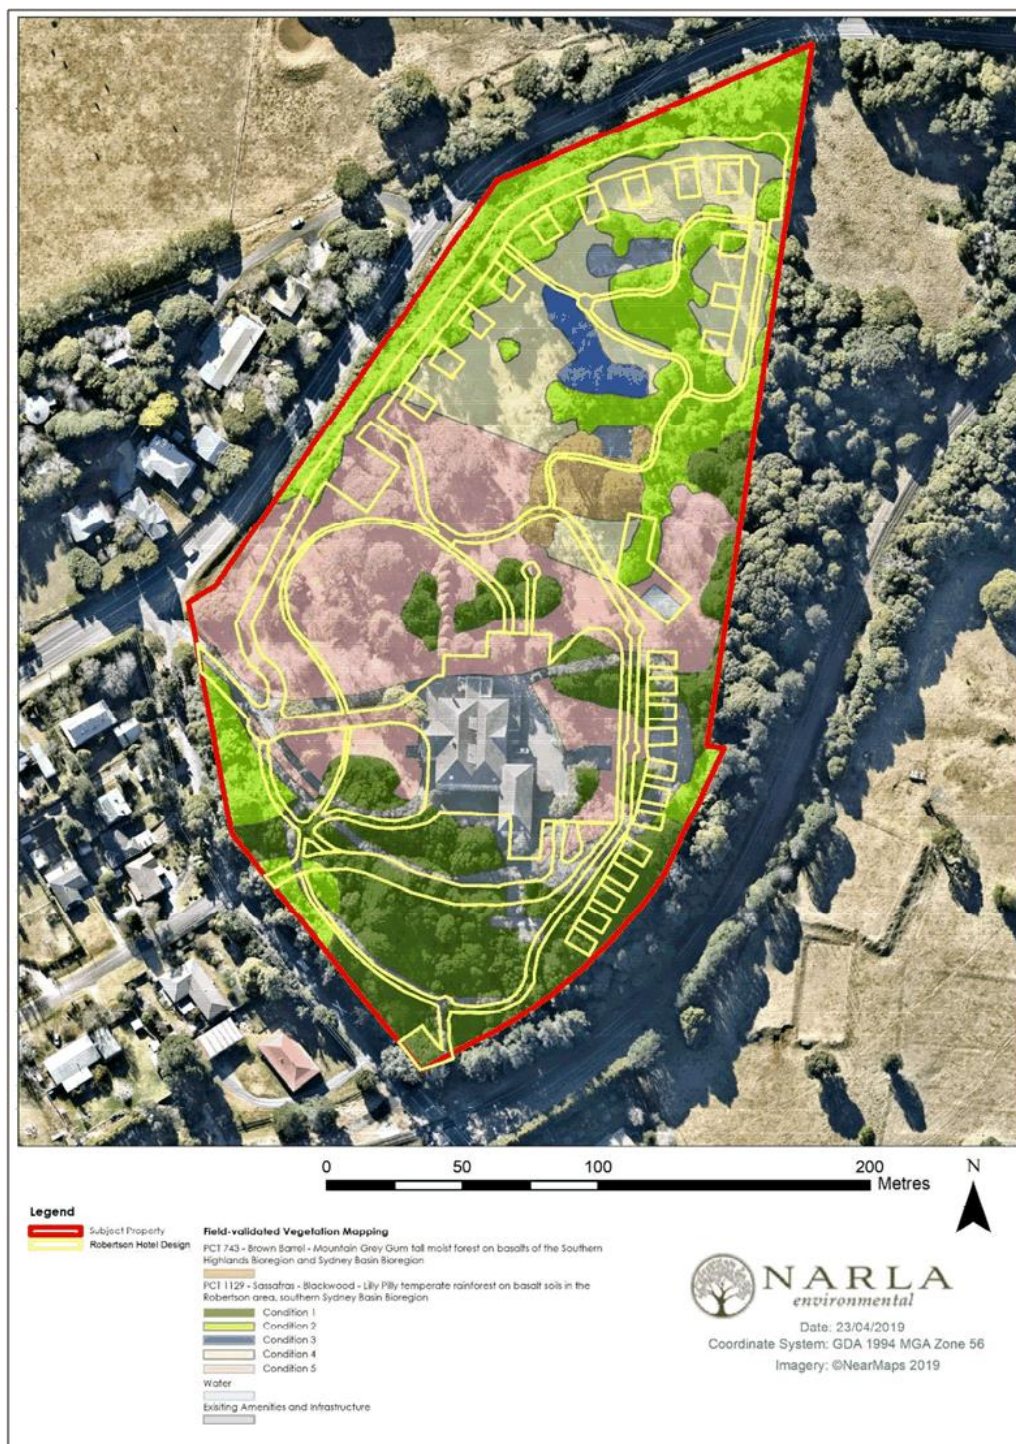
Figure 13. Previous Design (redesigned to avoid impacts on TEC and SAIL).

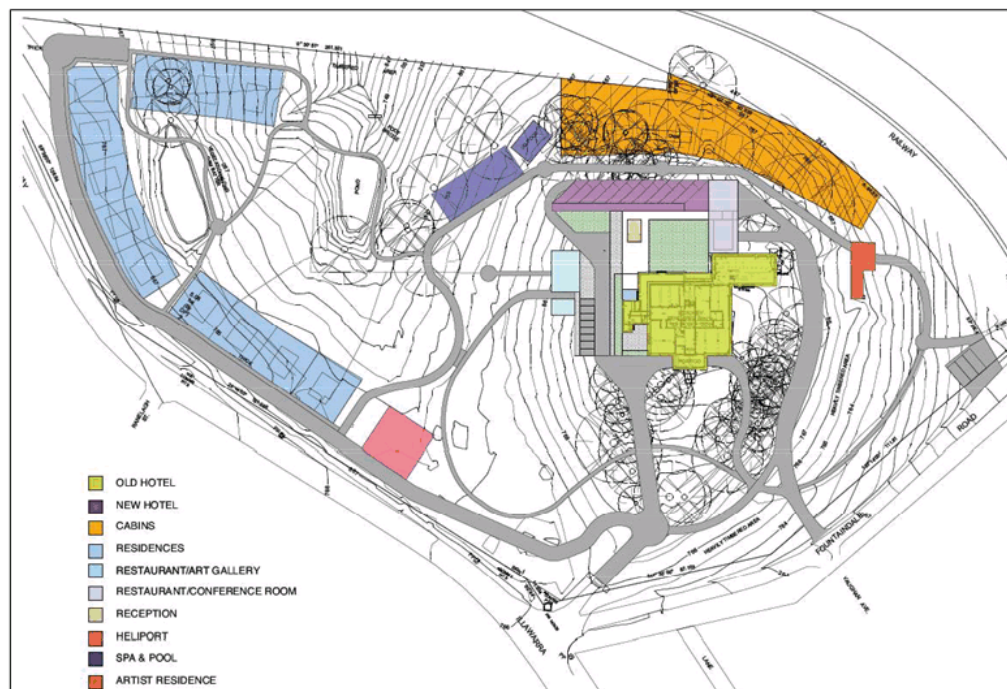
**Figure 2: Design Option A**

Option A was presented as the preliminary design scheme to the client, prior to any formal or informal discussions with Council (see Figure 2). This option included the following elements:

- Alterations and additions to the existing hotel and an increase in the number of rooms from 49 to 60;
- Refurbishment of the existing worker's cottage into a new artist studio;
- A new three storey hotel wing with 46 rooms, to the rear of the existing hotel;
- Construction of 12 eco tourist cabins on the eastern side of the site;
- Construction of 12 eco villas on the eastern, northern and western sides of the site;
- Basement car parking below the hotel;
- New helipad;
- A new spa and pool area that is ancillary to the hotel, but can be made available to local organisations by arrangement;
- New internal roads and pathways to access the new accommodation as well as the existing landscape features that are currently fenced off from the public

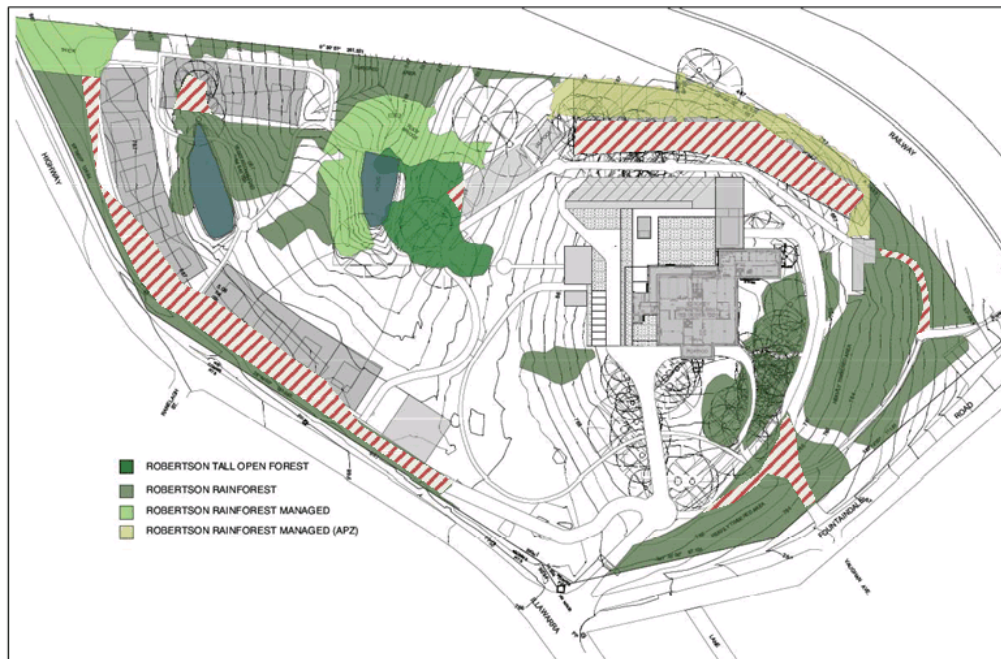
**Figure 3: Design Constraints of Option A in the  
Context of the Site's Ecological Conditions**  
(note: some smaller internal pathways are located within the rainforest area  
but are not identified on this plan)

The site is constrained by the location of Robertson Rainforest. While the majority of new work to the hotel and the villas are located outside the identified rainforest areas, portions of the villas, cabins and roads intrude into this area (see Figure 3).

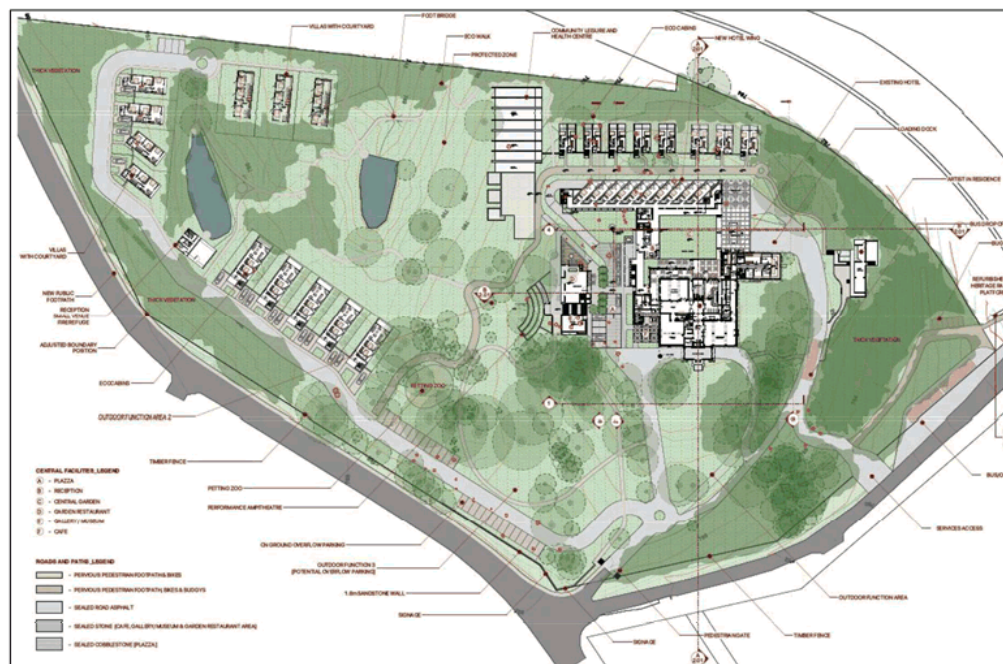
**Figure 6: Design Option C**

The design of the proposal was further refined in Option C (see Figure 6). The majority of the proposed works remain the same as Option B, with the following modifications:

- Deletion of four eco-cabins on the eastern side;
- Replacement of five villas on the western side with five eco-cabins and provision of new reception and fire refuge; and
- Adjustment of the western and north western internal road to follow the outer line of the rainforest.
