War Memorial Clock Tower

Main Street, Mittagong

Conservation Management Plan

For Wingecarribee Shire Council

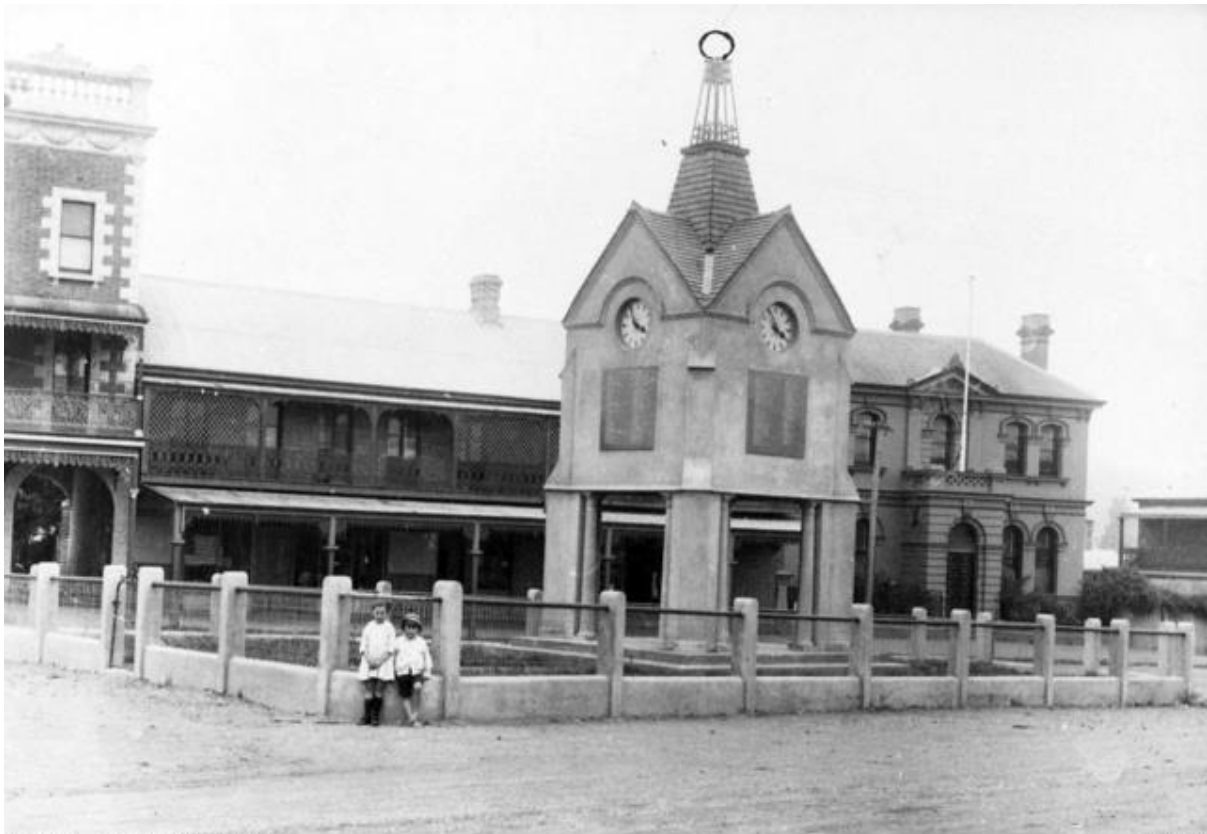
The globe on top of the memorial was not installed for another 5 months due to the difficulty in the glass manufacturer meeting the architect's specifications. Concreting of paths and building of flower beds were also proposed at this time. (Robertson Advocate, 1921)

Figure 15. This photo was taken shortly after the opening of the Memorial in December 1920. The globe has not been installed. (Australian War Memorial, 2021)

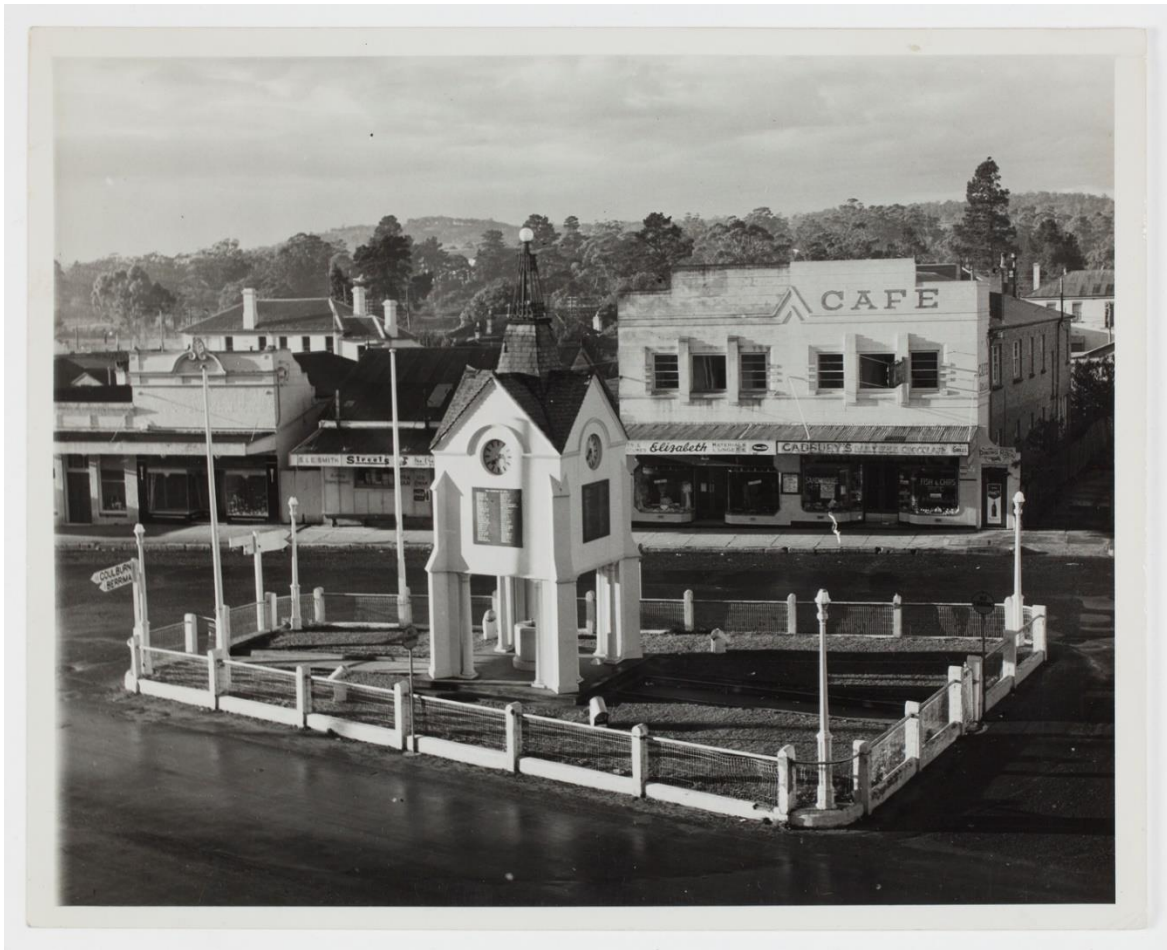
Figure 16. The War Memorial in 1955. The fence is in-situ, the site is grassed, and the drinking fountain is in place.⁴

A drinking fountain was installed after the opening of the War Memorial. It is captured in a photograph by Frank Hurley. (Hurley)

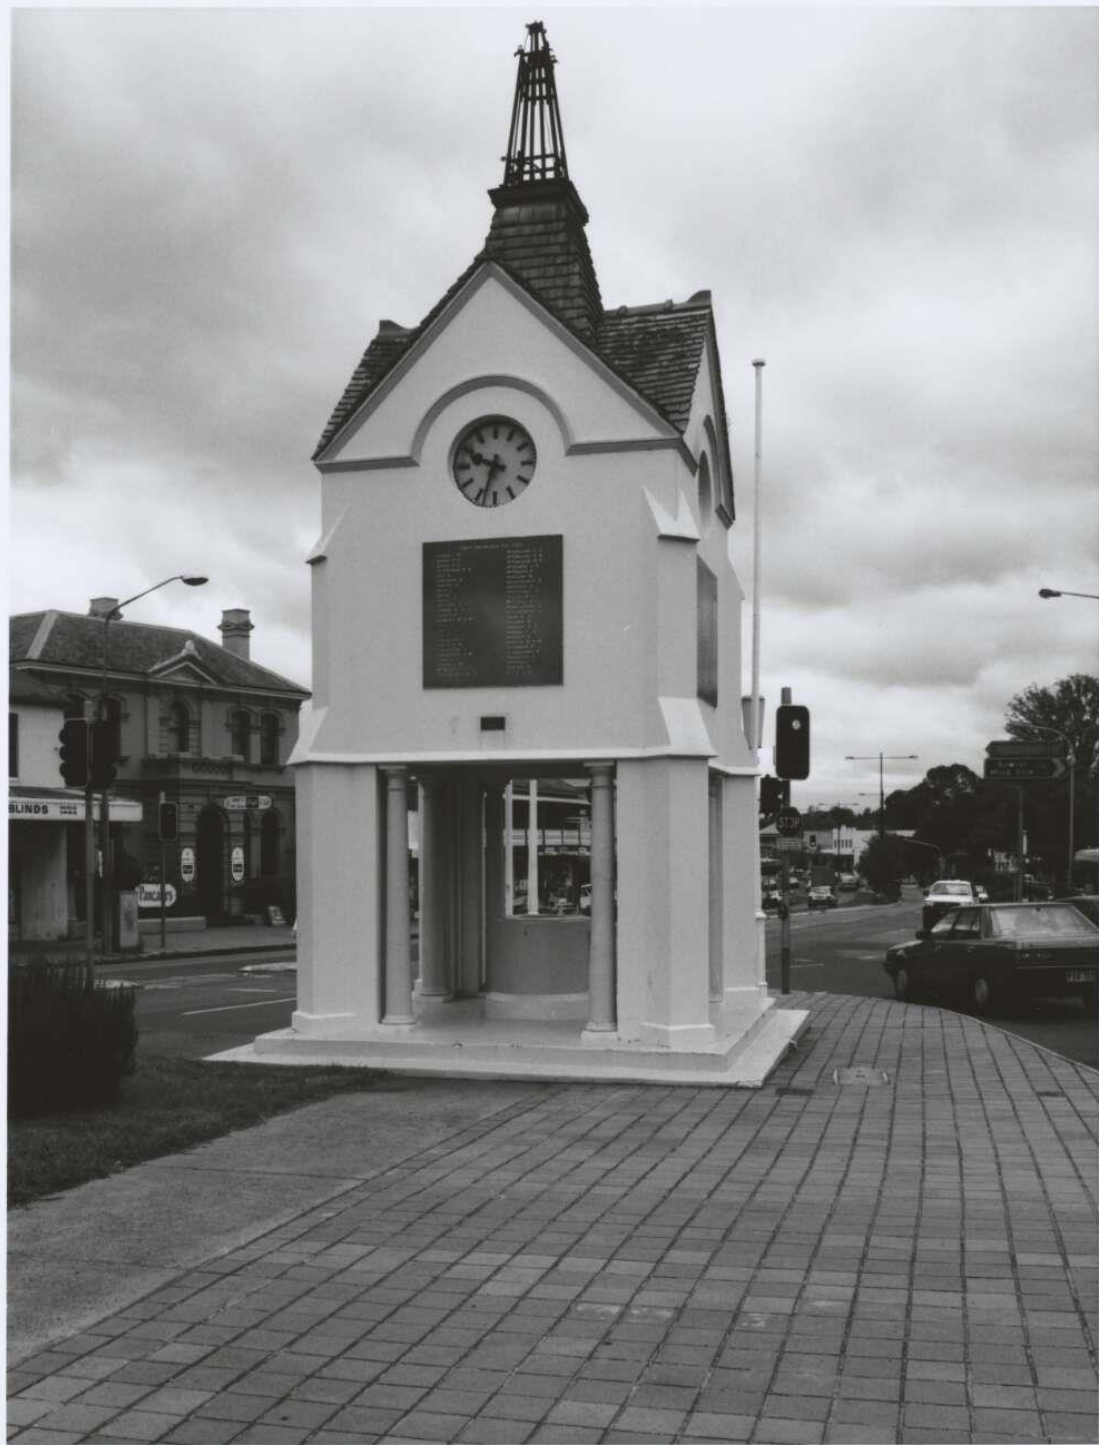
Figure 18. The War Memorial in 1996 prior to its restoration (Deane)

Figure 18 shows the memorial with plain faced walls and one main plaque on the wall containing the names of individuals. The clock face has not been covered and the roof has its original ridge capping and finials. There are also no lights installed in the turret or below the clock faces and the terracotta tiled stairs and floor haven't been installed.

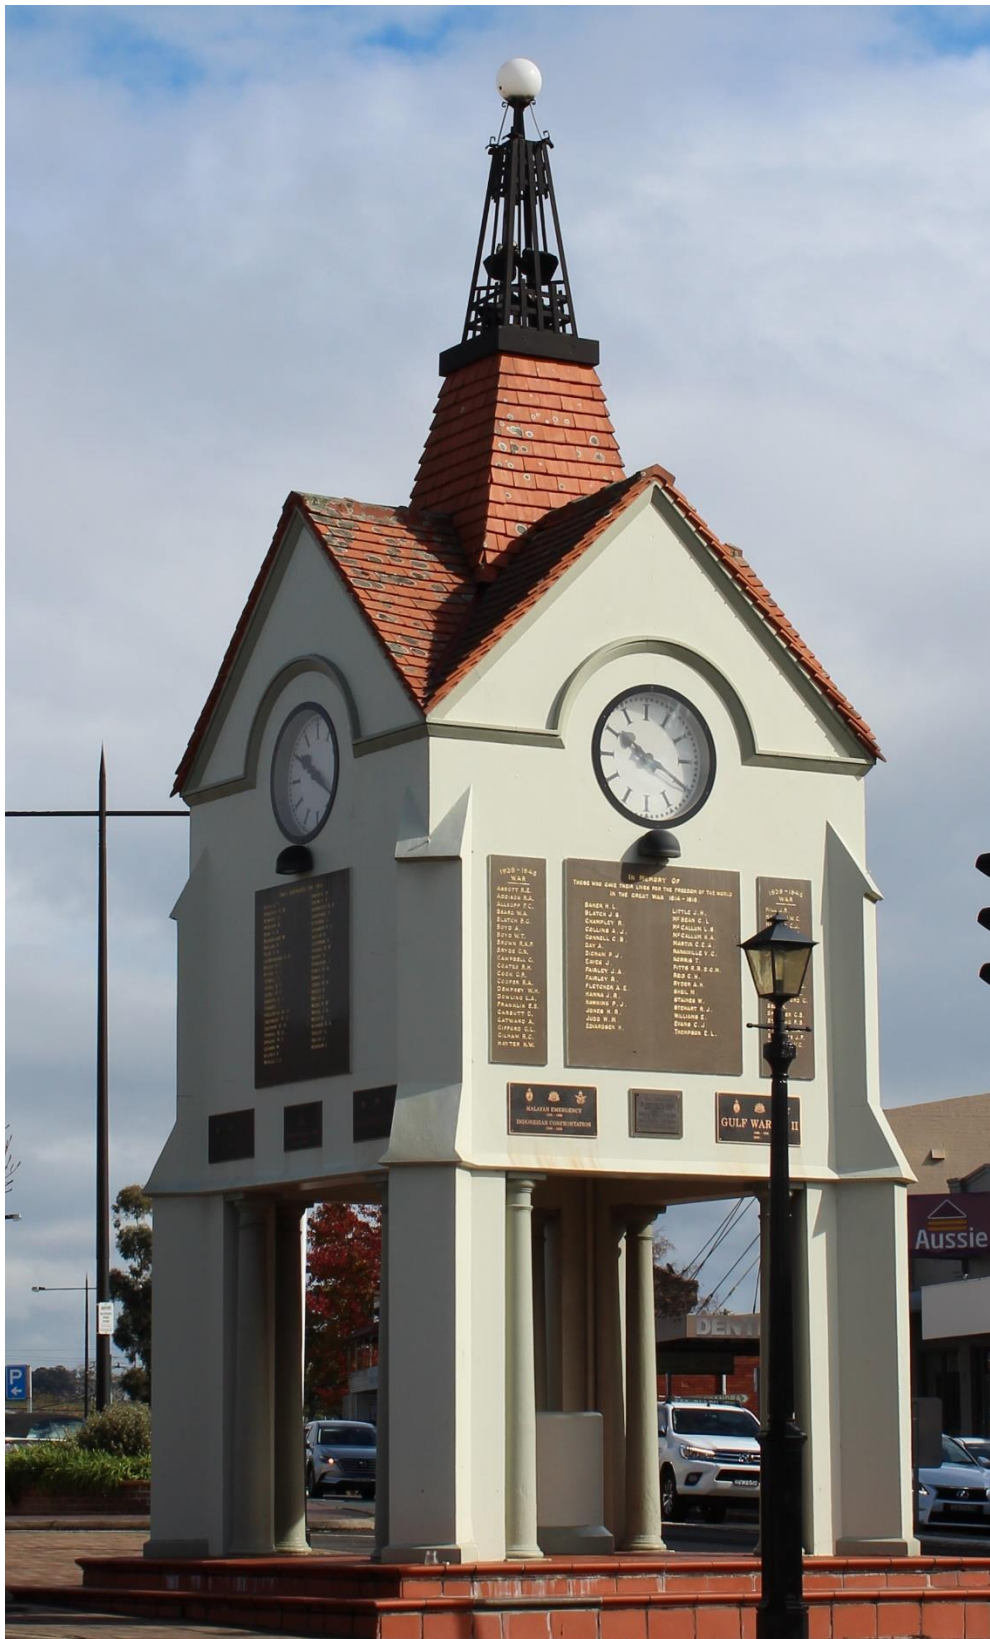
Figure 23. South and east elevations

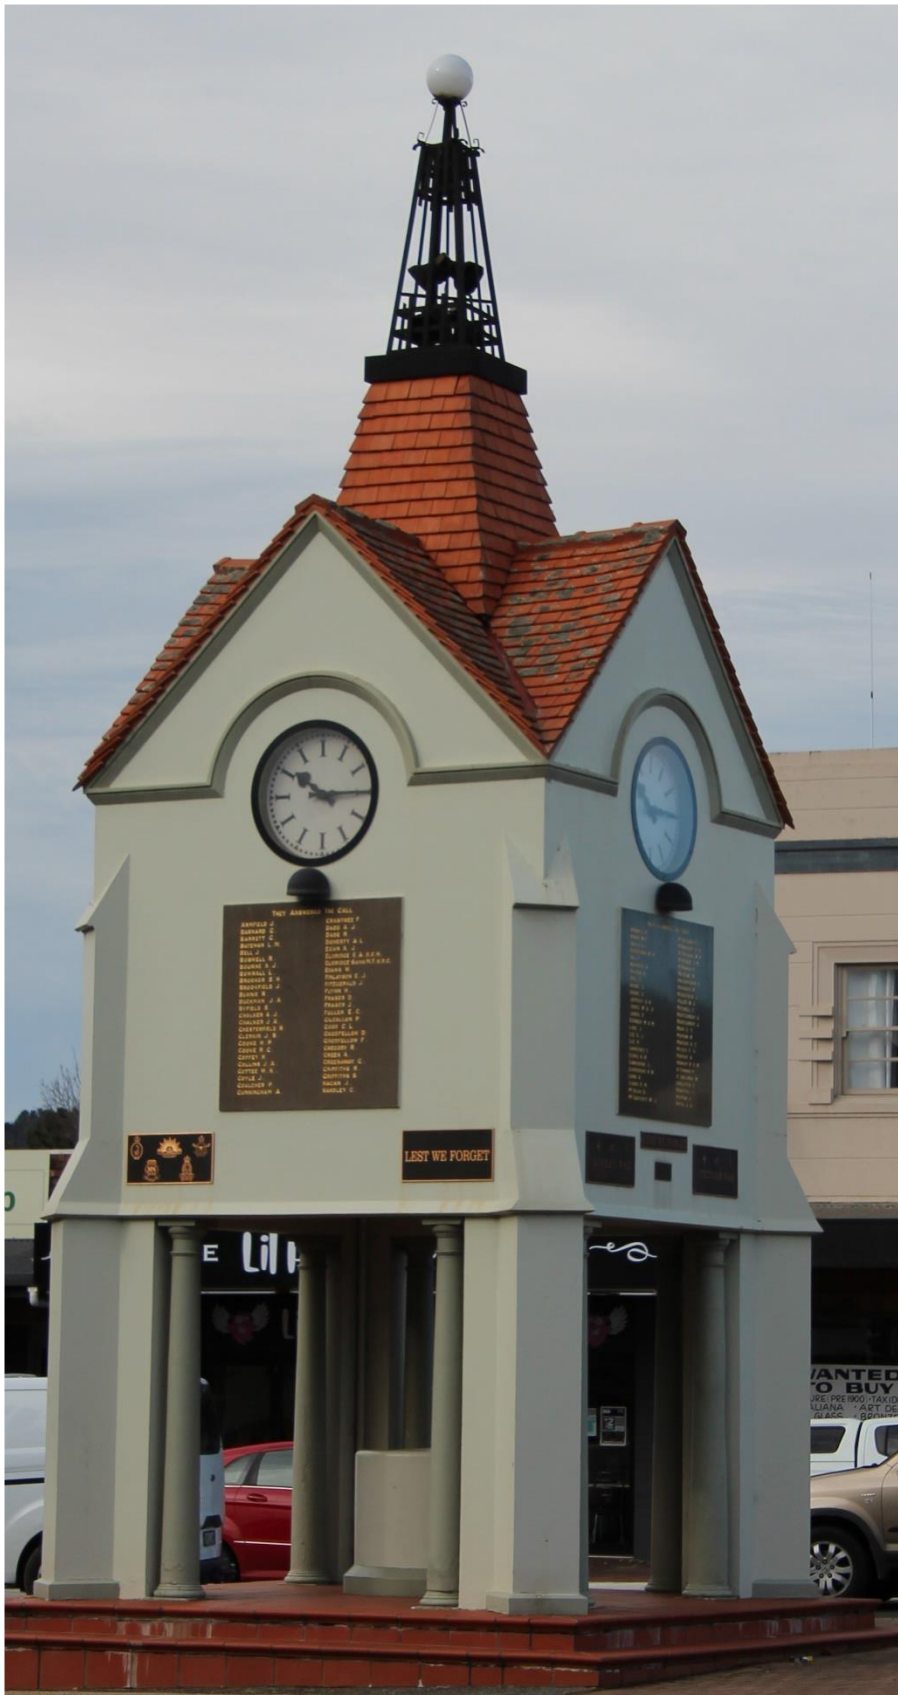
Figure 24. North and west elevations

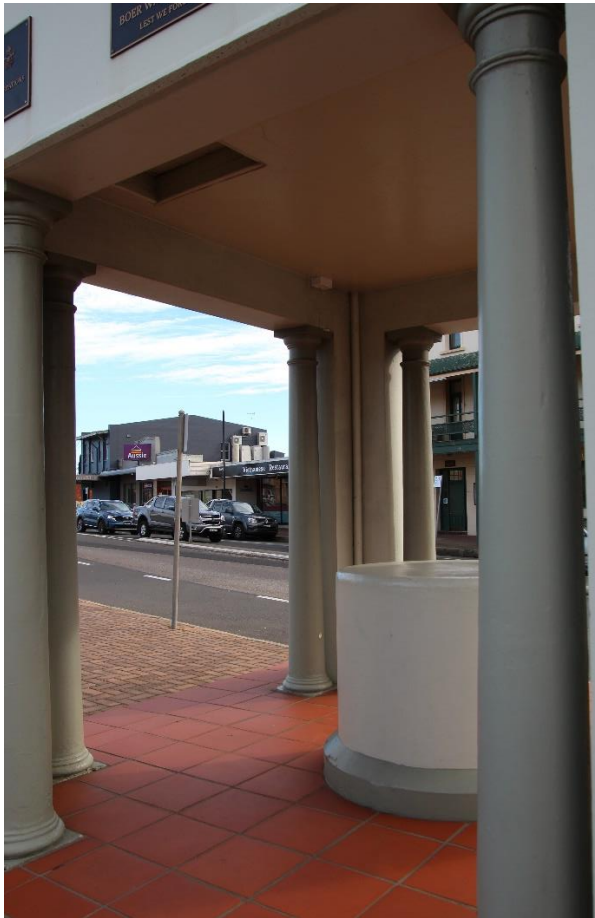
Figure 25. Interior of War Memorial showing layout of columns, tiles and centre plinth

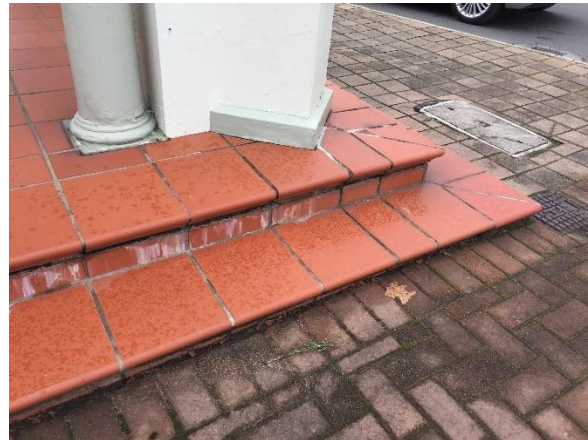
Figure 26. Paving, tiles, column and buttress

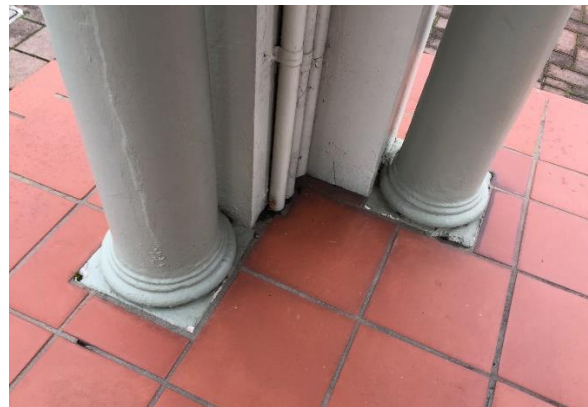
Figure 27. Tiling and column bases

The existing terracotta tiles have a very different character to the original base of the memorial by virtue of their colour and paved appearance.

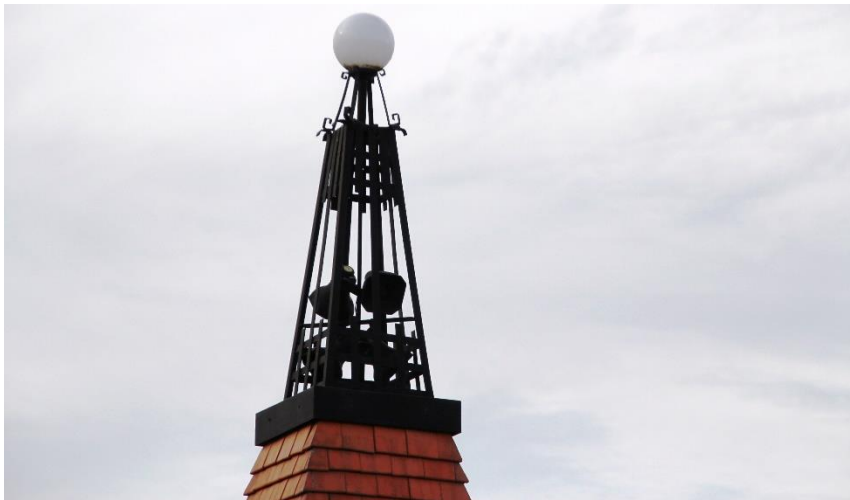
Figure 28. Top piece of tower – globe, wrought iron, capping and lights

The lights in the turret have been added since 1955.

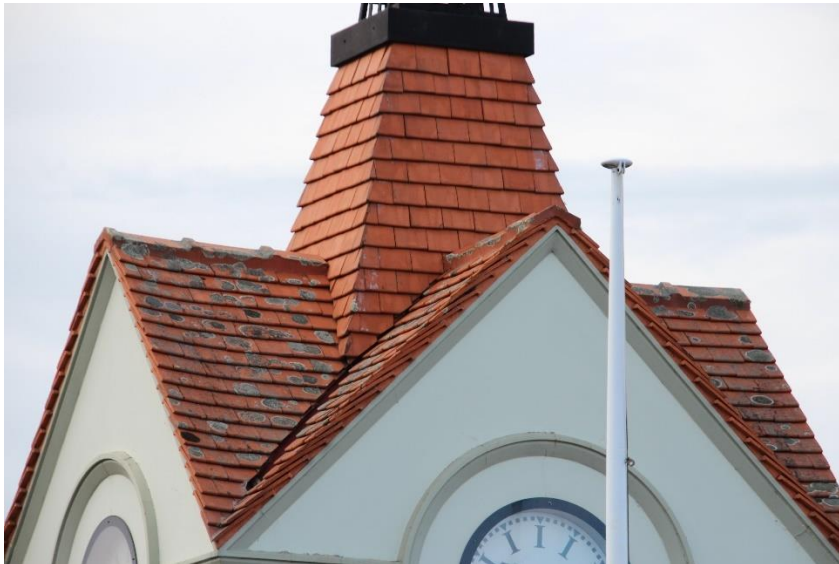
Figure 29. Roof, intersecting gables and gable ends

The roof tiles have been repaired, or possibly replaced. A box of spare tiles is stored in the clock tower.

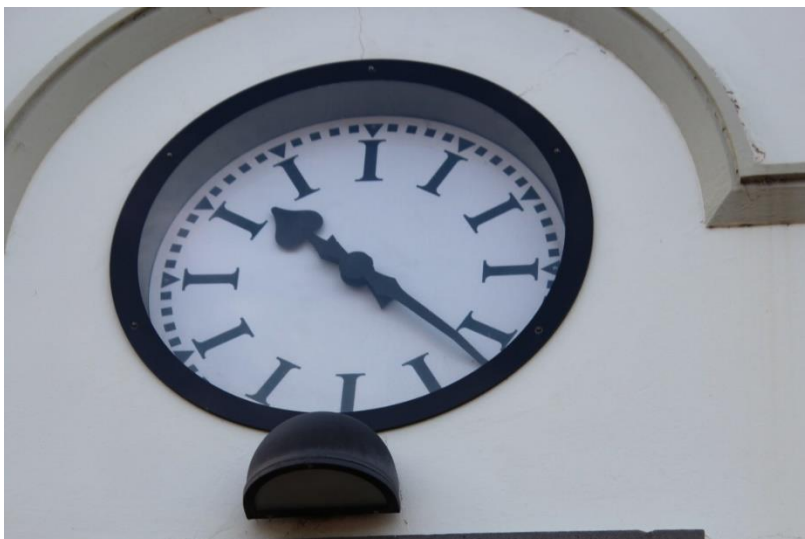
Figure 31. Face of the clock.

Modification – The clock now has a glass cover and black band. There is a black spotlight below the clock face above the plaque on each side of the memorial.

Original clock mechanism	High	Kept in the clock tower.	Important to significance, should be retained on site in the clock tower.
Lights beneath clock faces	Intrusive	Visually intrusive. Have a negative impact upon aesthetic significance.	Removal is recommended when a more effective lighting design is implemented that does not impact significance.
Pediment, label mould	High	Key part of the original design.	No change except for maintenance.
Walls	High	Part of the original design.	No change except for maintenance.

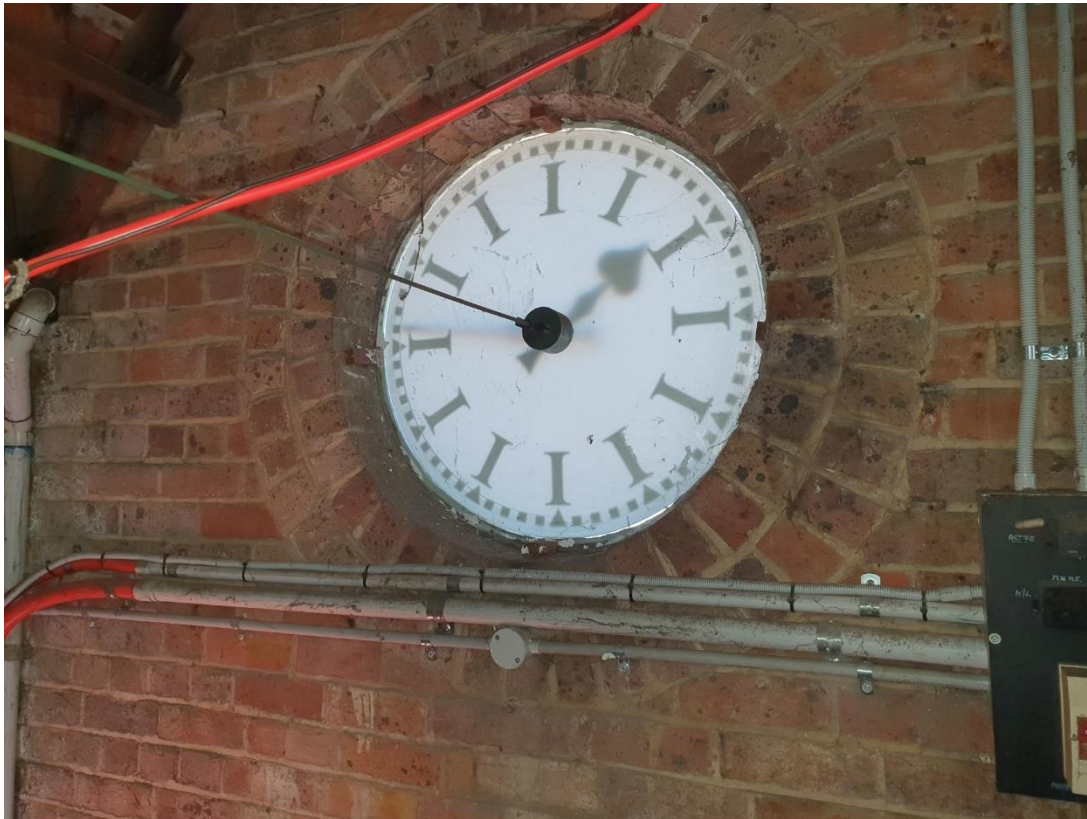
Figure 32. The interior wall and clock face. The original brickwork is evident without the render which was applied to the exterior. (Wingecarribee Shire Council)

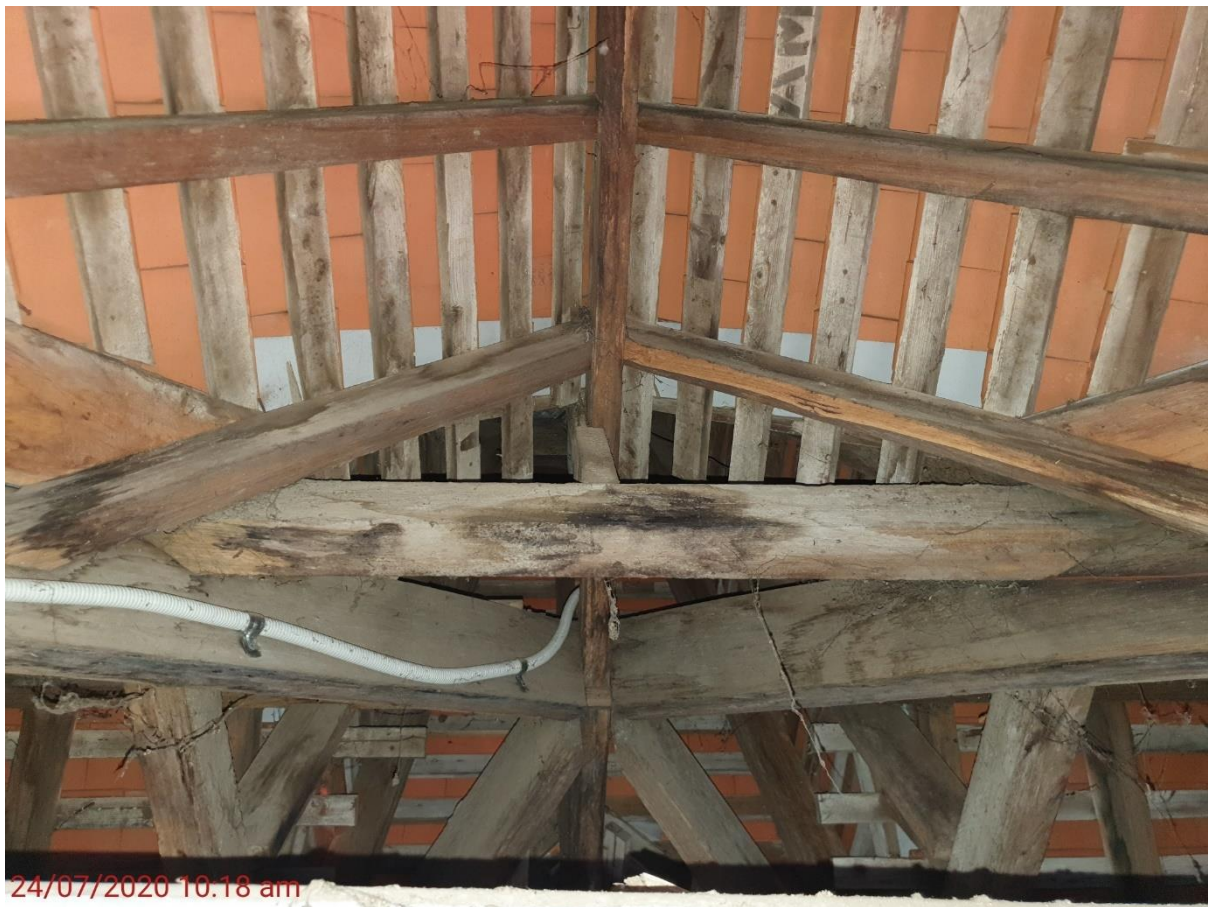
Figure 33. View of roof rafters, battens and structural timbers. The underside of the terracotta roof tiles can also be seen. (Wingecarribee Shire Council)

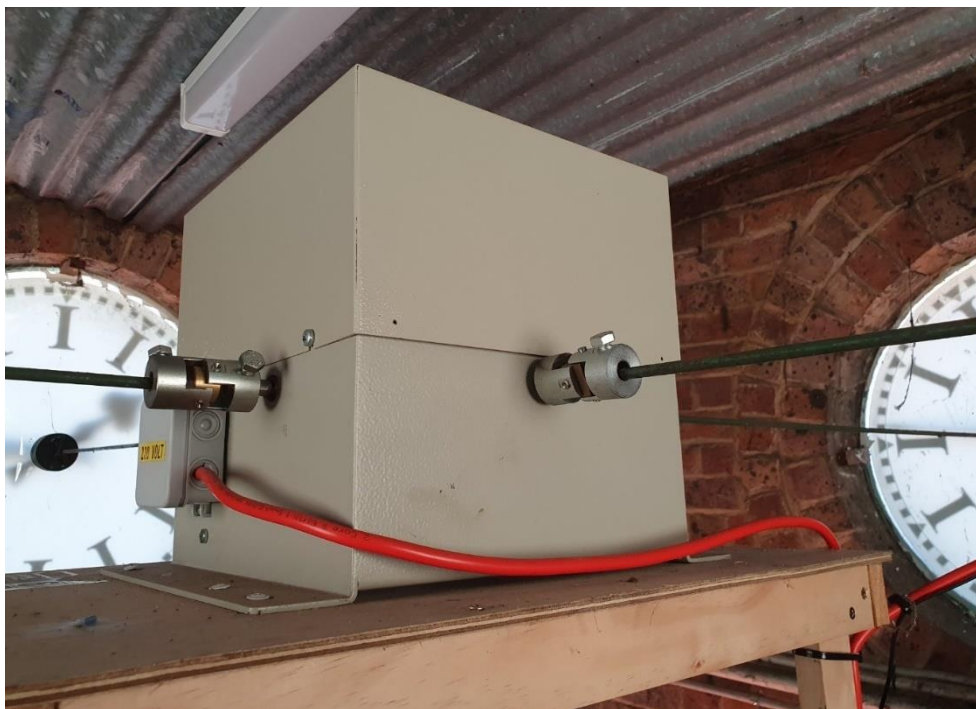
Modification: The original mechanism operating the clock has been replaced with an electric motor. The original mechanism is stored in the clock tower.

Figure 34. The electric clock mechanism. A corrugated steel ceiling has been installed above the clock.

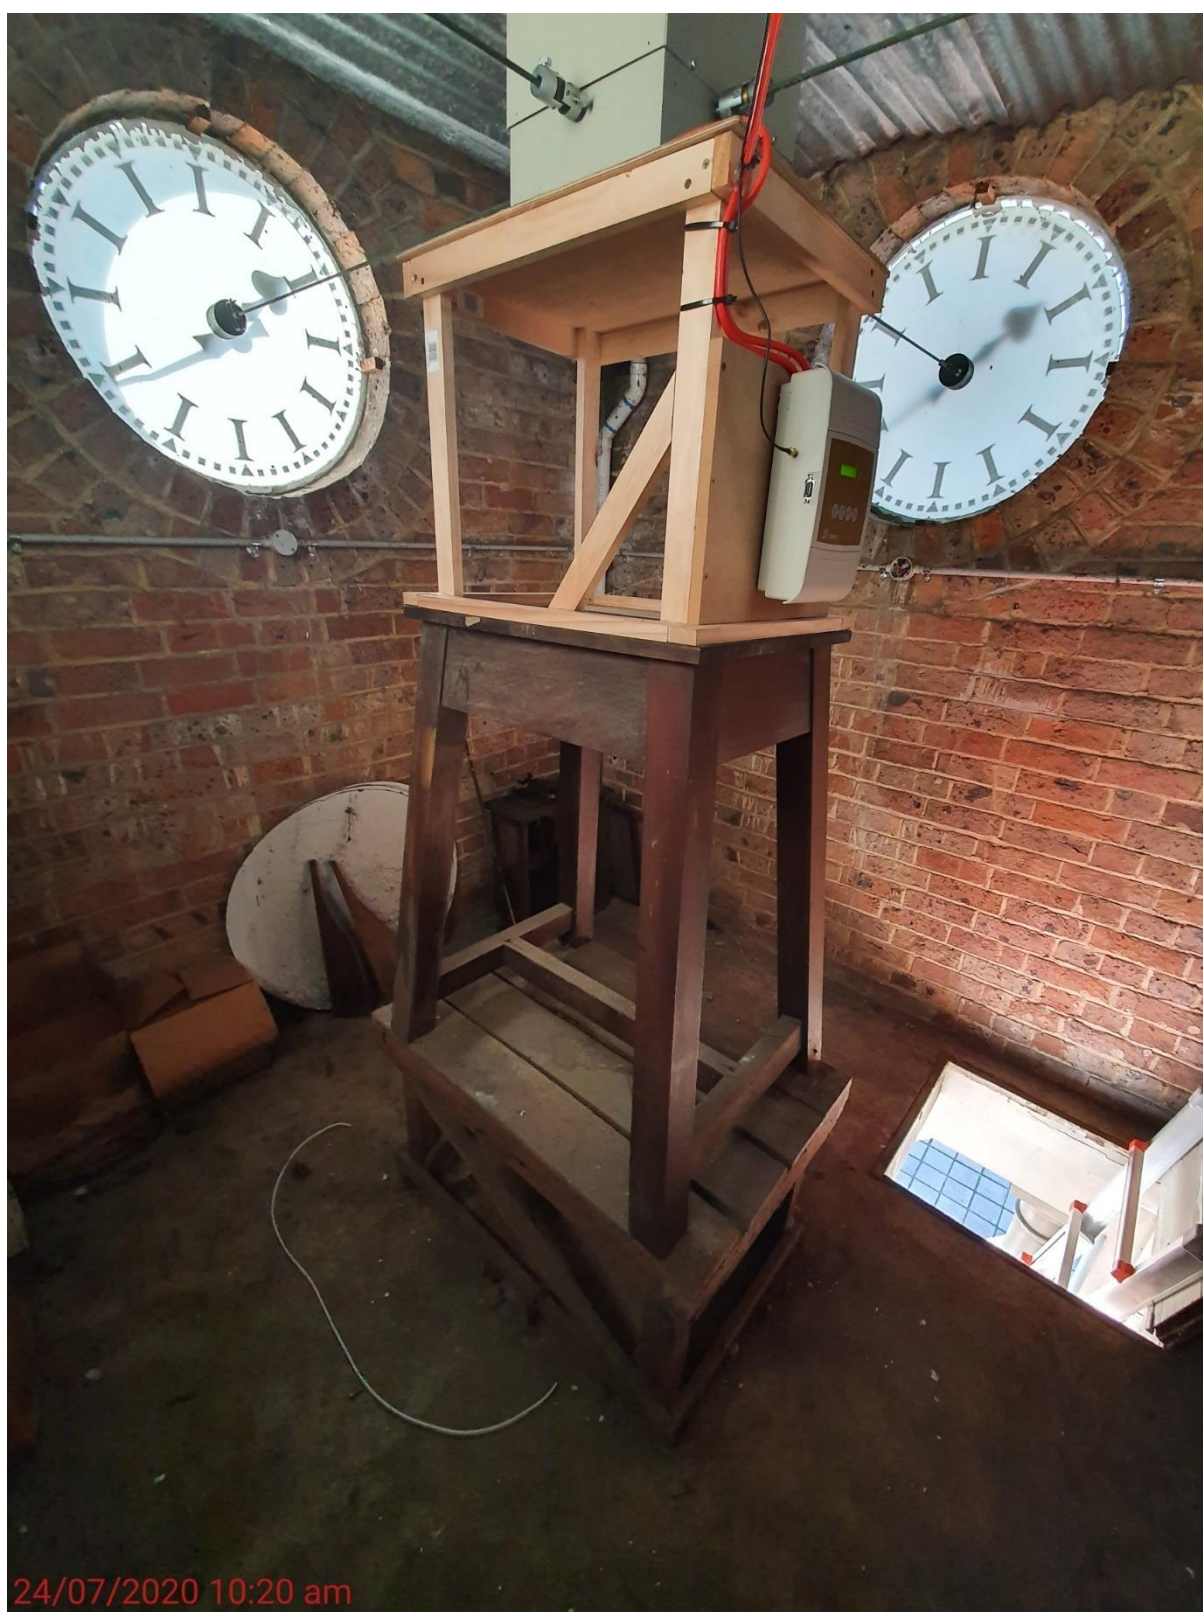
Figure 35. An overview of the clock tower interior.

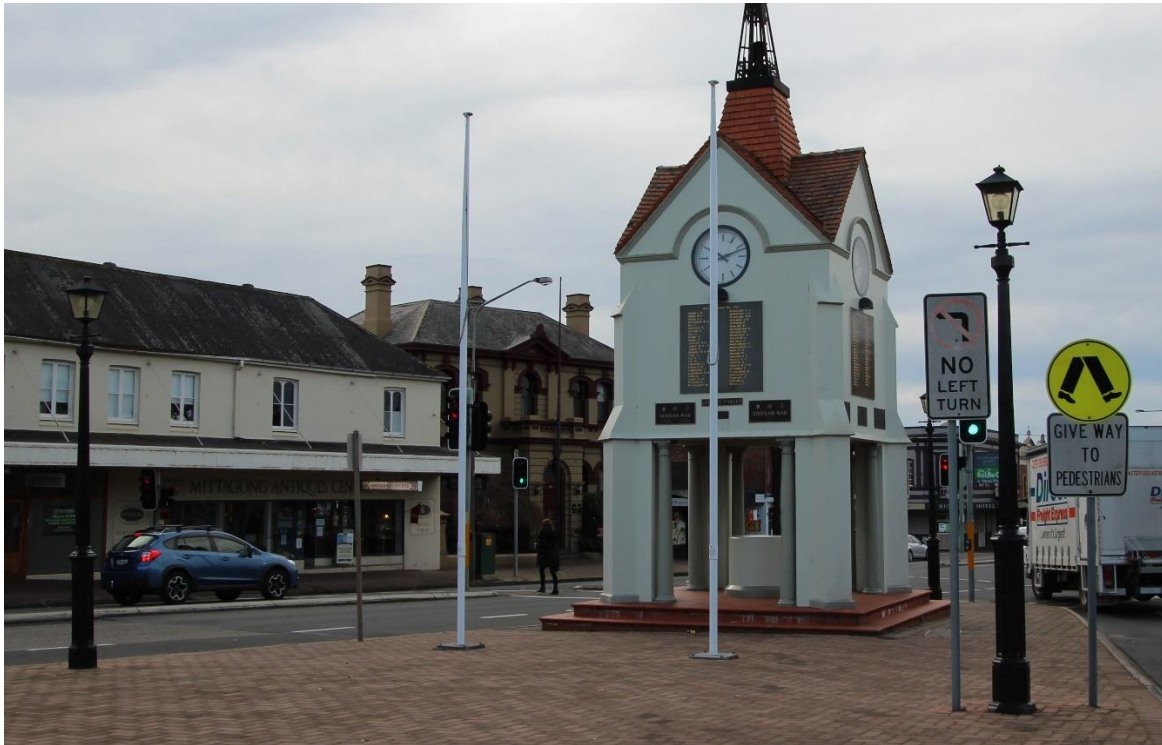
Figure 36. Light standards and flag poles

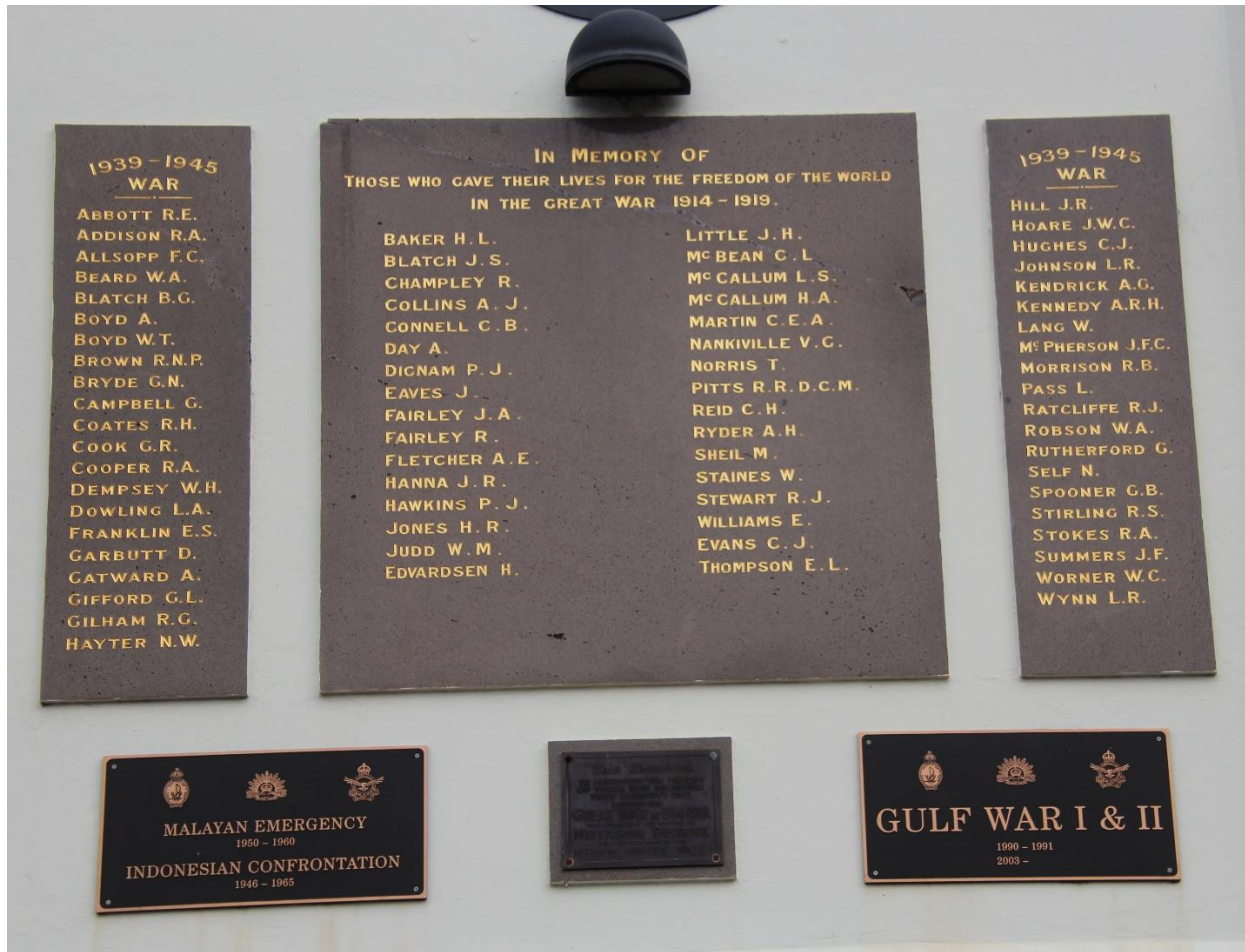
Figure 38. Plaques on the eastern elevation. Top left and top right commemorate the 1939-1945 War; The centre plaque commemorates the Great War 1914-1919; Bottom left Malayan Emergency and Indonesian Confrontation; far right bottom Gulf War I and II; and centre bottom row is the original plaque installed when the Memorial was established. The text is transcribed below.

This Memorial
TO PERPETUATE THE MEMORY
OF THOSE WHO ANSWERED
THEIR COUNTRY'S CALL
DURING THE
GREAT WAR OF 1914-1919
WAS ERECTED BY THE PEOPLE OF
MITTAGONG DISTRICT
AND HANDED OVER TO THE
MITTAGONG MUNICIPAL COUNCIL

Commemorating other conflicts other than WWI has occurred and plaques have been installed at the War Memorial. This has changed the overall appearance of the Memorial. The Memorial has no further capacity for plaques on its main walls. Should any additional plaques be proposed, an alternate location should be found after careful consideration of the impact upon significance and according to their relevance.

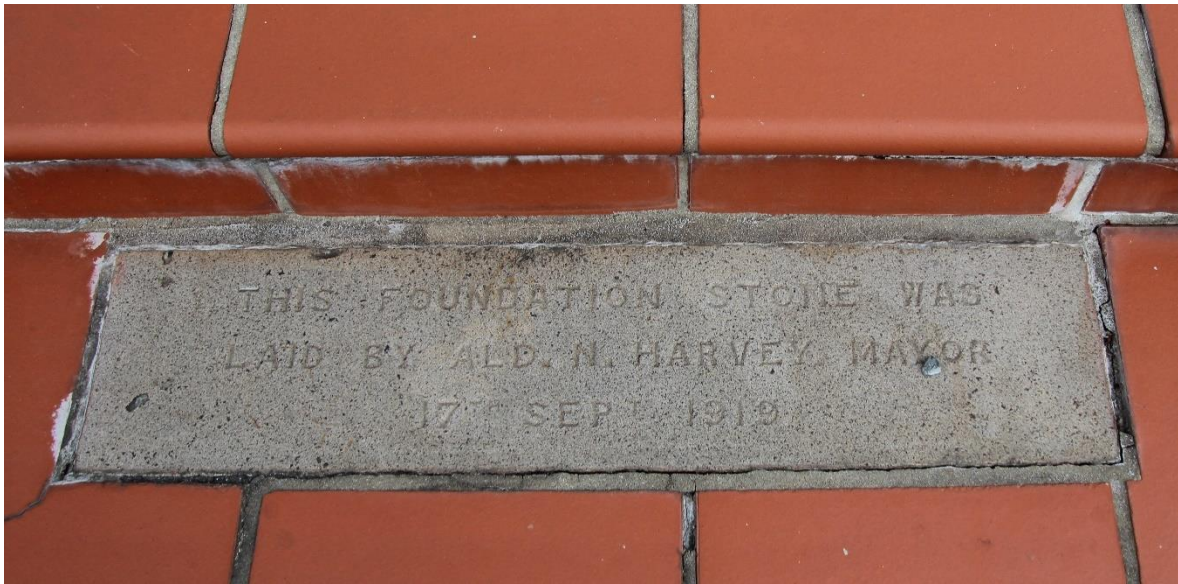
Figure 41. The foundation stone is embedded in the tiled steps. The inscription reads "This foundation stone was laid by Ald. N. Harvey Mayor 17 Sep 1919".

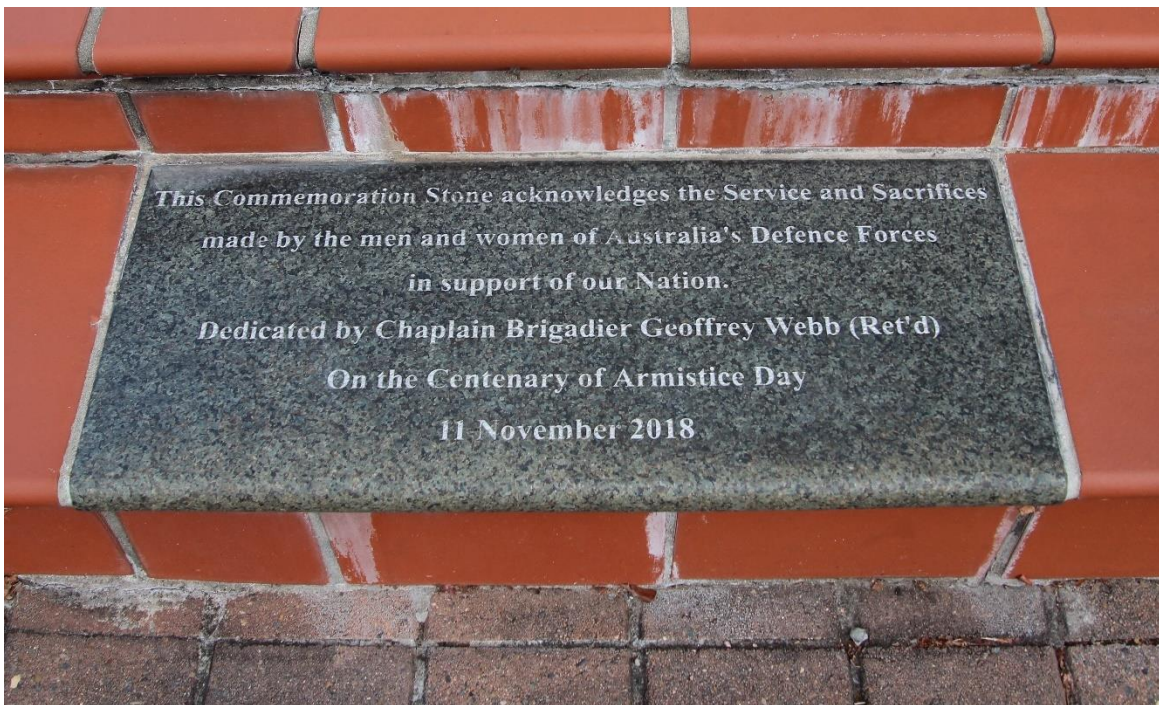
Figure 42. A commemorative plaque in the steps to mark the centenary of Armistice Day in 1918.

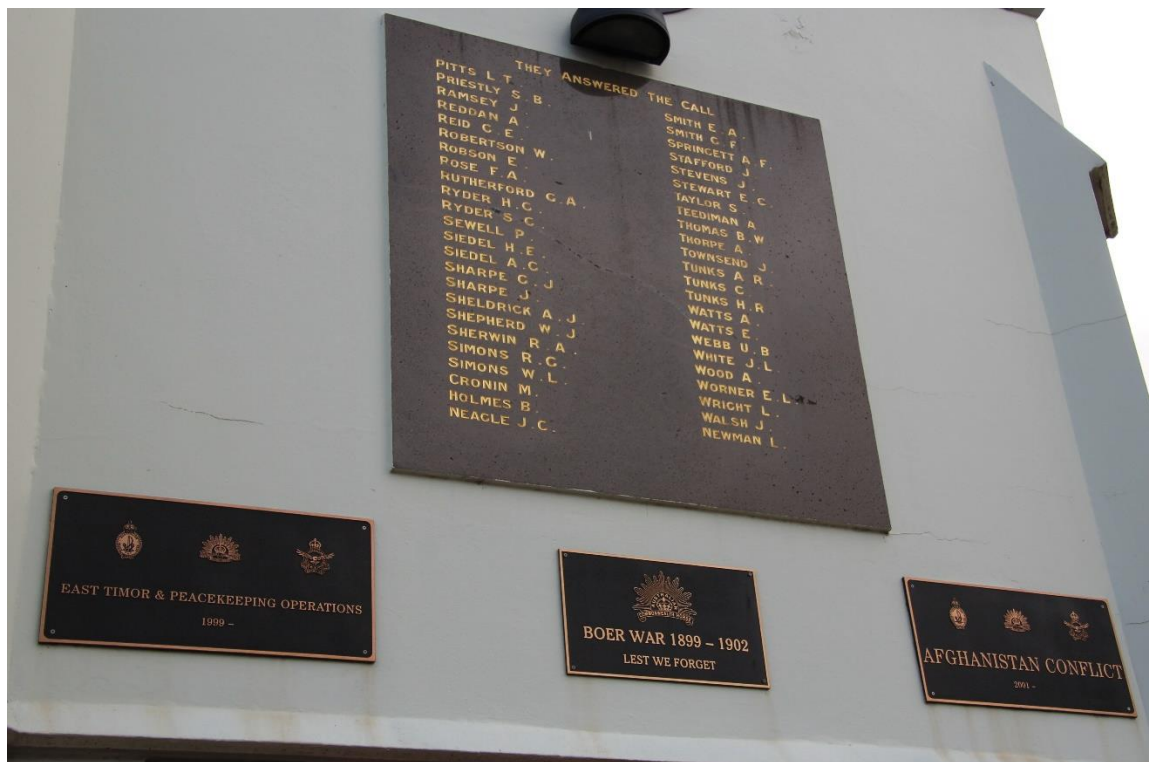
Figure 43. Plaques on the southern side of the memorial. The top plaque reads “they answered the call and lists names from Pitts to Newman. Bottom left the plaque is for East Timor and Peacekeeping operations. The centre plaque for the Boer War 1899-1902 and the third for the Afghanistan Conflict.

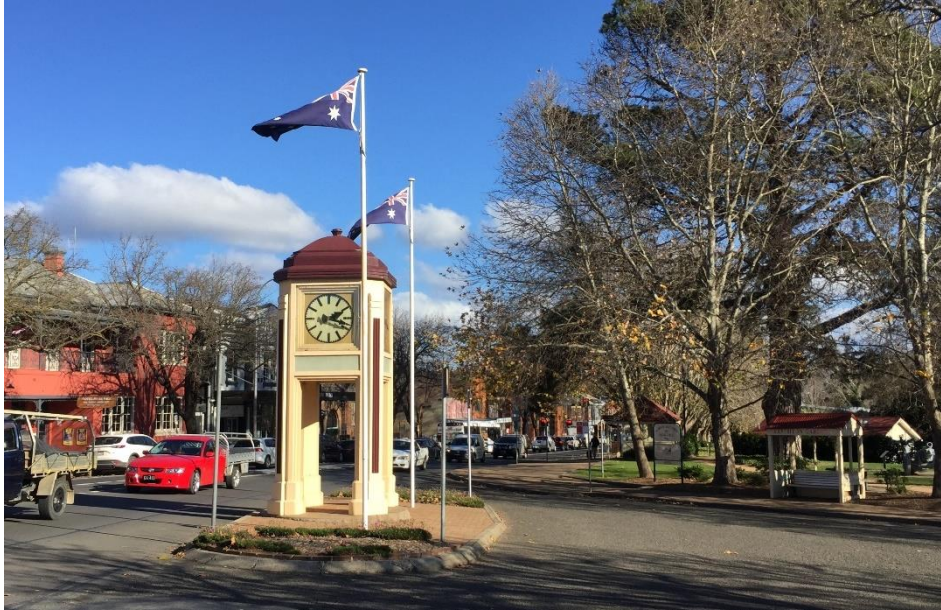
Figure 48. Dr JM Alcorn Memorial Clock Tower

The memorial clock tower is located on a traffic island in Argyle Street, Moss Vale. It is a memorial and a town clock but not a war memorial.

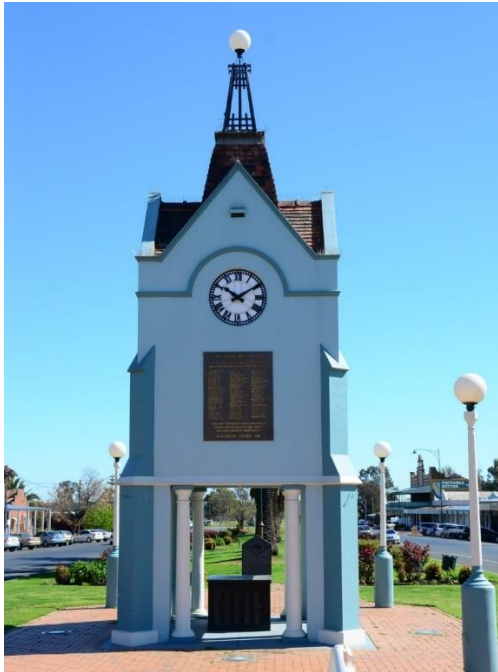
This memorial consists of a cement rendered cruciform-shaped clock tower raised on two lots of four pillars. An honour roll with dedication is attached towards the top of the tower. The clock tower was originally erected in honour of those who fell in the First World War and was unveiled on Empire Day, 24 May 1928.

Underneath the tower, a black stone cenotaph engraved with an honour roll for the Second World War and later conflicts has been installed at a later date. Several other commemorative plaques are attached to the memorial, and the Junee Long Tan memorial is also in proximity to the tower. (NSW War Memorials Register, 2021)

Figure 49. Junee War Memorial Clock Tower, National Register of War Memorials (Australian War Memorial, 2021)

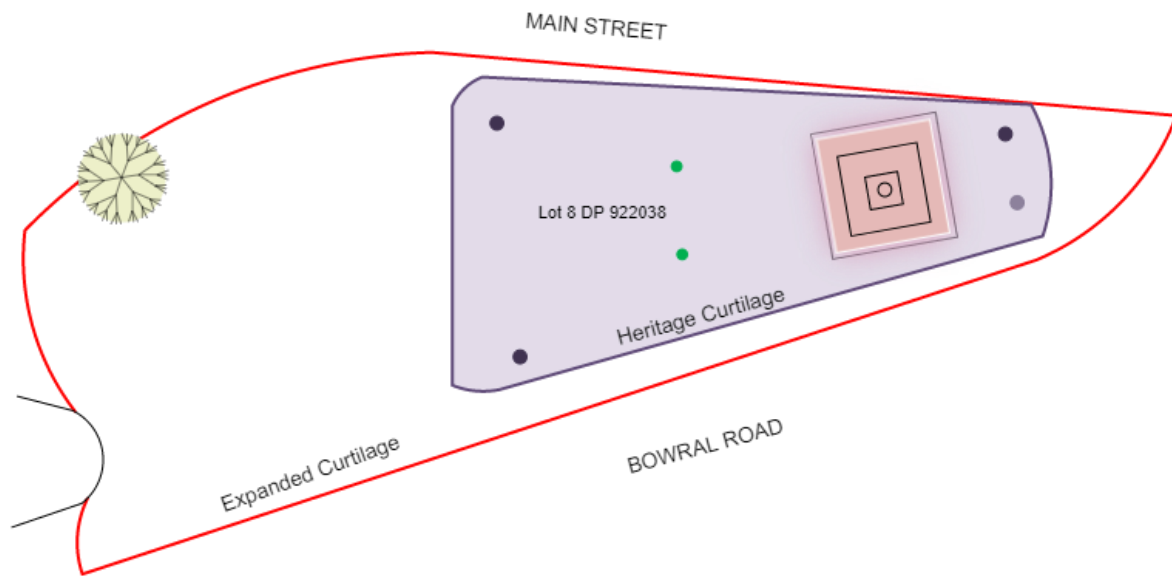
Figure 50. Diagram showing the heritage curtilage and the expanded curtilage. (Not to scale)

An expanded heritage curtilage is outside the lot boundary and provides a public open space setting to the heritage item to allow it to be viewed in the round, and in the case of the War Memorial to provide a forecourt for commemorative purposes.

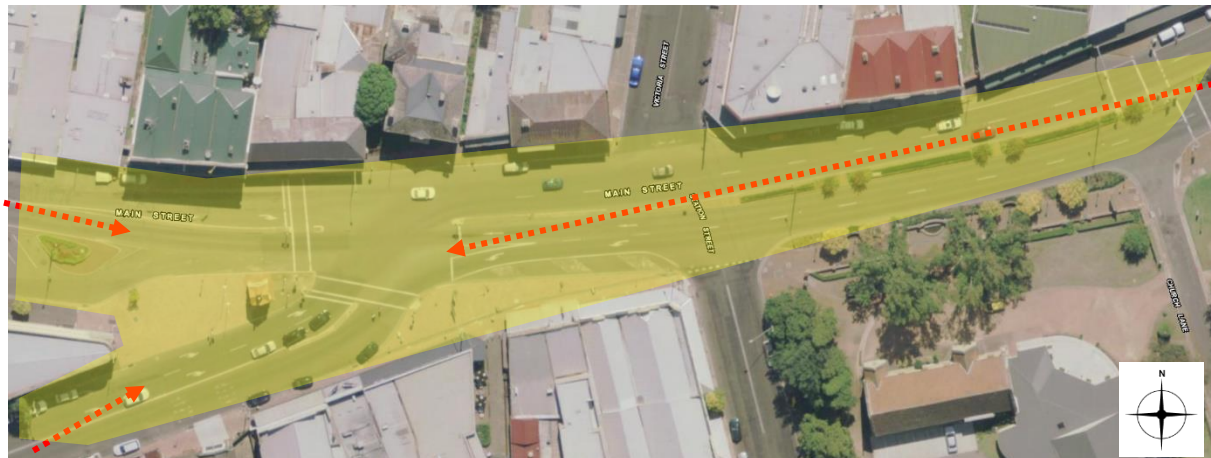
Figure 51. Diagram showing the key views to the War Memorial.

There is a significant view to the Memorial along Main Street from the east. This street joins the main road into the Southern Highlands from the north and the Memorial is a focal point at a key junction. Views from the west along main Street and along Bowral Road are also significant. These views need to remain unobstructed to conserve the significance of the Mittagong War Memorial.
