War Memorial Clock Tower

Main Street, Mittagong

Conservation Management Plan

For Wingecarribee Shire Council

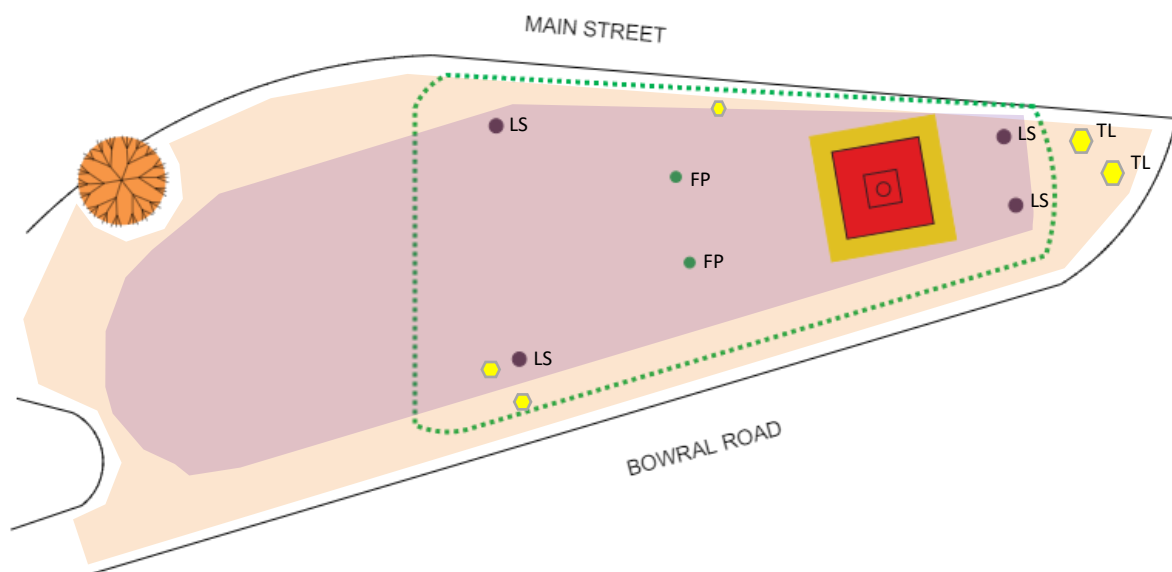
Figure 52. Site plan diagram with colours indicating relative significance. Explanation is provided in Table 1.

Element	Grading	Justification	Tolerance for change
		no relation to the period of construction.	
Pedestrian sign (S)	Intrusive	'Give way to pedestrians' sign is inside the heritage curtilage and obscures views to the Memorial.	An alternative location for the sign should be found that does not have an adverse visual impact.
No right turn sign (S)	Intrusive	'No right turn' sign is inside the heritage curtilage and obscures views to the Memorial.	An alternative location for the sign should be found that does not have an adverse visual impact.
No standing sign (S)	Intrusive	'No standing' sign is inside the heritage curtilage and obscures views to the Memorial.	An alternative location for the sign should be found that does not have an adverse visual impact.
Two traffic light posts (TL)	Intrusive	The two traffic light posts are inside the heritage curtilage and obscure significant views to the Memorial from the east.	It is recognised that the traffic lights have an important function and it would be difficult to move them. Future road design should examine the potential to relocate the traffic lights.

Element	Grading	Justification	Tolerance for change
Globe	High	Part of the original design.	Replacement only if broken and must be on a like for like basis.
Metal turret	High	Key part of the original design.	Repair and paint. Work must be on a like for like basis.
Spot lights in metal turret	Intrusive	Obscures the original open turret design.	Removal is recommended when a more effective lighting design is implemented that does not impact significance.
Roof form	High	Key part of the original design.	No change except for maintenance.
Roof tiles	High	Part of the original design.	Original ridge capping and finials could be reinstated.
Clock faces	High	Key part of the original design.	No change except for maintenance.
Covers to clock faces	Little	Not part of the original design.	Protects clock face from grime due to high traffic volume.
Electric clock mechanism	Medium	Not part of the original design but retains the clock in working order.	Can be changed to keep the clock working.

Original clock mechanism	High	Kept in the clock tower.	Important to significance, should be retained on site in the clock tower.
Lights beneath clock faces	Intrusive	Visually intrusive. Have a negative impact upon aesthetic significance.	Removal is recommended when a more effective lighting design is implemented that does not impact significance.
Pediment, label mould	High	Key part of the original design.	No change except for maintenance.
Walls	High	Part of the original design.	No change except for maintenance.

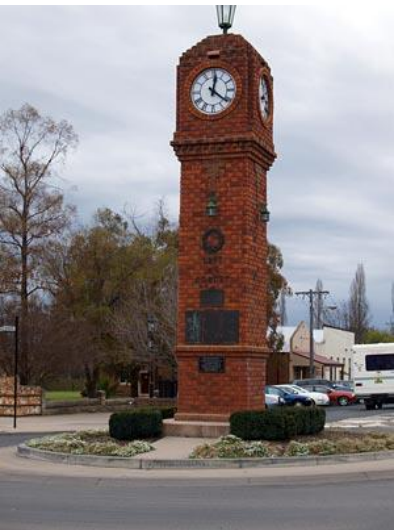
Mudgee Memorial Clock Tower	Red brick four sided clock tower in the middle of the road with garden bed forming a road roundabout. Commemorates WWII	<p>Brick</p> <p>Four-sided clock tower</p> <p>Commemorates a later war</p>

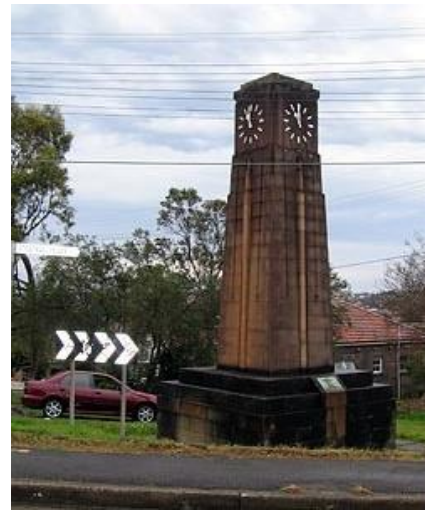
Northbridge
Memorial
Clock Tower

Commemorates
World War II

Four-sided clock on a
tapered stone tower
base with a stepped
plinth.

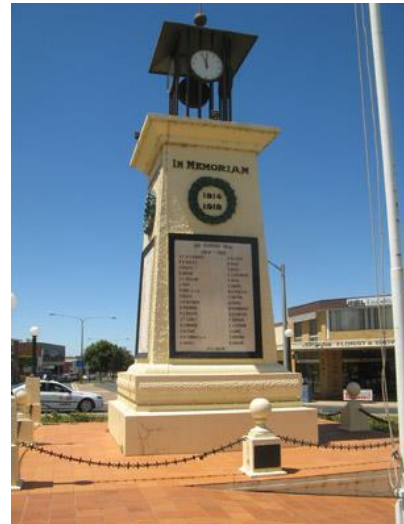
ANZAC
Memorial
Clock Leeton
NSW

Clock is a metal
structure separate
from the rest of the
structure.

Masonry is rendered
and painted.

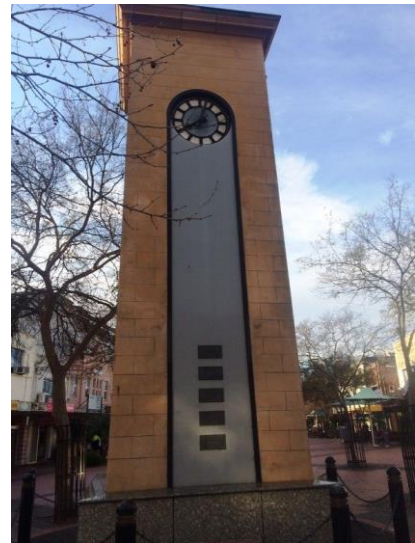
Campsie Clock Tower Memorial
194 Beamish Street, ANZAC Mall, Campsie,
Stone clock tower
Has been modified

The Clock Tower Memorial was originally erected in 1932 to commemorate those who served in World War One. The tower was remodelled in 1951
Source: Monument Australia)

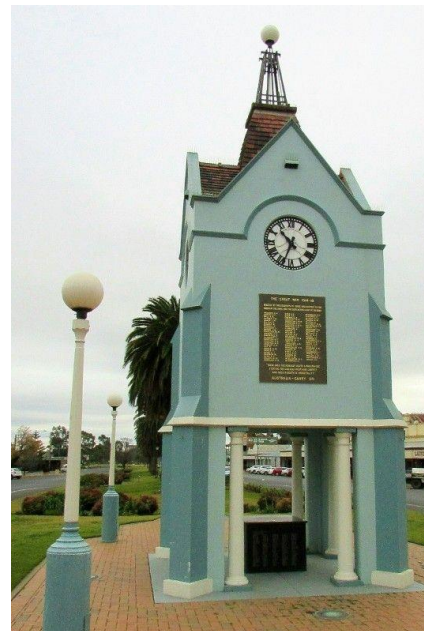
Junee Soldiers War Memorial Clock Tower
Broadway Street, Junee,
Dedicated 1928. Commemorates both World Wars
Made to the same design as the Mittagong War Memorial. The roof is slightly different as Junee War Memorial has parapets.

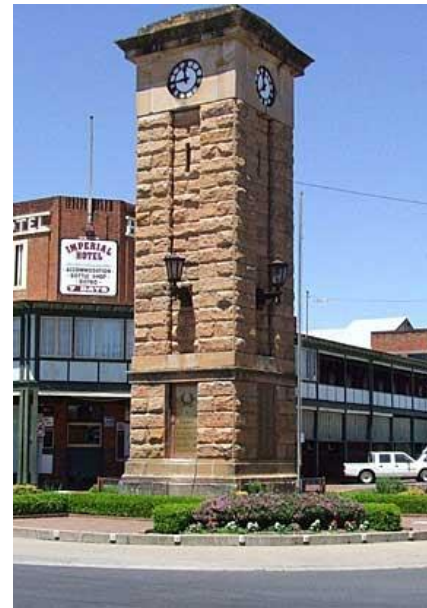
Coonabarabran War Memorial Clock Tower

A large rectangular tower made from local sandstone with a four faced clock at the top. East wall, with the dedication. There are two flagstaffs on the North and South sides. Established 1928

A clock tower with four clock faces
Memorial to WWI

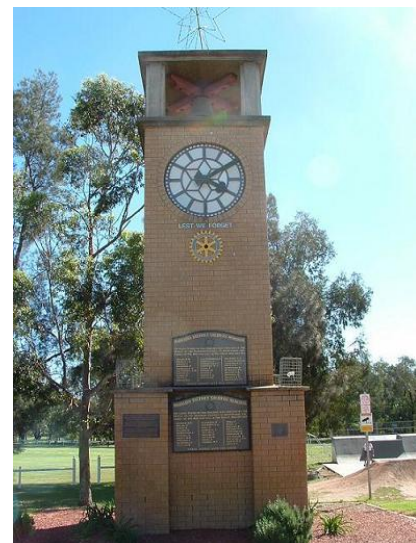
Narrabri Rotary Clock Tower

Constructed by Narrabri Rotary Club in 1978 to commemorate the Great War 1914 – 1918

A more recent version of the clock tower memorial.

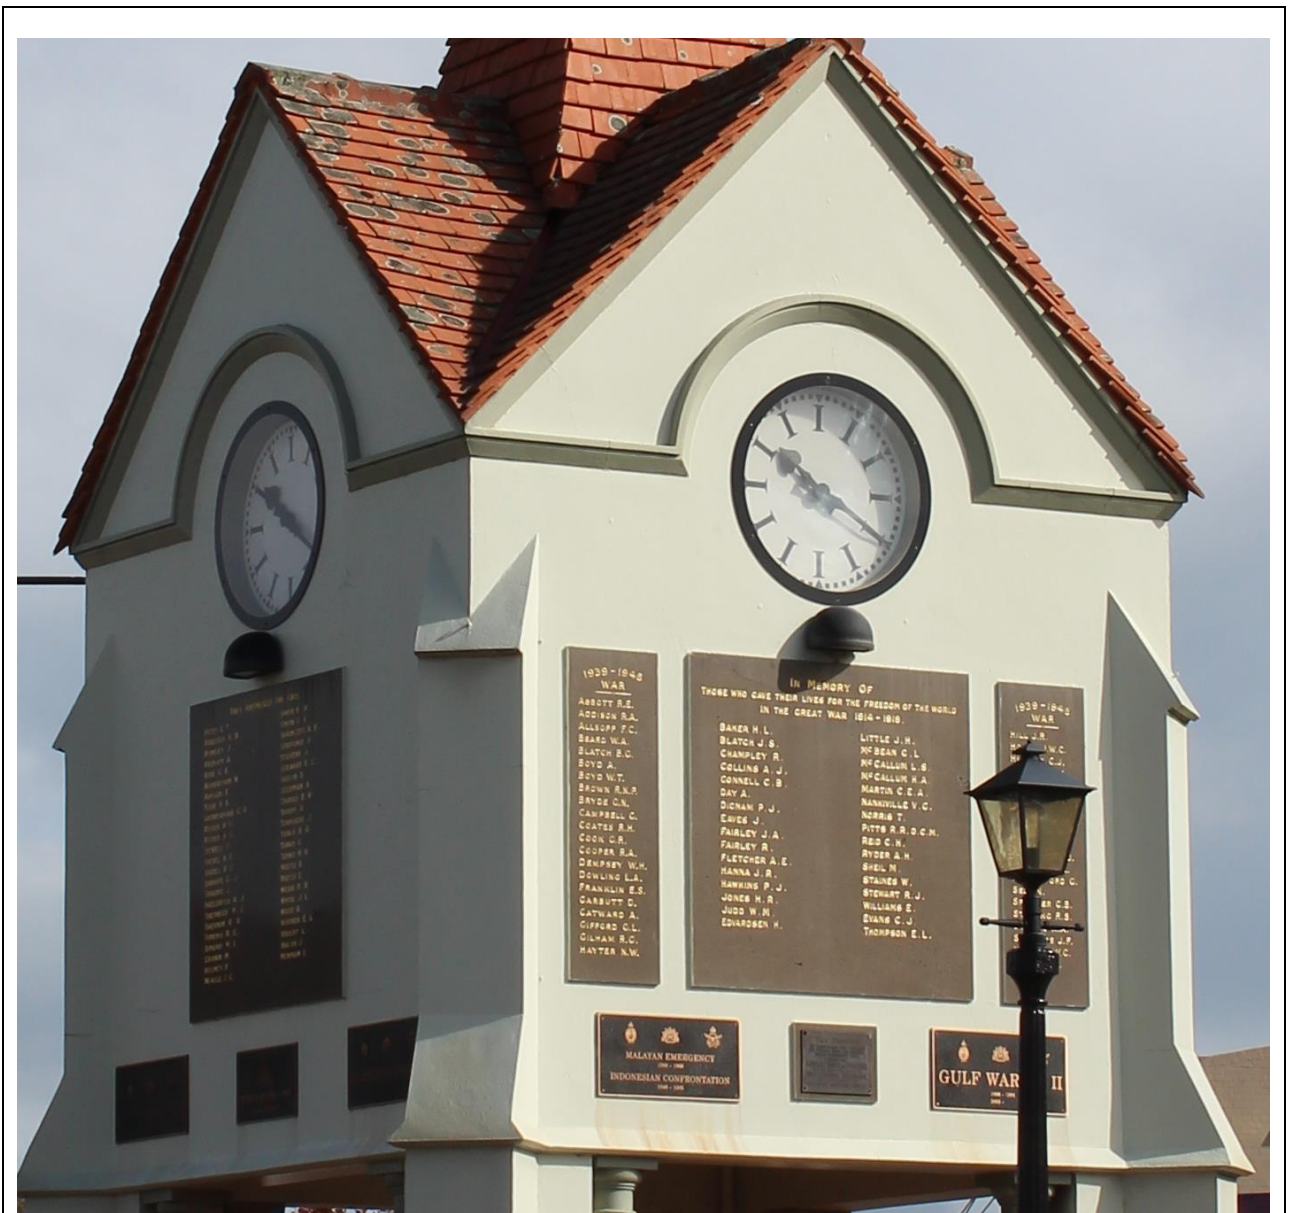
Image caption	Close view of the walls and pediments on two sides with the plaques.				
Image year	2021	Image by	Megan McGrath	Image copyright holder	Wingecarribee Shire Council

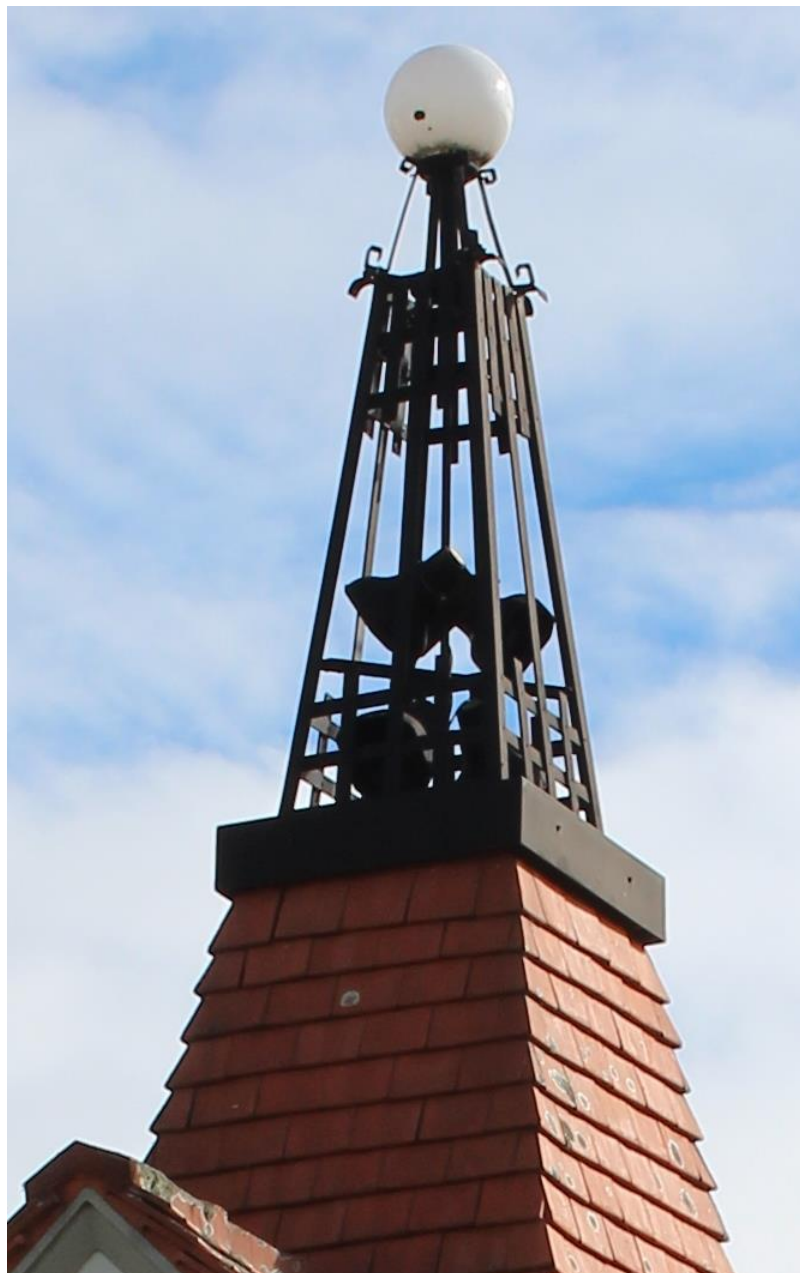
Image caption	Close view of the steeple.				
Image year	2021	Image by	Megan McGrath	Image copyright holder	Wingecarribee Shire Council
