Mittagong Creek Riparian Management Plan

Wingecarribee Shire Council (WSC)

3-11062

Revision B - 26.01.12

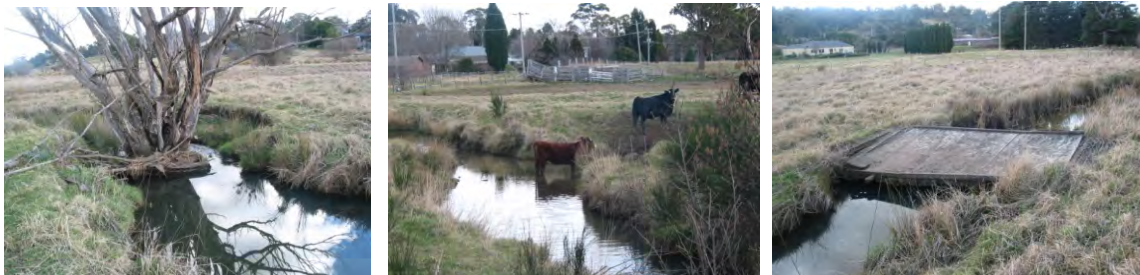
Site 2: Bowral Street – via Stanley Park and Constructed channel. Drawing 3-11062-4

The creek here has been realigned and converted into a trapezoidal drain engineered to efficiently convey flows. Shallow battered banks slope down to the channel bottom. There are no trees along the entire length of the channel with mown batters along the southern bank, adjacent to the park/ open space. On the north side of the channel, pastoral grasses and blackberry dominate. The channel floor is dominated by dense growth of *Typha*, providing a water quality function and slowing flows. There are little or no in-stream morphological features (pools or riffles) or variation.

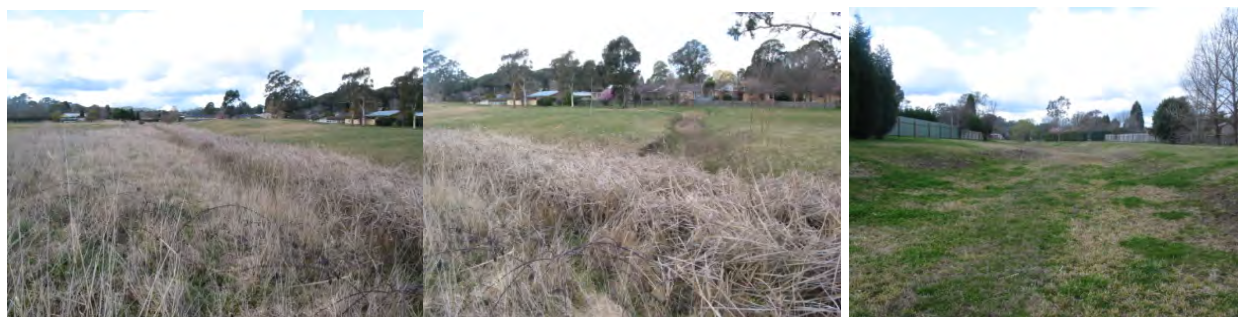
Immediately downstream from the confluence of the channel and Site 1, there is bank instability, particularly on the southern side adjacent to the park/ open space area. This is on the outside of a stream bend and erosion and bank slumping are evident. The internal side of the bend is covered with un-kept pastoral grasses and blackberry but the banks are intact. There are no trees along this section of the creek. A small concrete access point, imbedded with large rocks has been constructed adjacent to the confluence of a storm water drain. This acts as a small drop down/ riffle. The stormwater drain enters from the south and scouring of the banks is evident at this point. From the drain to the small foot bridge accessing Stanley Park there is bank erosion and increased weed occurrence, particularly on the northern bank. There is an increase of trees and riparian vegetation along the northern bank from this point as opposed to the open grasslands of the previous sites.

Stanley Park is a Bush Care site with the northern or True Right (when looking down stream) bank showing improved bank stability and occurrence of native, riparian vegetation. The southern bank (True Left – when looking downstream) borders private property and is devoid of significant native riparian vegetation, with only weedy tree species and mown grass evident. Bank instability on the true left is also evident. A growth of bamboo (likely *Phyllostachys* spp.) is evident in the property adjacent to Bowral St and the creek and appears to be spreading. There is also an increased occurrence of *Typha* from this point along the length of the creek excluding the constructed channel.

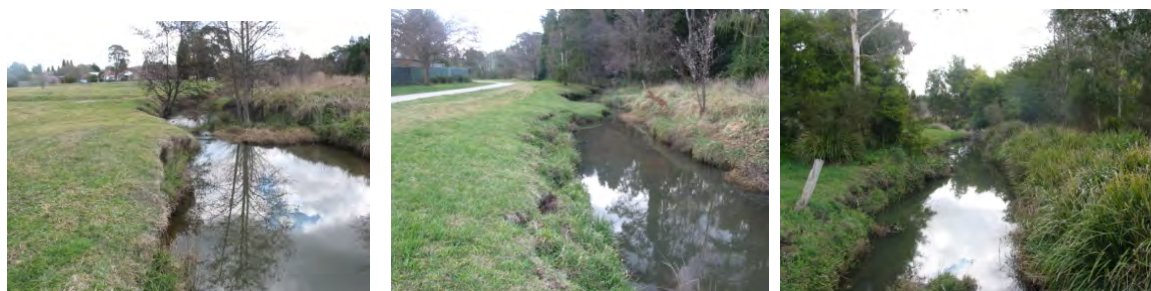
Site 3: Bowral Street – Shepherd Street. Drawing 3-11062-6

There is a significant increase in the occurrence of weed species on the true right of the creek as the system enters the urban environment and private land bordering the creek. Weed species include *Vinca major*, Japanese Honeysuckle, Ivy, Blackberry, thistles, fennel and privet. Bank erosion is an issue along the true left of the creek in this section primarily due to the lack of riparian vegetation at the top of bank. This is due to current management practices whereby riparian areas are mown to the top of the bank. There is good canopy cover within this site with large old stand trees and groupings of *Acacia* bordering the creek and adjacent open space.

There is significant erosion adjacent to a stormwater pipe out let near Bowral Street with large sediment slugs evident at the outlet and downstream. This is more evident at the Shepherd St Bridge where there is significant *Typha* growth. This is probably due to flow velocities being slowed at this point by the alignment of the creek with the bridge causing sediment to accumulate which are then colonised by *Typha*. Upstream from Bowley St a rock weir and bank armoring have been implemented by the Bowral Urban Landcare Group as part of the Mittagong Creek Restoration Project.

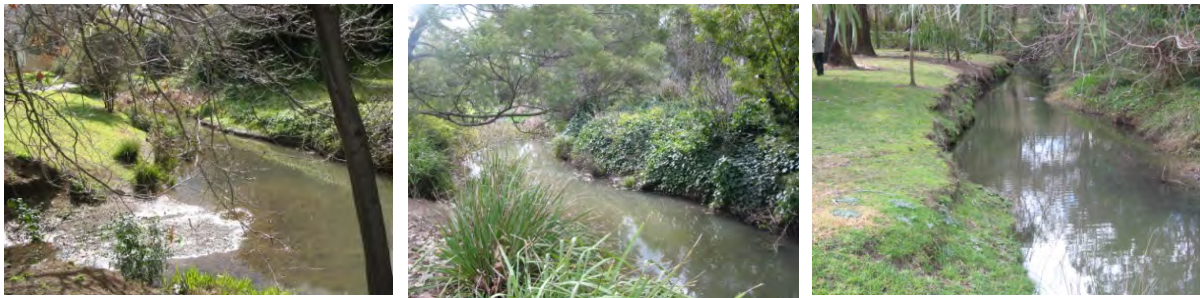
Site 4: Shepherd Street – Merrigang Street – Rose Street. Drawing 3-11062-6

This site contains the best example of urban riparian management, structure and care along the entire Project. The bank, riparian vegetation and in stream condition are all very good as presented by its highest ranking for potential successful rehabilitation (57%). Existing works to stabilise the banks with rip rap and planting have proved successful and there is good canopy cover along the length of the site apart from a small section between the footbridge and the Merrigang St Bridge. There is also a V-notch weir constructed between Merrigang St and the pedestrian footpath and a rock weir immediately downstream of Shepherd St.

Sediment slugs are evident within the channel and these have again been colonised by *Typha* and *Phragmites*. Small slugs appear within the section but significant sedimentation and weed cover is found upstream of the Merrigang St Bridge again due to the slowing of flows due to the alignment of the creek with the bridge, and the subsequent deposition of material.

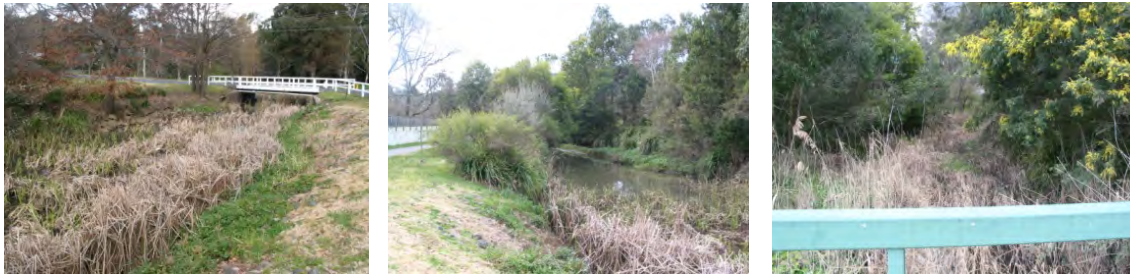
Site 5: Rose Street – Victoria Street – Mittagong Road. Drawing 3-11062-8

This is the most degraded and complex site along the creek. While parts of the creek within this site are in relatively good condition bar weed and minor bank stability issues (up and down stream of Rose Street) there are several locations where severe bank instability and erosion are expressed. This is complicated also by the proximity of the existing and the contaminated site adjacent to the Gas Works. Vertical cut erosion and large woody weed species along with the occurrence of in stream weeds (*Typha*) are the major issues. Much of this section requires further detail in the way of survey, flow analysis and construction solutions and is beyond the scope of this plan.

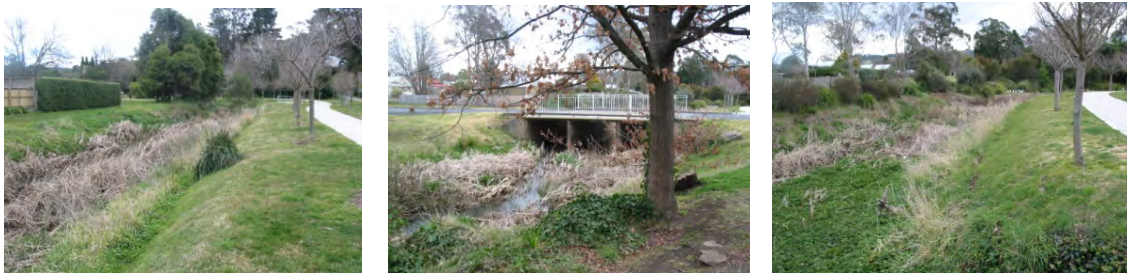
Victoria Street – Mittagong Road. Drawing 3-11062-8

Again this site is in relatively good condition aside from weed and minor bank stability issues, however there are several locations where severe bank instability and erosion are expressed. This is particularly evident on the outside of bends which are subject to higher energy flows during storm events. Conversely, the internal bends exhibit sediment slugs and deposition that are colonised by weedy riparian species (*Typha*).

There is little riparian vegetation along this entire length with mown grass, open space areas occurring to the top of the bank. On privately owned land adjacent to the creek there are significant weed species including *Vinca major*, Japanese Honeysuckle, Ivy, Blackberry, thistles, fennel and privet.

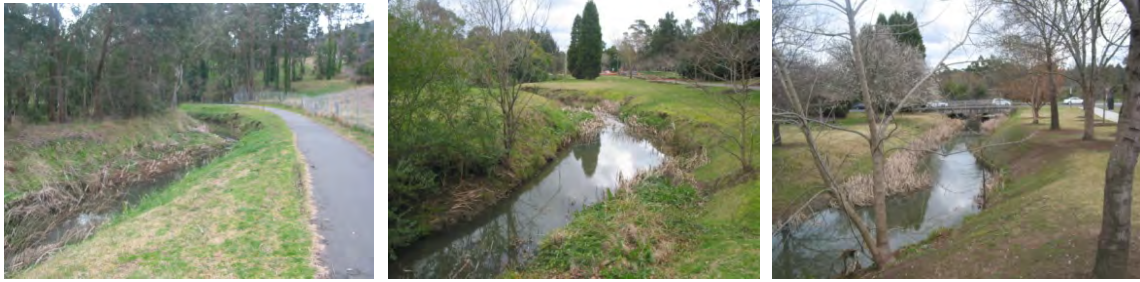
Site 6: Northern Tributary. Drawing 3-11062-9

The majority of this site runs through private property and was unable to be accessed for assessment. The area adjacent to the Centennial Park Dog Park however has significant large weed tree species, namely Privet with smaller weeds species including *Vinca major*, Japanese Honeysuckle and Blackberry present. Another large tree thought to be 'White Poplar' also occurs adjacent to the creek. Bank stability along this section is generally very good with only minor erosion evident. There is a good mix of canopy trees both native and exotic observed on neighbouring private property.

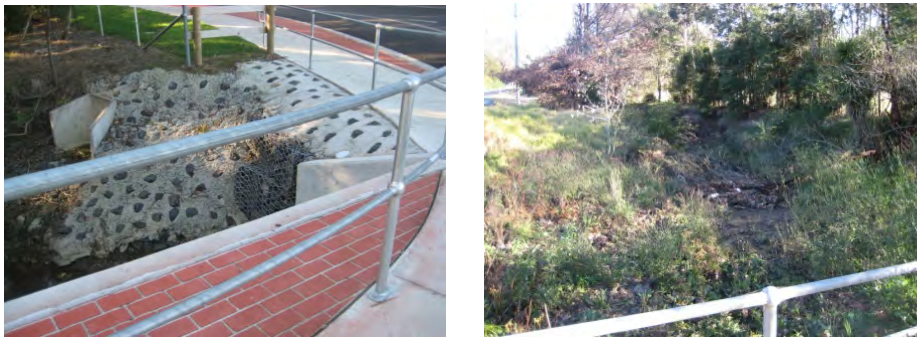
Site 7: Centennial Road – Mount Road. Drawing 3-11062-10

There is a large amount of sediment build up on the western side of the culvert to Mittagong Road and significant scouring immediately downstream of the culvert with 2m vertical banks exposed. This zone, to approximately 100m downstream of the culvert will require further detailed investigation and is beyond the present scope. Works in this area are also complicated by the amount of large existing trees at the top of bank which are currently maintaining bank integrity.

Downstream of the above site the banks and vegetation are generally in good order with the only main issue being the presence of large woody weed species, namely Privet and under storey weeds such as Blackberry. Bank stability will need to be assessed and will be dependent on the amount of weeds to be removed (trees). As there is also a significant number of native tree species along the bank, bank battering may not be appropriate. Several in stream sediment slugs were identified and also impediments to stream flow due to trapped debris. Excessive sediment build up was observed at the Mount Rd Bridge with flows restricted to one section of the under bridge structure. Removal of sediments at this location will require extensive protection of the toe of the bank to prevent scouring around the bridge structure.

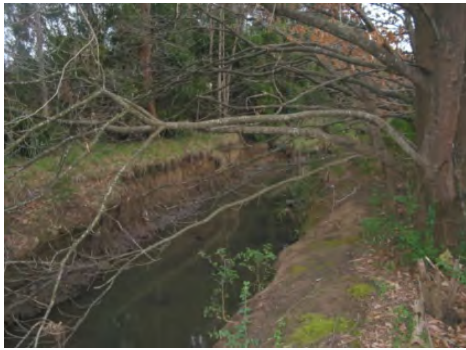
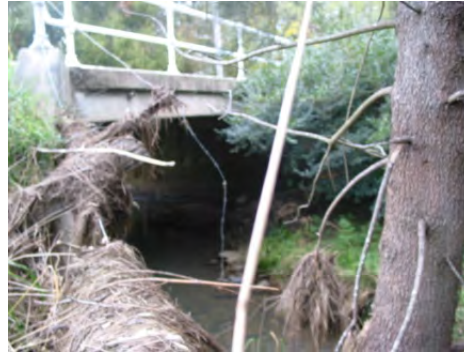
Site 8: Mount Road – Willow Road. Drawing 3-11062-11

Immediately downstream of Mount Road there is evidence of riparian planting with the occurrence of *Lomandra* and *Acacia* sp amongst weedy grass species. The native plantings are presumably as a condition of consent associated with neighbouring industrial development. There is a lack of successional canopy species near Mount Road and the occurrence of weeds such as Blackberry and Privet increases further downstream while tree canopy cover from *Casuarinas* and Eucalypt species also increases. Bank stability in this site is generally good with only a small number of locations expressing any threat of erosion. There is evidence of bed lowering due to the narrowing of the channel caused by vegetated sediment slugs that form benches adjacent to the toe of the bank. In stream obstacles caused by trapped debris and dams created by local children were observed.

Adjacent land practices of grazing and agriculture have limited the width of the riparian zone on the true right while on the true left, industrial activities have generally been limited to property boundaries and the riparian zone, although weedy is a fairly wide Council Reserve on the true left with considerable scope for rehabilitation. This section was previously the focus of a local Landcare group's rehabilitation activities, including Willow control and revegetation, though little maintenance has been carried out in recent years. There is some evidence of dumping of material from the industrial sites and windblown rubbish within the riparian zone, although this wasn't as bad as might be expected and was limited to only a couple of locations.

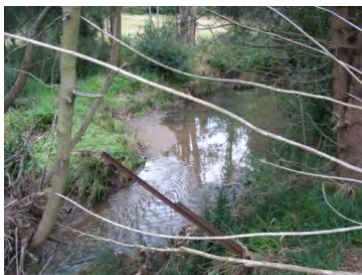
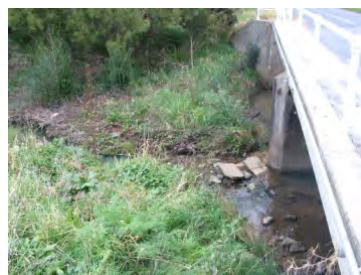
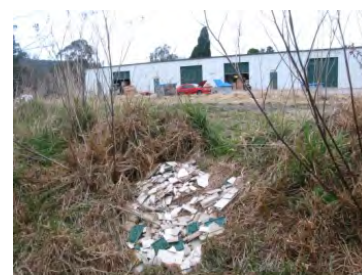
Site 9: Willow Road – Oxleys Hill Road Drawing 3-11062-12

This site is extensively weedy with Privet and Willow the dominant weed species punctuated with native canopy species. Bed and bank stability is generally good and supported by native trees and weedy undergrowth. The significant threat in this section is the occurrence of large amounts of debris caught in stream, inhibiting flows. Sediment slugs were also identified along with bank erosion. But again banks are generally stable.

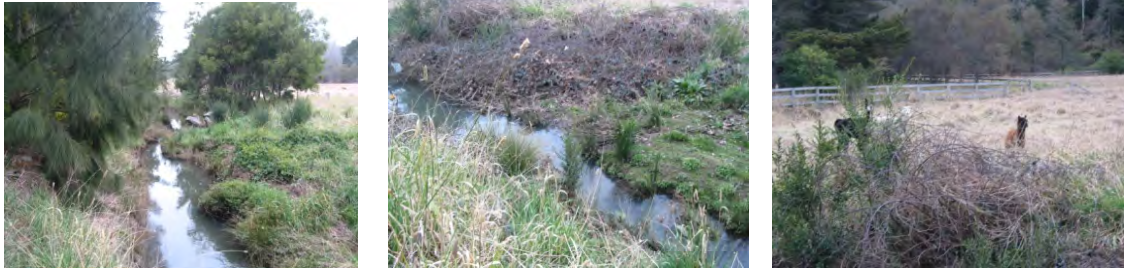
Site 10: Oxleys Hill Road – Sewage Treatment Plant. Drawings 3-11062-13, 14

This site is generally free of canopy weed species with Blackberry, Honeysuckle and grassy weeds the dominant weeds. Bank stability through this section is generally very good with low, shallow batters. Bed condition is also good with only a handful of sediment slugs observed. There are also a number of drop downs and pools helping this site rank highly in the ranking assessment (49%). This is primarily due to the lack of weedy trees increasing the potential for successful rehabilitation.

Rubbish and drains were observed on the Industrial side of the creek with unchecked (no scour protection, trash racks etc) flows from pipes noted. Again this was only noted in a couple of instances and in general it appears that industrial activities are not contributing significantly to in stream or embankment rubbish accumulation.

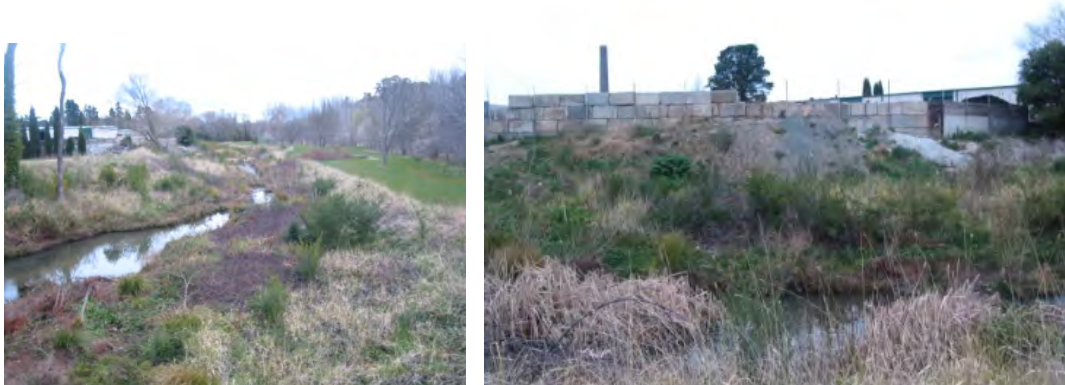
Quarry – Sewage Treatment Plant

The creek has been altered through this site due to quarrying activities and has been straightened with pools and riffles created. There is no issue with bank stability through this section as the creek breaks out into an open flood plain over constructed riffles. There has been significant native tree species planted in this area. A large number of young Willows are starting to establish within the rock riffles and Blackberry is the dominant terrestrial weed species. This area shows very good potential for rehabilitation.

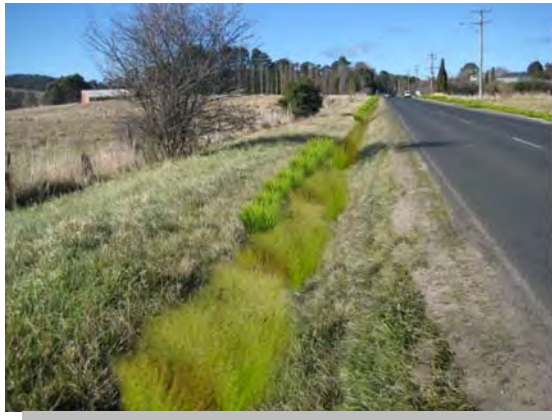
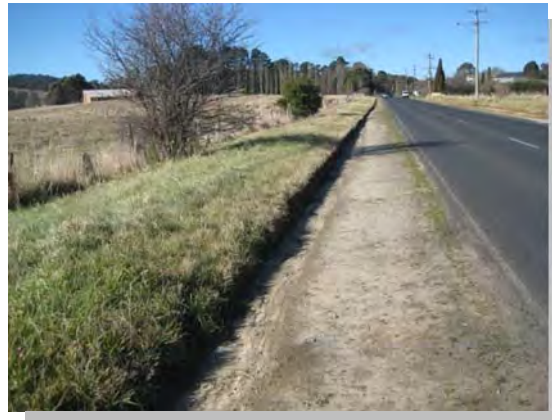
Grass buffer strips should to be established and maintained along landscape depressions where overland flow concentrates and enters small channels or gullies to reduce sediment and nutrients entering the creek. The aim is for a broad, well-grassed strip covering the entire area of flow concentration if possible, to protect against times of heavier rainfall. Eg.

It is important to keep livestock out and to maintain the buffer to ensure there is almost complete ground cover and a good height of vegetation (grasses should be at least 10-15 cm) to maximise the capacity for sediment and nutrient entrapment. The ideal width and management practice for grass buffer strips depends on the volumes of water and sediment being transported and the nature of the adjacent landscape, however it is generally recommended that an ideal combination of 10m of grass buffer and 10m of natural vegetation

Figure 2-1:	Locality map, Mittagong Creek.....	5
figure 12-1:	Grass buffer strips trap sediment and protect the ephemeral gully and main creek channel from sediment, nutrients and animal wastes. (Australian Wetlands, 2008)	39
Figure 12-2:	Conceptual image of pioneer planting (Australian Wetlands, 2008)	40
Figure 12-3:	Conceptual image of structural reconstruction (Australian Wetlands, 2008)	41
Figure 12-4:	Conceptual image of riparian water quality buffer indicating existing degraded condition (above) and revegetated riparian water quality buffer (below). (Australian Wetlands, 2008)	42

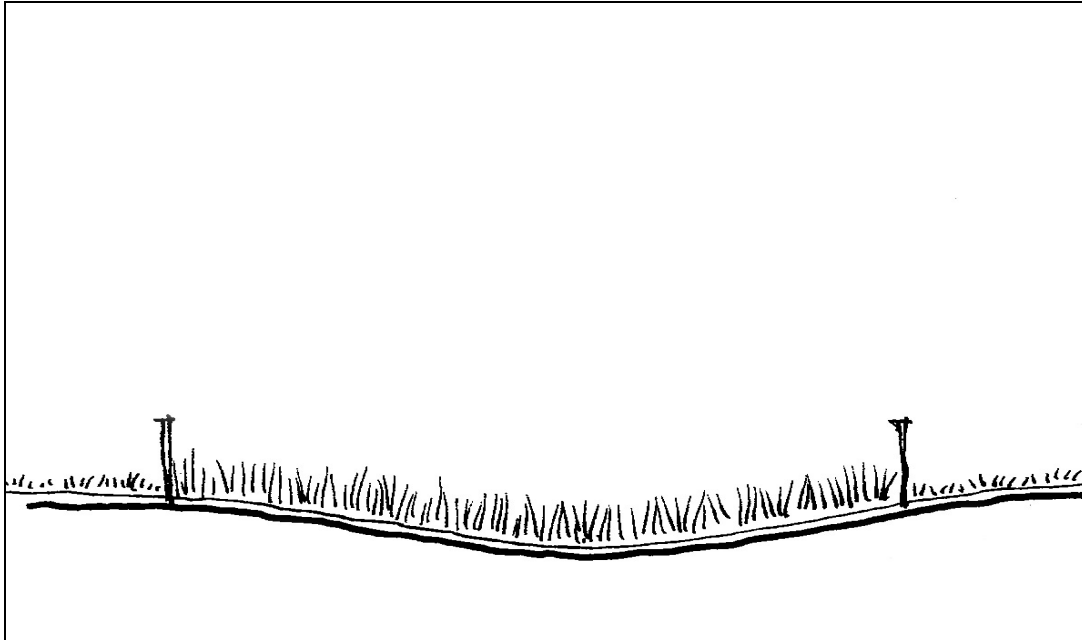
figure 12-1. Grass buffer strips trap sediment and protect the ephemeral gully and main creek channel from sediment, nutrients and animal wastes. (Australian Wetlands, 2008).

adjacent to a stream will be effective in most situations (Prosser and Karssies, 2001). Width will be subject to landowner negotiation, however between 10m and 20m is recommended.

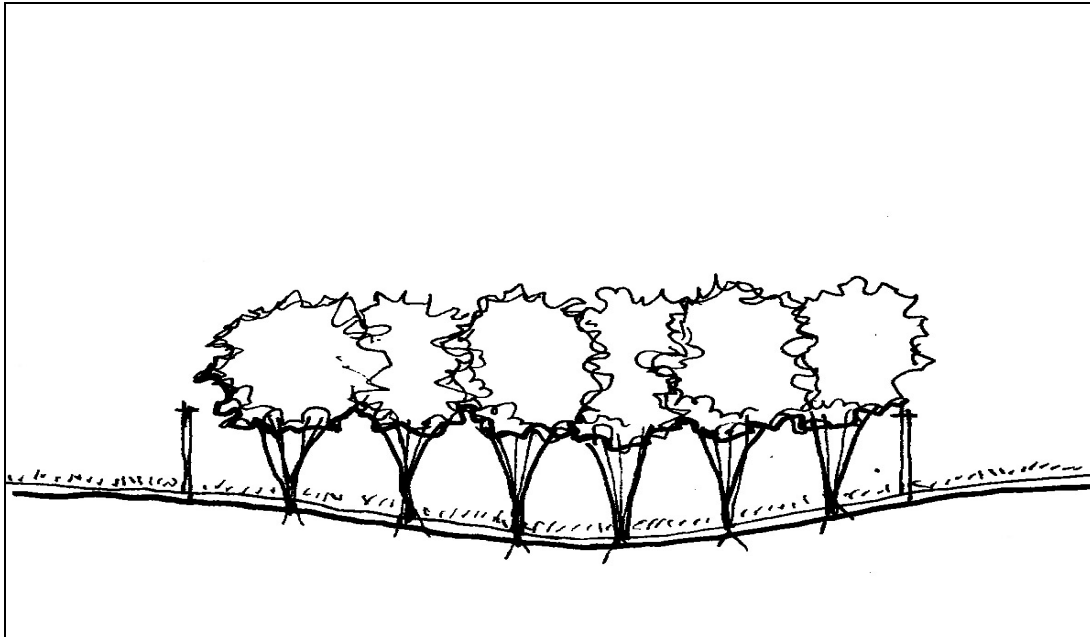
Figure 12-2. Conceptual image of pioneer planting (Australian Wetlands, 2008).

The primary aim of the planting is to improve water quality, however this style of planting has potential additional value a woodlot or carbon sink without its water quality function being compromised. Similar to grass buffers, it is recommended that this planting type be at least 5m wide and be situated to ensure that ephemeral and overland flow paths are intercepted.

Establishment of this buffer would involve fencing to exclude livestock, slashing and spraying of pasture grass, planting of appropriate native species at a density of between one and two tubestock per square metre, initial watering and periodic follow up weeding until the native plants are sufficiently established to suppress weed growth.

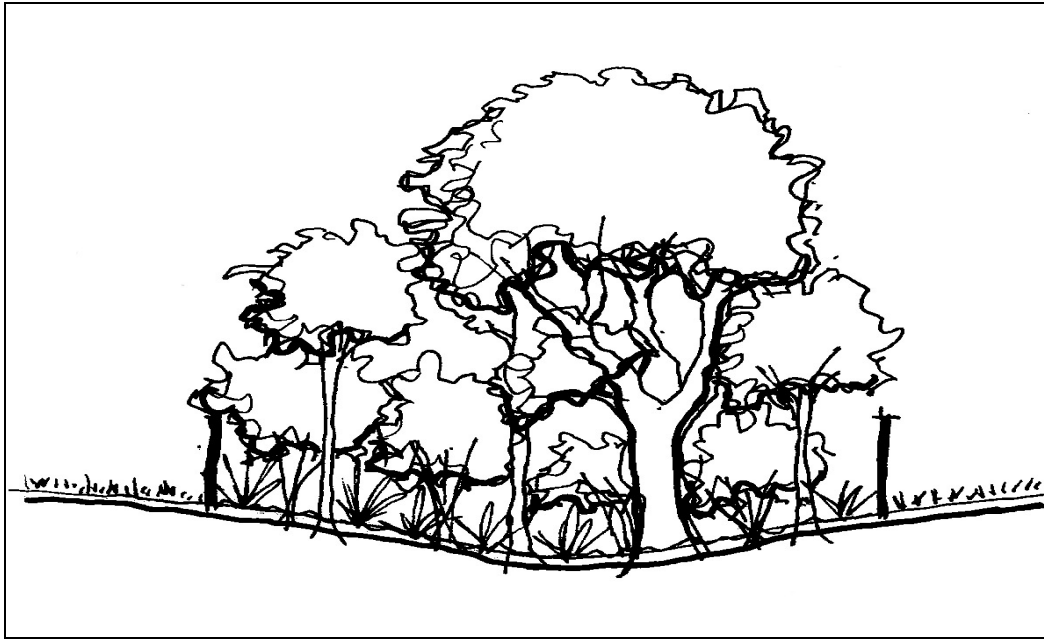
Figure 12-3. Conceptual image of structural reconstruction (Australian Wetlands, 2008).

Restoration in this context would involve primary weeding using techniques such as cutting and painting or drilling and injecting woody weeds, spraying of herbicides and scraping and painting canopy weeds such as vines. Beyond this primary weeding phase, secondary weeding will be required, possibly in combination with mulching or brush matting of exposed soils.

Planting of appropriate native species is required to recreate the site's original vegetation community with respect to species and composition. Follow up weed control and then maintenance weed control over a two to three year period is assumed to be required.

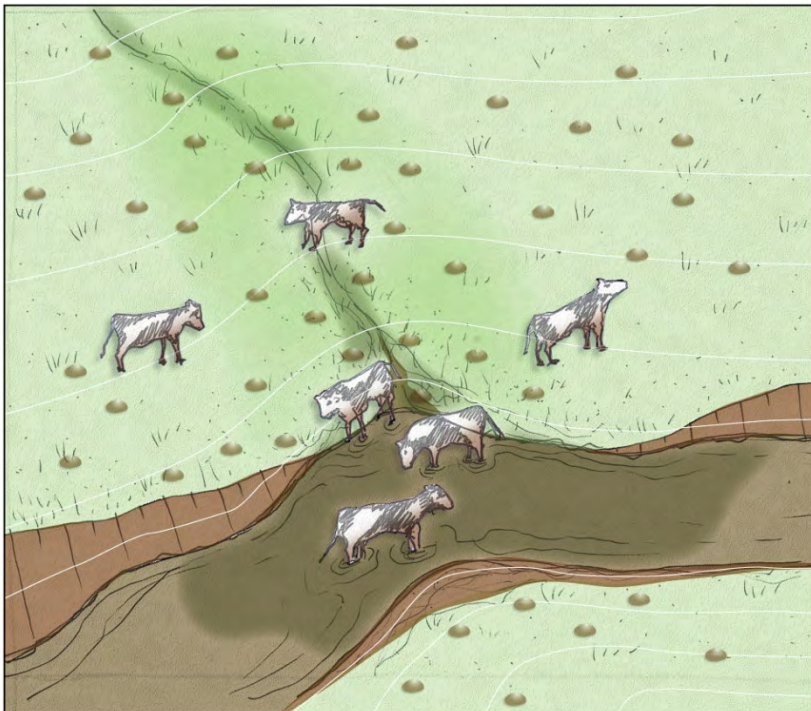
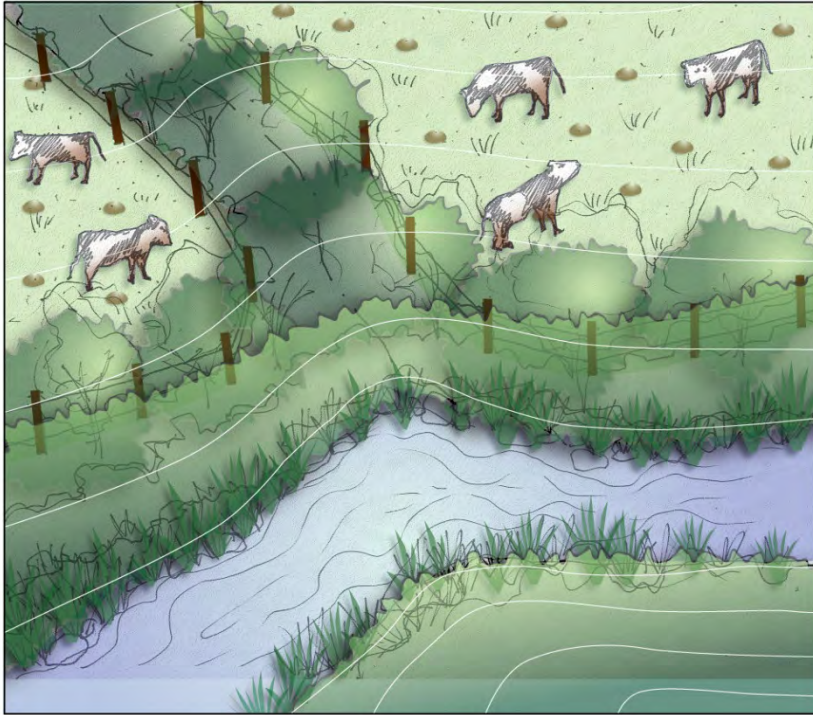
Figure 12-4. Conceptual image of riparian water quality buffer indicating existing degraded condition (above) and revegetated riparian water quality buffer (below). (Australian Wetlands, 2008).

A Water Quality Buffer is an area of the riparian vegetation parallel to the waterway that is planted with the aim of improving water quality by removing sediment and sequestering nutrients and other pollutants from overland flow, while increasing the stability of the creek banks. Four types of Water Quality Buffers are discussed further in this plan; grass buffer strips, pioneer species planting, structural reconstruction and designed landscape response. A conceptual image contrasting the existing degraded condition and a revegetated Water Quality Buffer is provided in Figures 12.1 – 12.4.

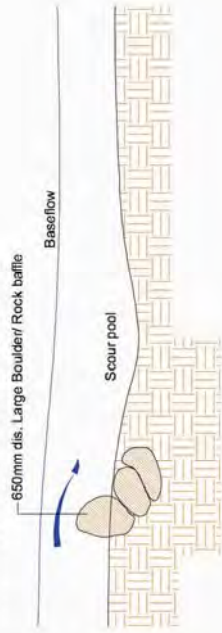
Instream Boulders/ Rock Baffles (NTS)

- Clumps of boulders are located in creek sections where stream banks are stable.
- Boulders should be placed away from stream bank edges as they can cause localised bank scour.

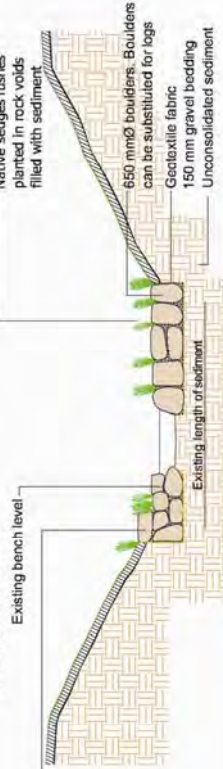
Rock/log Ribs (NTS)

A rock rib is formed excavating approximately one metre by one metre trench across the bench, lining with filter cloth, then backfilling with rocks. The ribs are to be revegetated.
